# Understanding what went wrong

## Investigating the de-bonding of vinyl flooring at a health centre

When a contractor insisted that damp was causing recently-installed vinyl flooring to de-bond, BRE were asked investigate

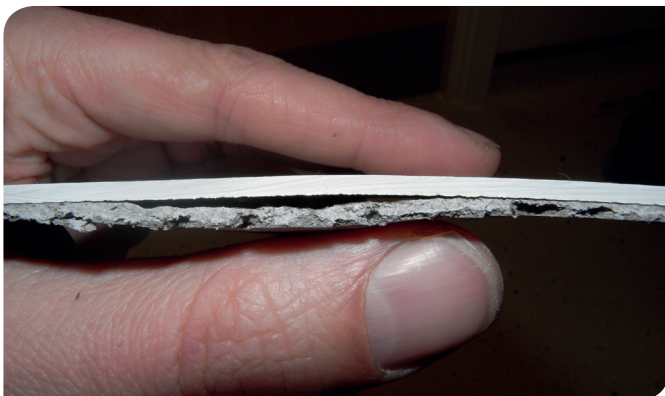
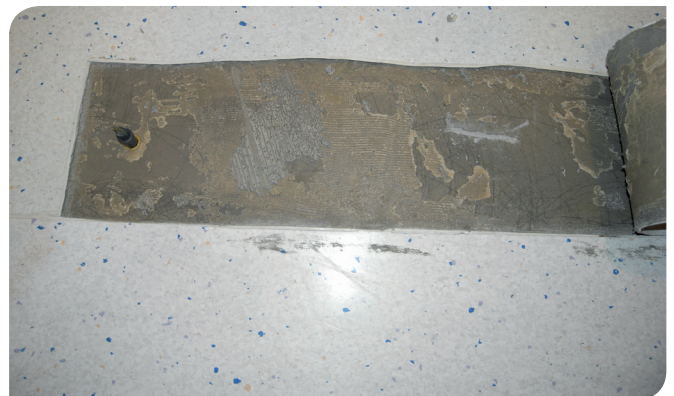
Soon after vinyl flooring was laid in a new health centre, bubbles began to appear, signifying that it had de-bonded from the sub-floor. The flooring was replaced but the problem persisted in some areas. Following an investigation in the two affected areas, the flooring contractor reported that the problem was caused by damp, rather than poor workmanship. However, the main contractor wanted to be sure so called on BRE's expertise.

In this case, BRE carried out a full visual and intrusive investigation of the flooring, which involved lifting the vinyl, examining the condition of the materials and measuring the dampness levels of the subfloor in 20 locations across the site. This more extensive investigation than the one carried out by the flooring contractor, revealed that the subfloor wasn't damp enough to cause the failure

of the vinyl flooring. There were, however, several problems with the workmanship during installation, which led to a weak bond between the primer and smoothing compound that caused the flooring to de-bond.

BRE recommended that the vinyl in the affected areas was removed, the surface of the screed properly prepared and primed and a rapid-setting smoothing compound laid. BRE also provided a specification for replacing the flooring in a short time window and recommended a room-by-room approach to repairs to minimise disruption.
