Annex C – Cavity Closures

Introduction

The objective of this study was to investigate the effectiveness of different types of window frame constructions at mitigating the entry of fire into a timber frame cavity.

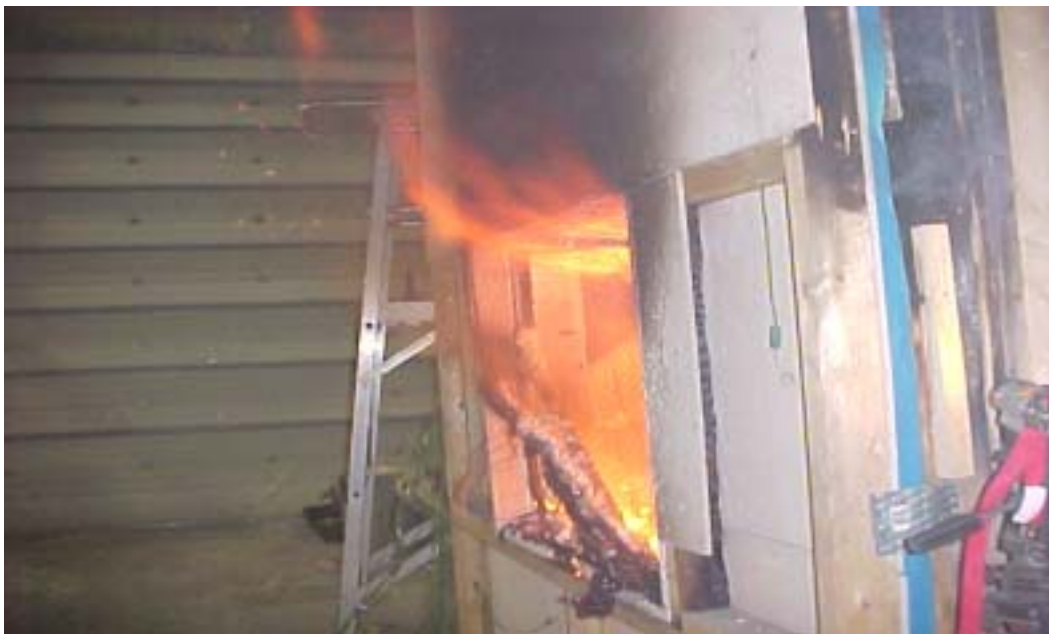
PVCu with timber bead

Photograph C1. Showing the break through of flames out of the enclosure

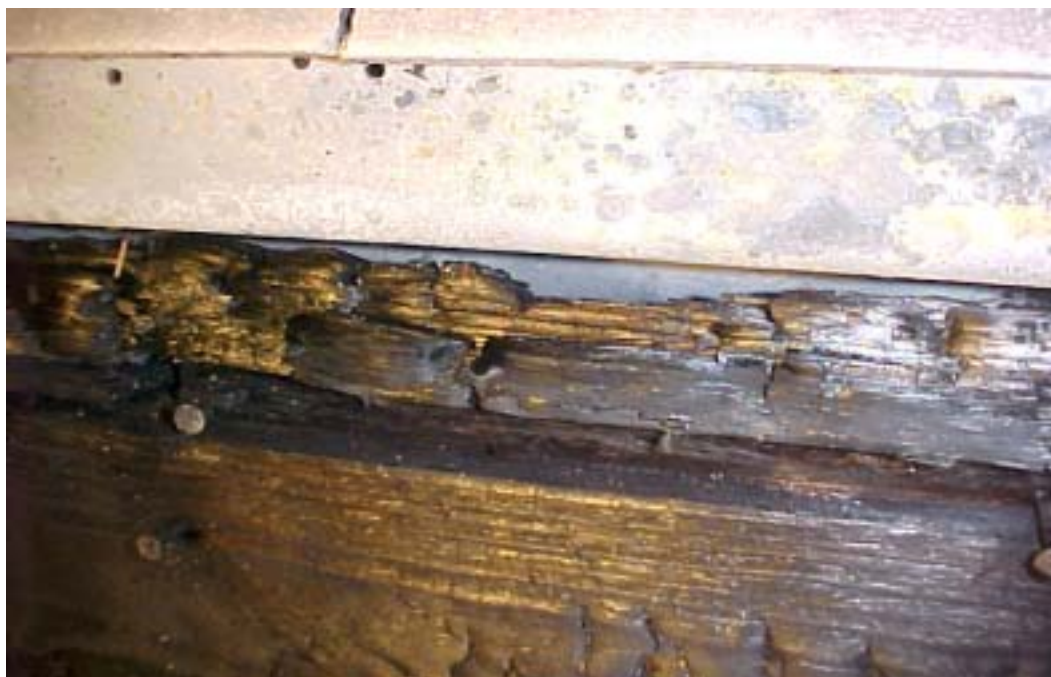
Photograph C2. Showing post test damage.

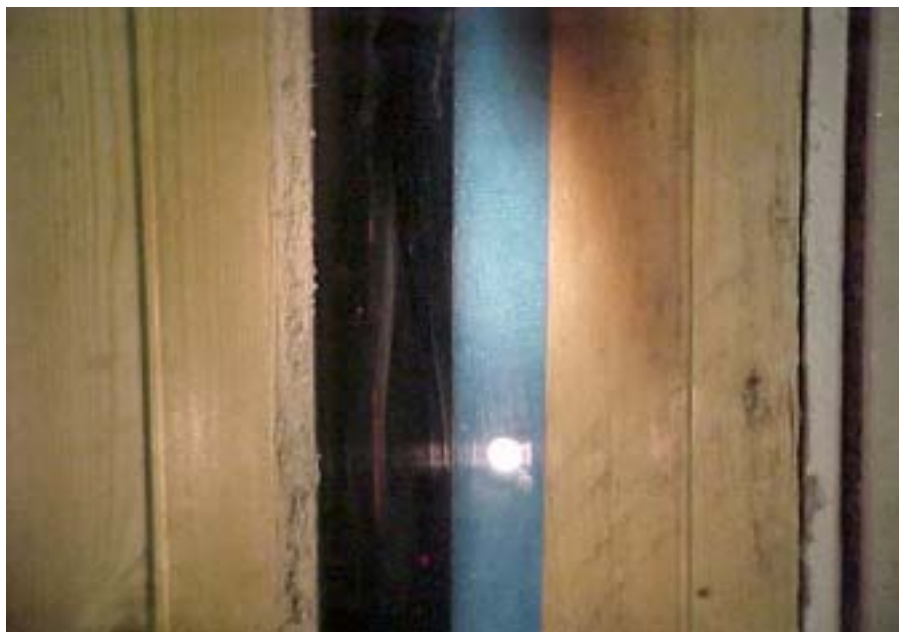
PVCu without timber bead

Photograph C3. Showing distortion of the window frame.

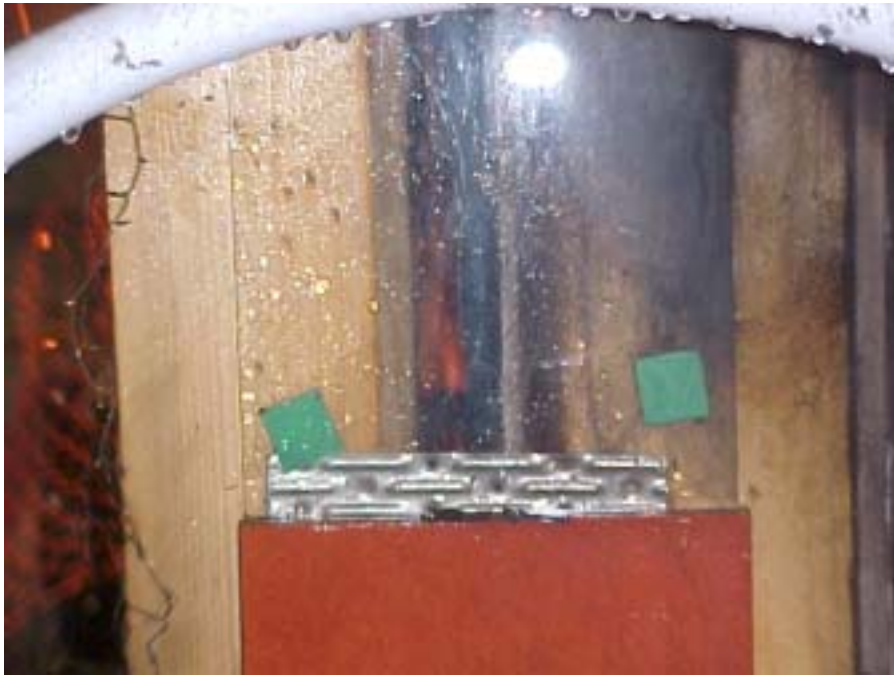
Aluminium with timber bead

Photograph C4. Showing flaming entering the cavity.

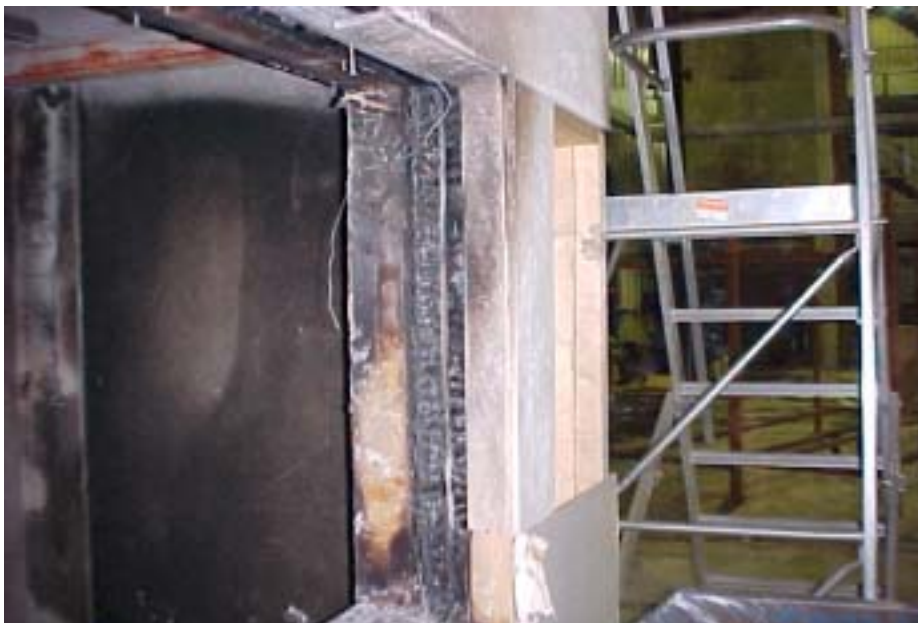
Photograph C5. Showing post test damage.

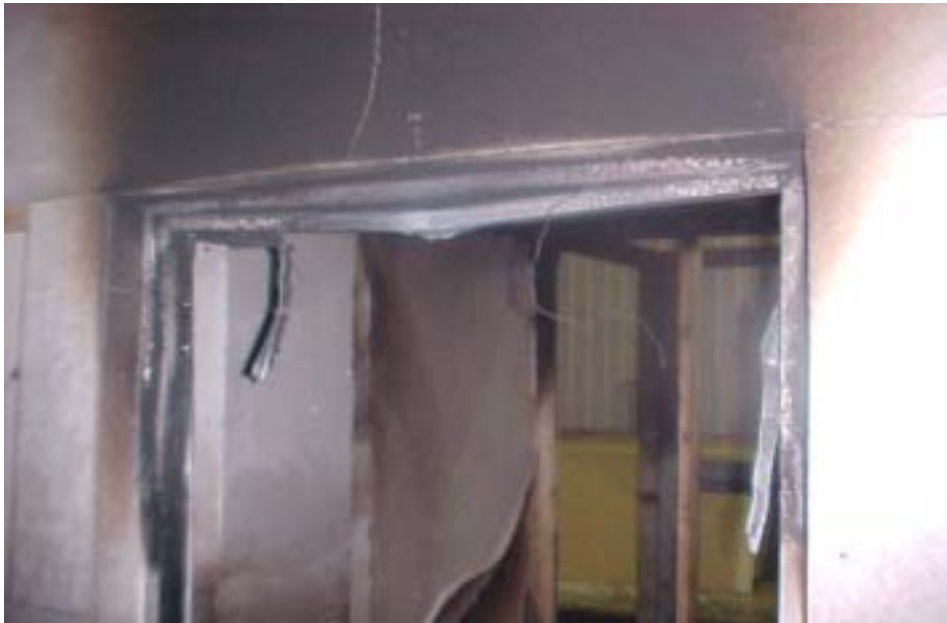
Aluminium without timber bead

Photograph C6. Showing post test damage.

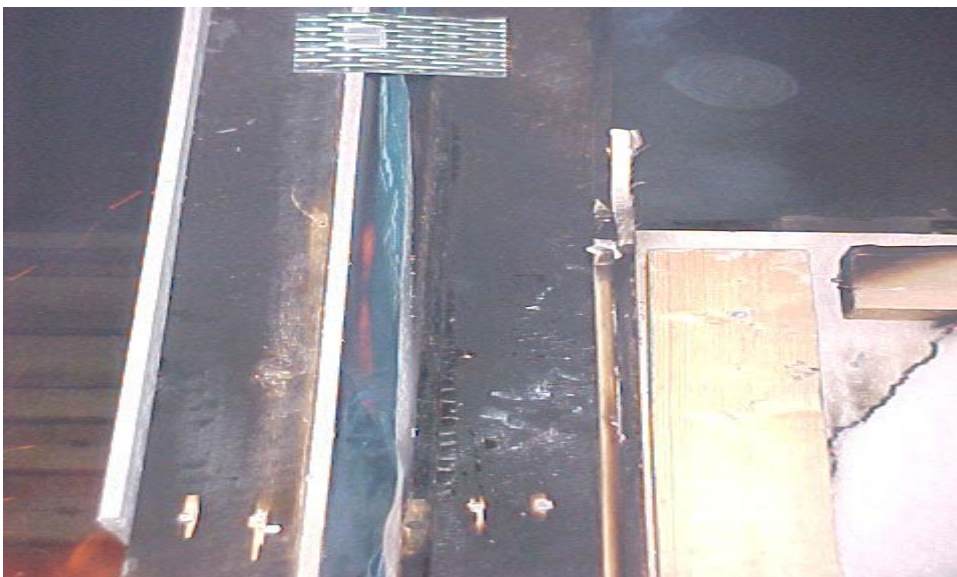
Hardwood with timber bead

Photograph C7. Showing flaming in the cavity above the window

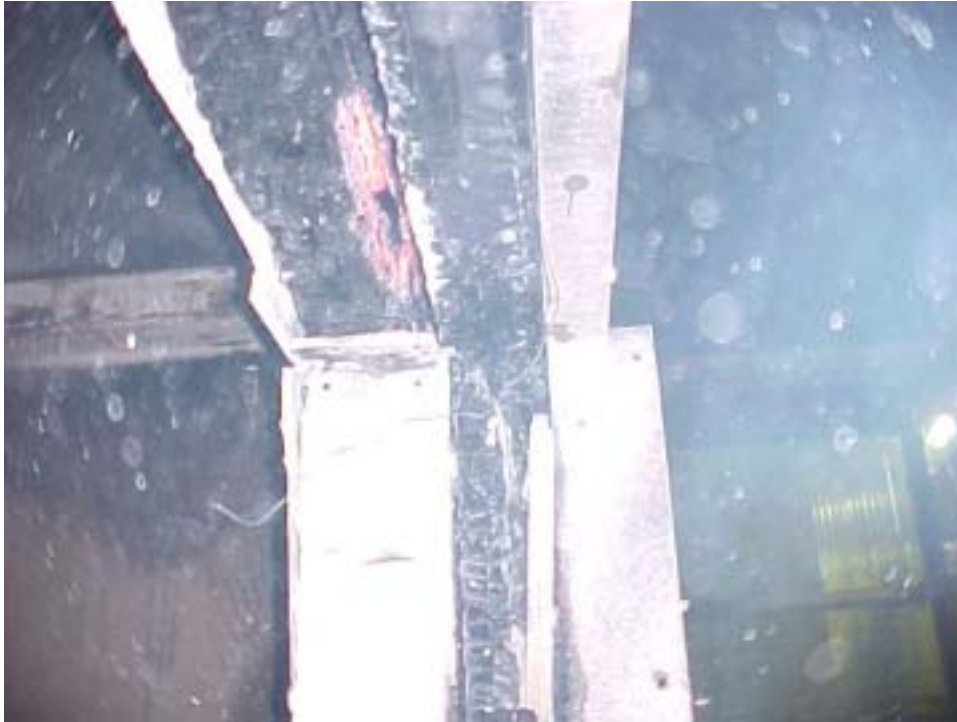
Photograph C8. Showing post test damage.

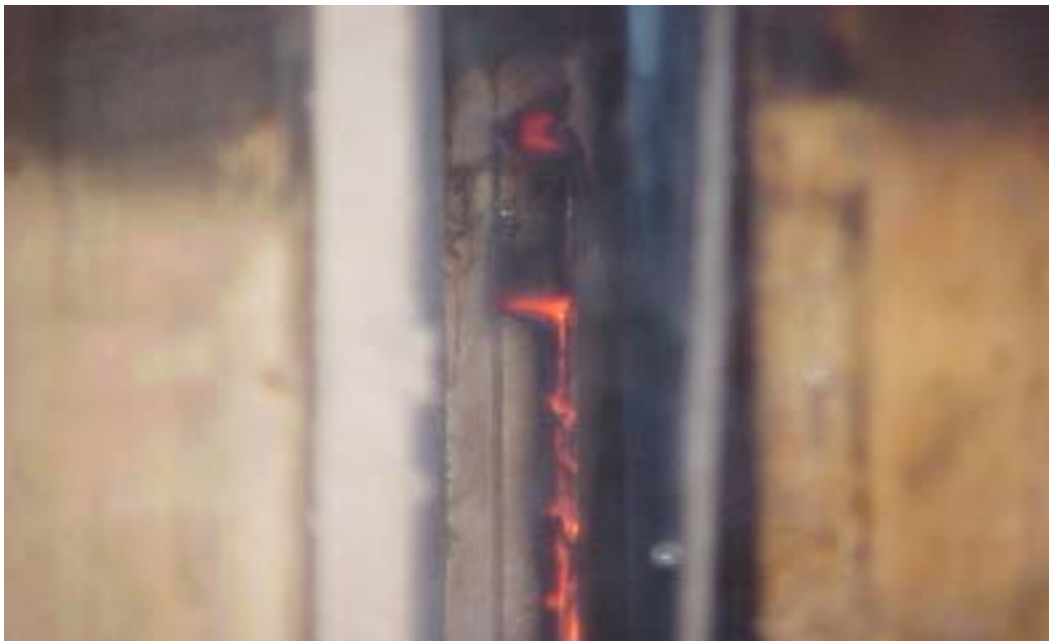
Hardwood without timber bead

Photograph C9. Showing flames entering the cavity.

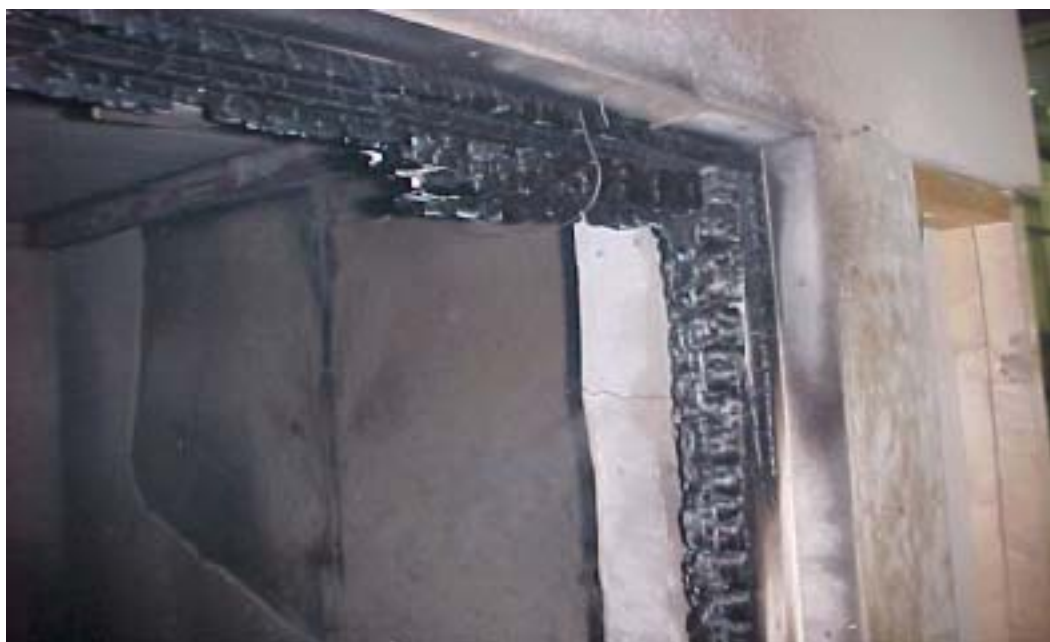
Photograph C10. Showing post test damage.

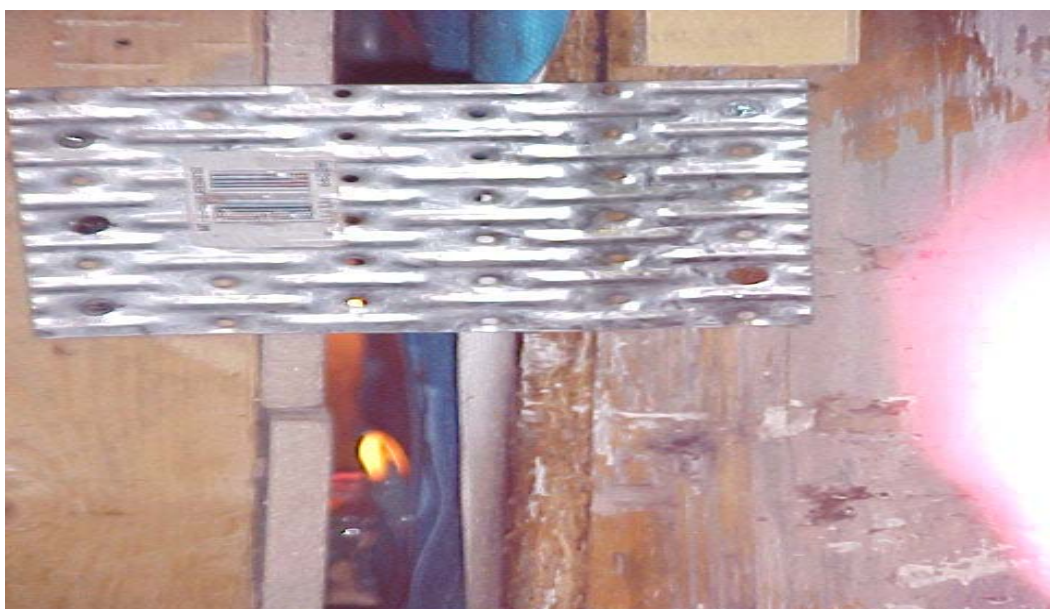
Softwood with timber bead

Photograph C11. Showing flames entering the cavity

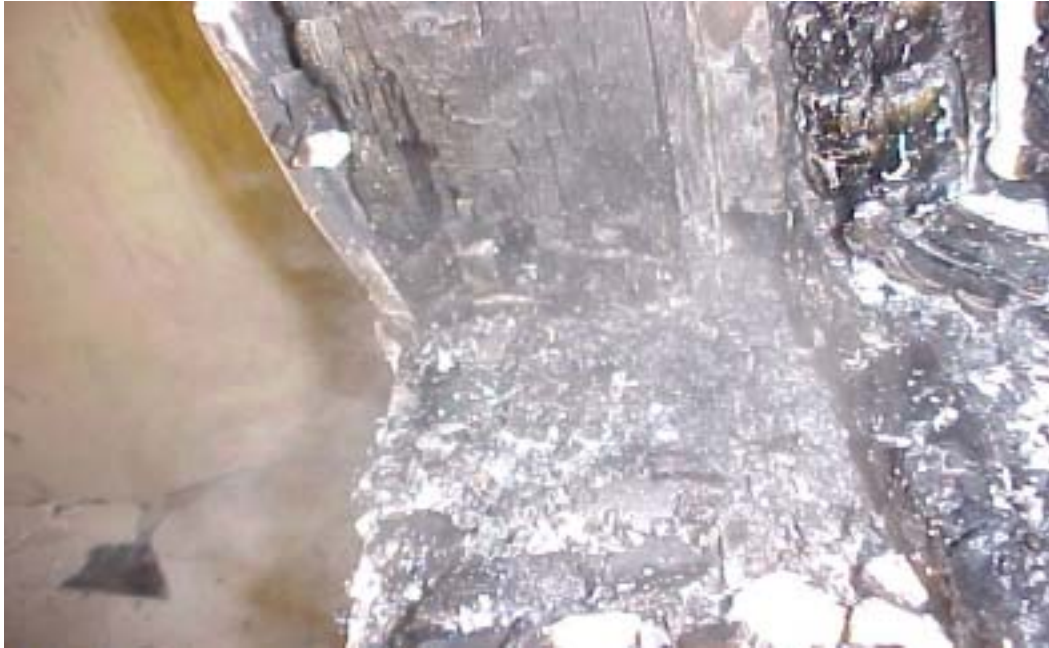
Photograph C12. Showing post test damage.

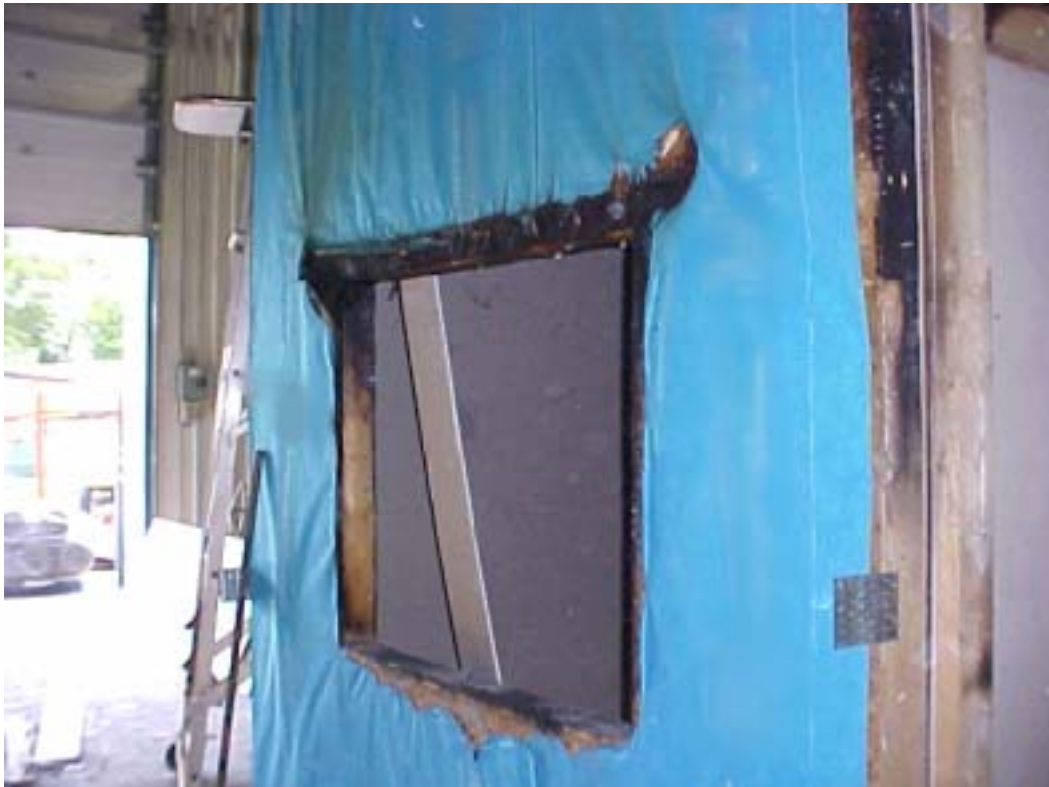
Softwood without timber bead

Note 1: post test inspection suggested that the window frame systems were still intact and that the breach may have been due to the failure of the joint detail between the enclosure and the window framework.

Photograph C13. Showing post test damage.
