# Fire compartmentation in roof voids

By Martin Shipp, Ciara Holland, David Crowder and Tom Lennon

### Case study 1 – Residential development (four and five-storey apartment blocks)

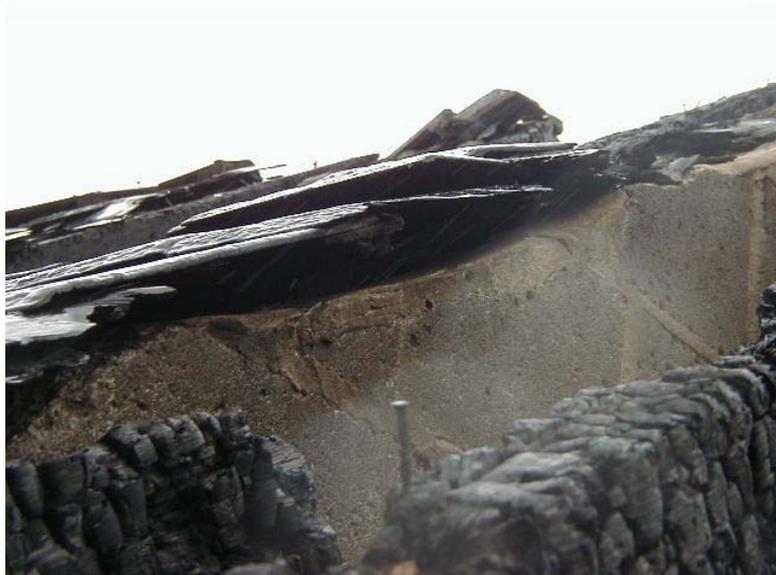
The fire started in a small section of a flat roof of one apartment block, ignited the sarking felt on the adjacent pitched roof and spread into the roof void. The fire spread within the roof space over three apartments, bypassing two compartment walls. Eventually, the fire spread into the roof void of an adjacent block, again involving three apartments and bypassing two compartment walls. The compartment walls were constructed from concrete building blocks. However, it was clear from the scene that no attempt had been made to fire-stop the junction between the walls and the roof as detailed in Approved Document B [2].

Figure 1 shows the junction of the compartment wall with the roof covering.

**Figure 1 – Lack of fire stopping between compartment wall and roof covering**

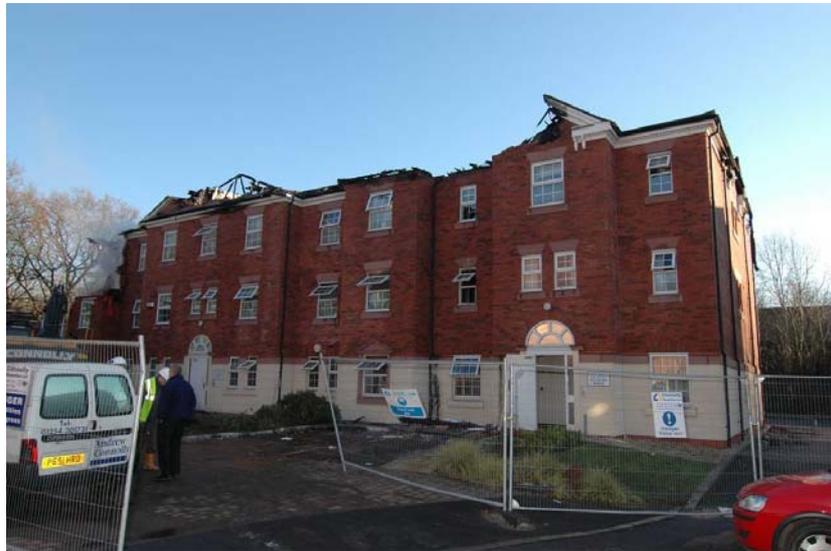
It is likely that the fire was initiated as a result of hot work being carried out on pipes penetrating the exterior wall of the three-storey block of flats. Initial fire spread was through the external wall cavity breaking out at roof level some distance from the point of origin. Once in the roof area, the fire spread rapidly, leading to collapse of the roof trusses and break out back into the floors below. It is clear from the speed and extent of the fire spread that the cavity barriers in the wall and compartmentation within the roof space were ineffective. Figure 2 shows the point of fire origin and the area where the fire broke out from the roof.

**Figure 2 – Block of flats showing the area of fire origin and damage to roof level. Arrow A indicates point of fire origin. Arrow B indicates point of break out at roof level**

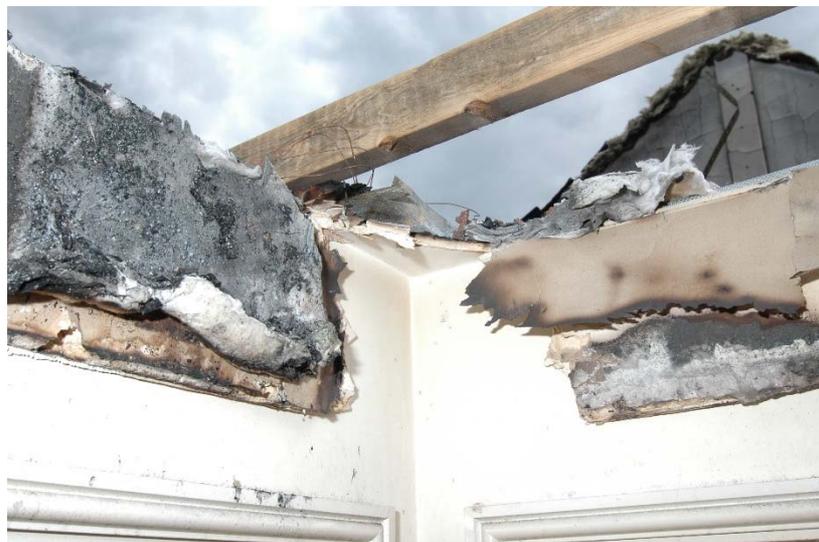
The fire is believed to have started on the landing of the second floor of a four-storey residential building. The fire spread from here to involve the third (top) floor landing and ultimately, to the roof structure, most probably via the roof soffit above a window onto the landing. Compartmentation was breached as the fire traversed the roof structure over a number of compartment walls. The compartment walls were constructed from concrete blocks clad in plasterboard with a plaster skim coat. The walls were continued up through the ceiling to the underside of the roof covering. The seal between the top of the wall and the roof covering seems to have been made from mineral wool (see Figure 3). It is believed that the fire spread due to a combustible membrane between the tiles and the roof structure (see Figure 4).

**Figure 3 – Mineral wool fire-stopping along pitch of roof in the background of the photograph**

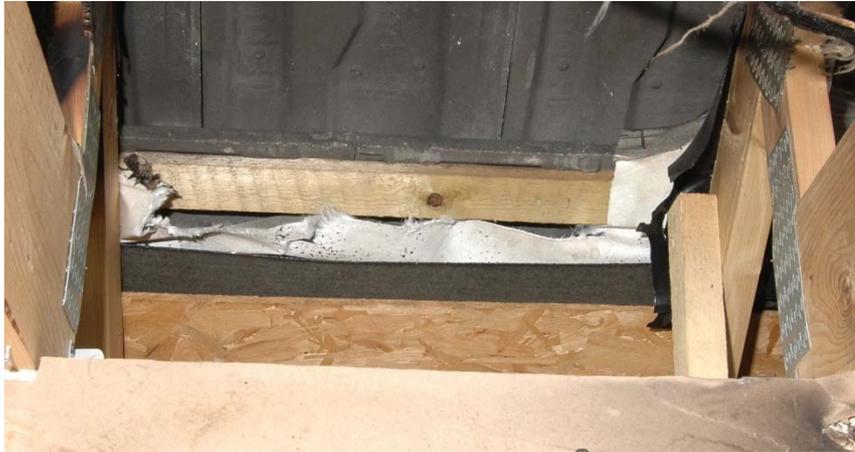
**Figure 4 – Combustible membrane under roof covering**

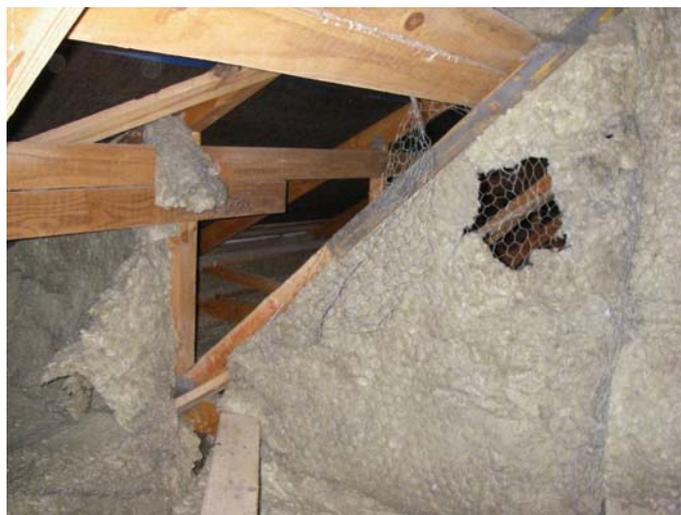
Fire broke out in one of the flats on the top floor of a four-storey apartment block. The fire broke out of the window and into the roof void through the roof eaves soffit and spread to destroy the entire roof area. The roof was a new pitched roof over an existing flat roof formed from a concrete slab. For this reason, the roof void could be considered to be a single compartment and separation would be necessary to maintain the maximum distances of cavities rather than specifically to maintain compartmentation. Separation was provided in the roof space at approximately 15m intervals, comprising mineral wool and chicken wire curtains held in place with metal bars fixed to the timber trusses. The separation in the roof space clearly did not perform as intended. The poor state of the compartmentation in the roof space had been highlighted in a previous report following a fire on the same estate. The condition of the fire stopping in the roof space in a similar block is illustrated in Figure 5.

**Figure 5 – Fire stopping in poor condition (Image courtesy of London Fire Brigade)**

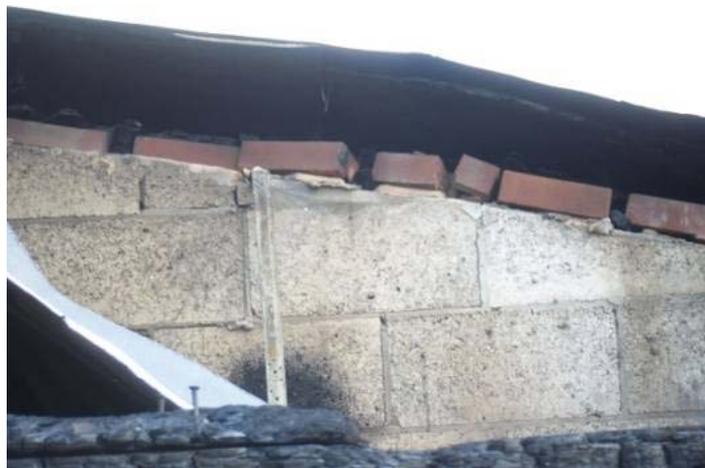
The fire occurred in a flat on the top floor of a three-storey block of flats and spread into the roof space. The fire developed to involve the roof space over all three flats on the top floor. Fire spread over the compartment walls in the roof area appears to have been due to a combination of poor fire stopping in the compartment walls above ceiling level, poor fire stopping where the curved sections of the roof crossed the compartment walls, and fire bridging the compartment walls due to the presence of combustible materials within the make-up of the roof covering. Figure 6 shows the attempt made to provide fire stopping where the curved section of the roof crossed the compartment wall.

**Figure 6 – Attempt to follow roof profile over compartment wall**

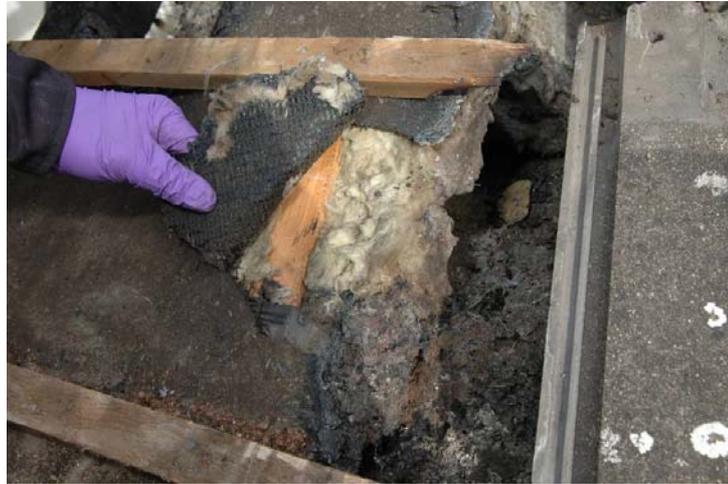
The fire started in a first floor flat of a block of flats, broke out of the room of origin through a window, and entered the roof through the eaves. Fire spread rapidly throughout the structure of the roof. The roof was constructed from lightweight timber truss rafters. The roof covering was ceramic tiles under which a bitumen impregnated sarking felt had been fixed. Fire separation within the roof space was completed using a mixture of blockwork and cavity barriers. The cavity barriers were constructed from mineral wool fixed to a wire mesh. The barriers were fixed to timber trusses using clamping plates. The fixing of the fire barrier to the timber trusses does not appear to have been in accordance with manufacturer's guidance since the barriers did not press up against the underside of the sarking felt so the fire was able to spread along the sarking felt over the top of the cavity barriers (see Figure 8).

**Figure 7- Fire stopping against underside of sarking felt but not pushed up against underside of roof tiles**

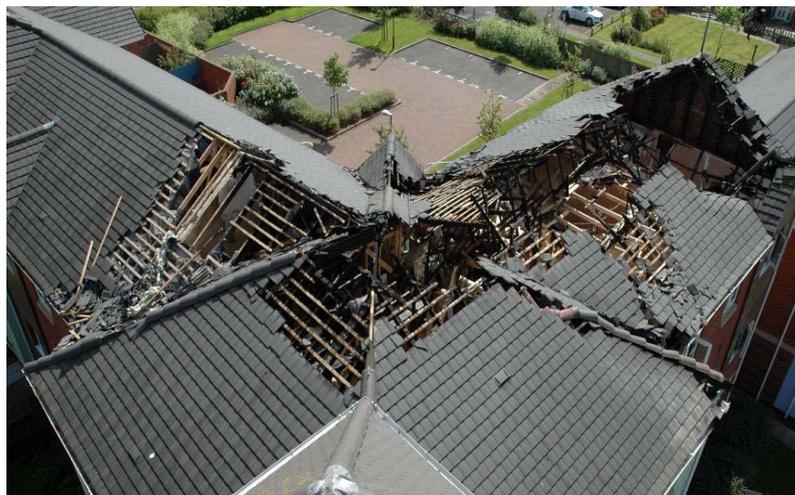
The fire is believed to have been started by a cigarette discarded in wood chippings in flower beds arranged around the outside of a three-storey block of flats and in contact with the external wall. The fire spread from the wood chippings into the cavity of the external wall via a plastic air brick providing ventilation to the cavity situated beneath the suspended ground floor. Cavity barriers in the external wall cavity were either missing or poorly fitted. The fire spread up the cavity to the roof of the building, causing significant structural damage to the roof and accommodation storeys. A combination of fire-fighting and effective compartmentation, both between compartments and within the roof space, prevented more extensive fire spread within the building. Figure 8 is an aerial view of the building showing the damage at roof level.

**Figure 8 – Aerial view showing damage to roof structure**

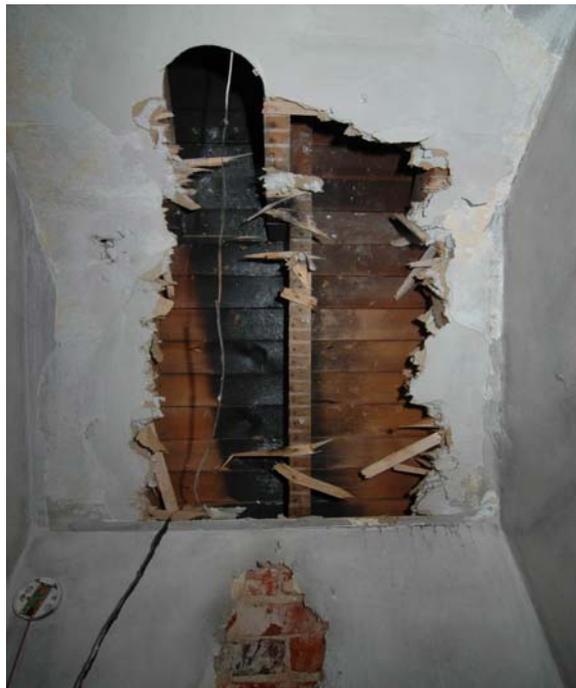
Fire started within a first floor bedroom of a two-storey residential care home. Smoke entered a wall cavity and found its way into the roof void where a detector was activated. Due to early activation and the prompt action of the Fire and Rescue Service, the fire was prevented from spreading into the roof void. However, there was inadequate separation within the roof space. The junction between the external wall cavity and the roof space is shown in Figure 9.

**Figure 9 – Close up of fire damage to pitch roof (arrow showing direction of fire spread from wall cavity)**

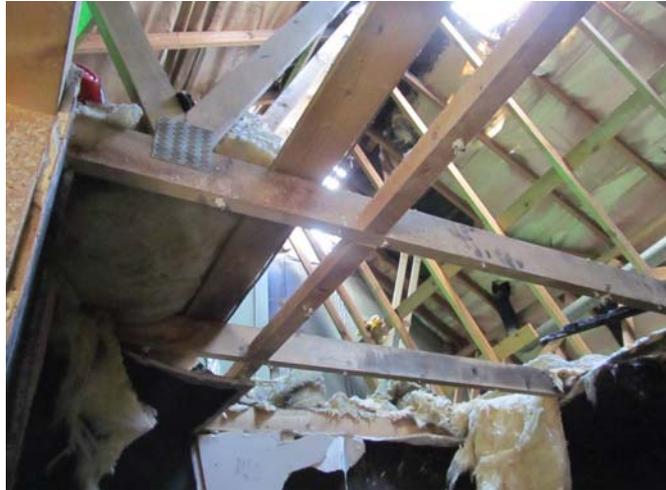
The fire was started within an upper floor bedroom of a three-storey timber-frame terraced house and flames spread into an external wall cavity through failure of a uPVC window frame. From there, it spread into a compartment wall separating dwellings. In this case, the quality of the compartmentation in the roof space prevented more widespread damage as can be seen from the undamaged roof trusses in Figure 10. The compartmentation was formed from two layers of plasterboard either side of the timber frame compartment wall, with all joints fully taped and sealed.

**Figure 10 – Undamaged roof trusses above seat of fire**

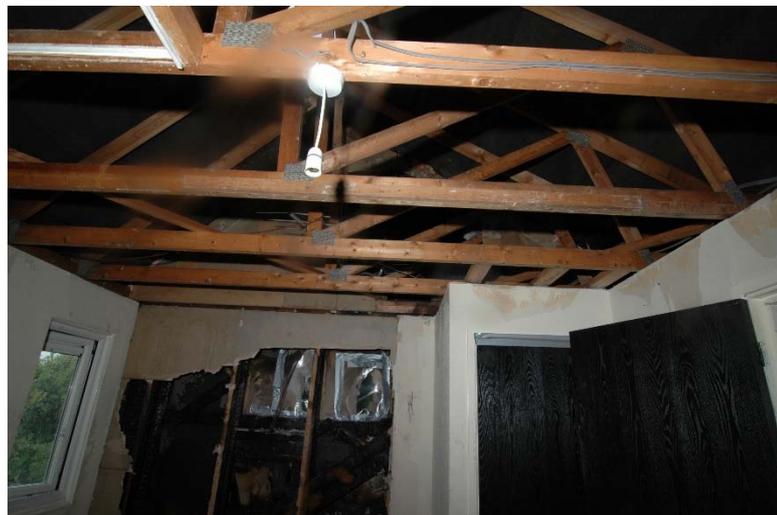
The fire started within a ground floor flat and spread via the external façade into the compartment wall between occupancies. As with the incident in Case 9, the quality of compartmentation in the roof space, as shown in Figure 11, restricted the amount of damage from the fire.

**Figure 11 – Top floor of property showing fire damage in party wall but roof trusses are unaffected by the fire due to compartmentation**
