Foster + Partners

Innovation in the design of tall
buildings

Thouria Istephan

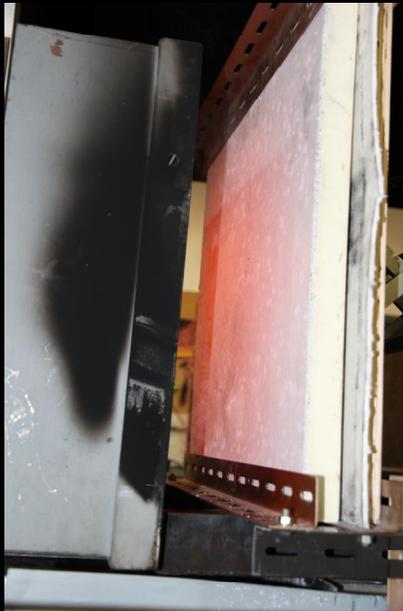
- The **thick** fire retardant coating was insufficient to prevent ignition of the PU foam behind

- Exposed to Heat Flux

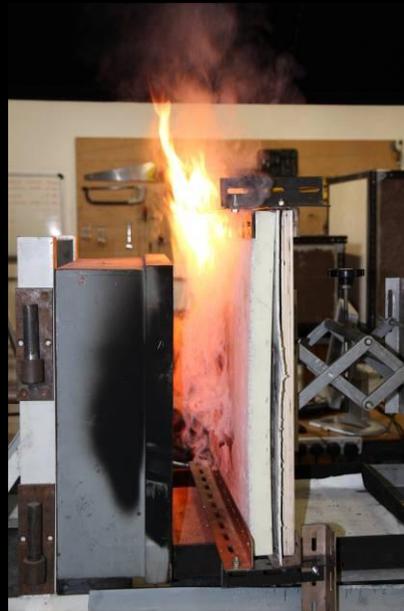
- Ignition

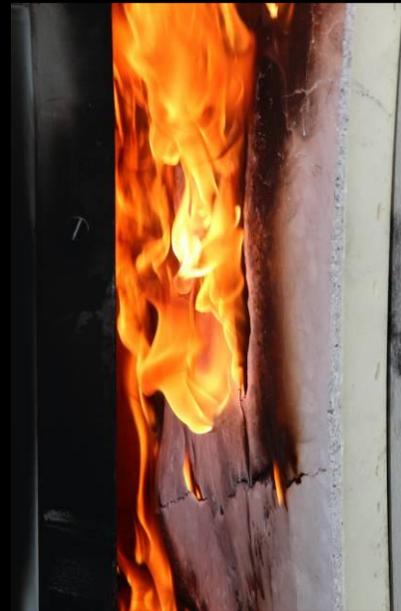
- Flaming

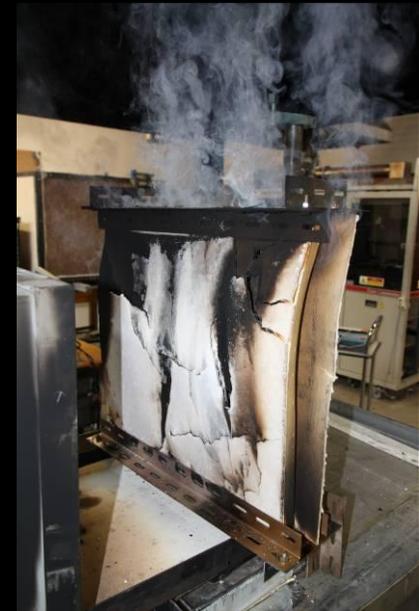
- After Being Extinguished

- The heat caused the fire retardant coating to crack
- The PU vapour poured through cracks, creating jets of flame
- The test sample produced so much toxic smoke it had to be extinguished by the lab technician, normally under test conditions this would not be necessary

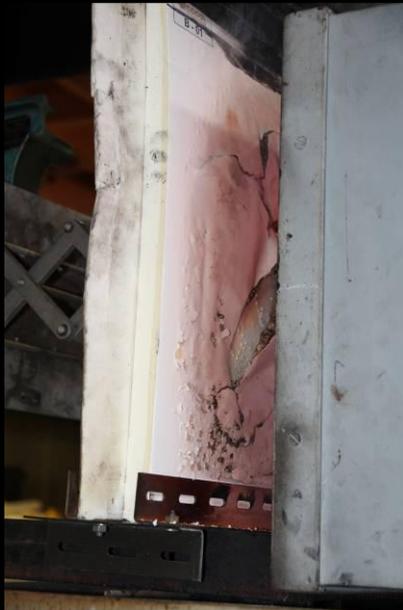
- The **thin** (paint) coating performed much worse, exposing the PU foam after only a few seconds
- The lab technician had difficulty extinguishing the sample

- Exposed to Heat Flux

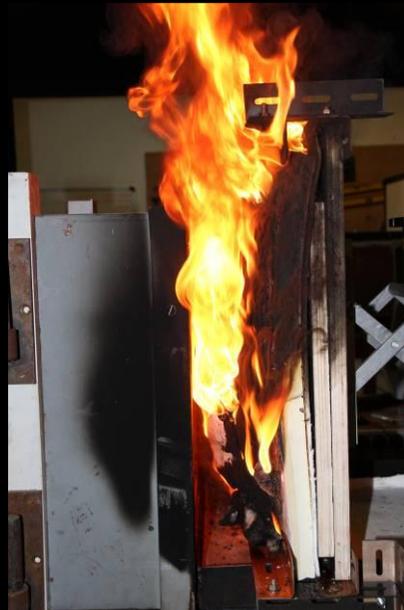
- Ignition

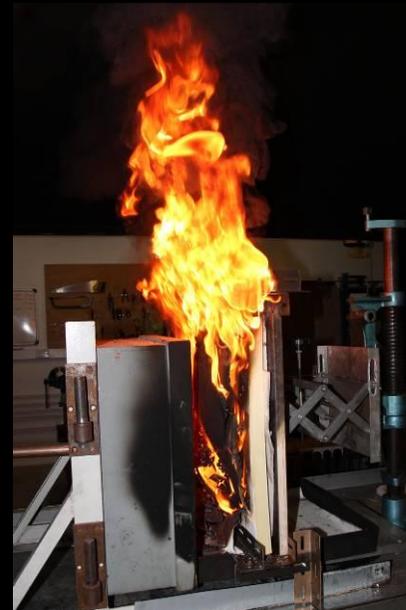
- Flaming

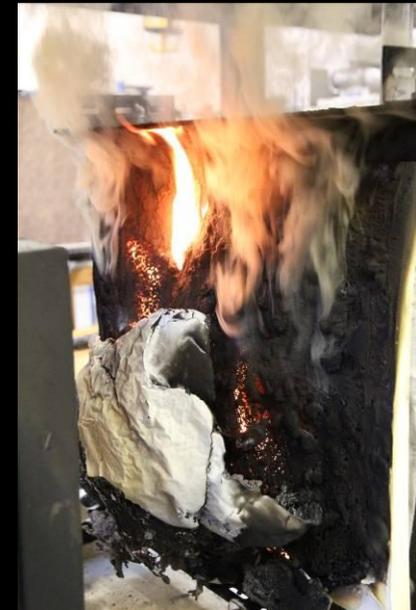
- After Being Extinguished

- The coating failed in less than 20 seconds, exposing the highly flammable polyurethane foam beneath.

- Polyurethane should not be used for building construction
- Polyurethane (PU) is highly flammable and produces highly toxic fumes when burned
- **New materials, particularly composite materials, must be tested for performance in fire by a competent fire safety professional**
