Potential Perils of Modern Methods of Construction – a short introduction

David Crowder
Business Group Manager, Fire Investigation
20th September 2011

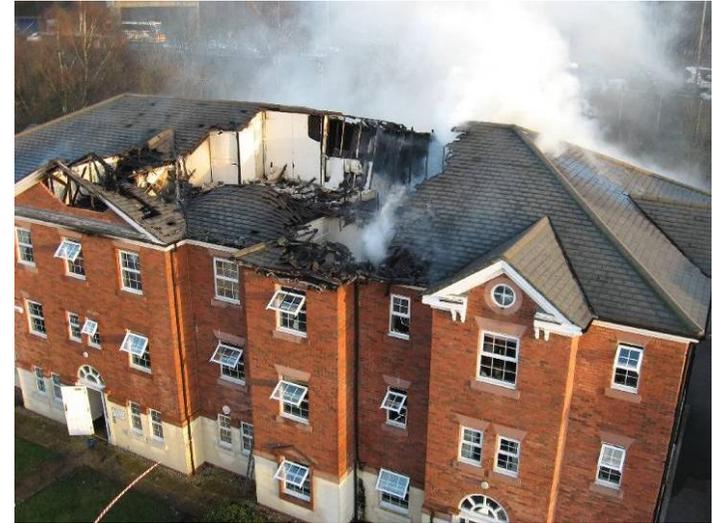
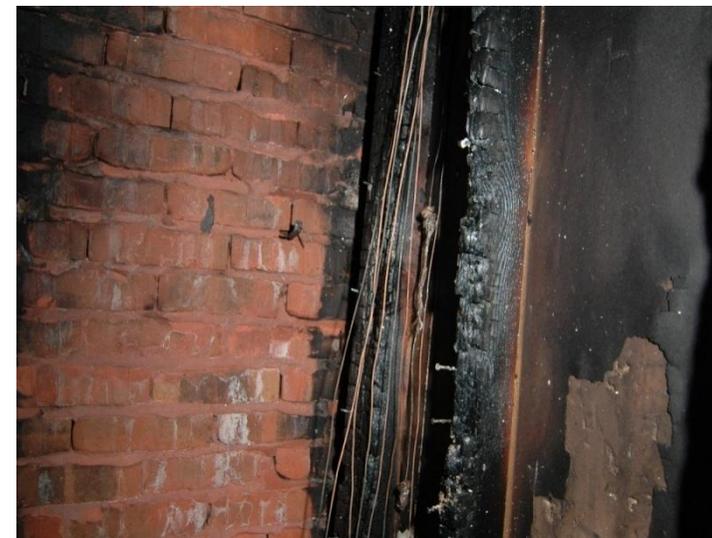
Manthorpe Avenue, Manchester 7th – 13th December 2007

- Timber frame block of flats
- Fire started by hot work (extension of exterior section of overflow pipe, heat transfer along pipe)
 - Detected 1-2 hours after completion
- Spread through timber construction and vapour membranes
- Construction detail allowed smouldering fires to readily propagate, develop and spread

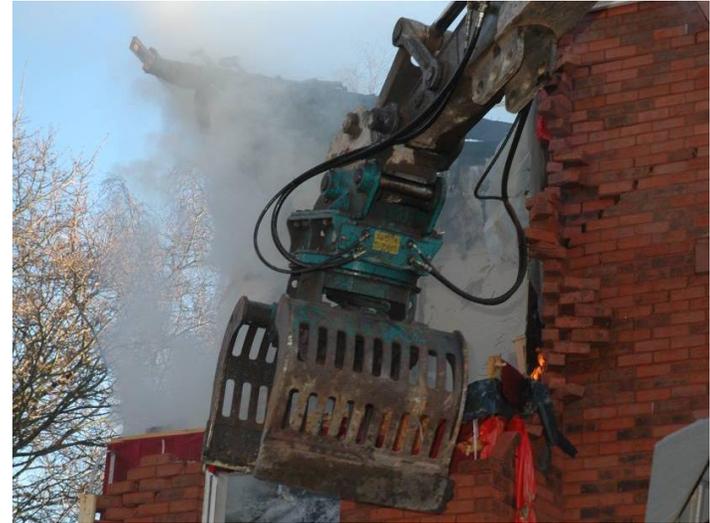
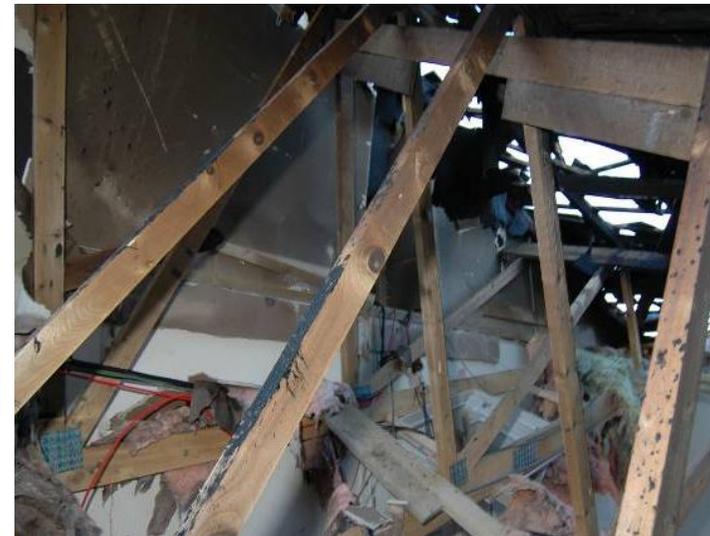
Manthorpe Avenue, Manchester 7th – 13th December 2007

- Demolition required six days after fire breakout in order to ascertain extinguishment
- Brigade forced to commit resources to this incident for 6 days
- Collapsed unburned roof trusses

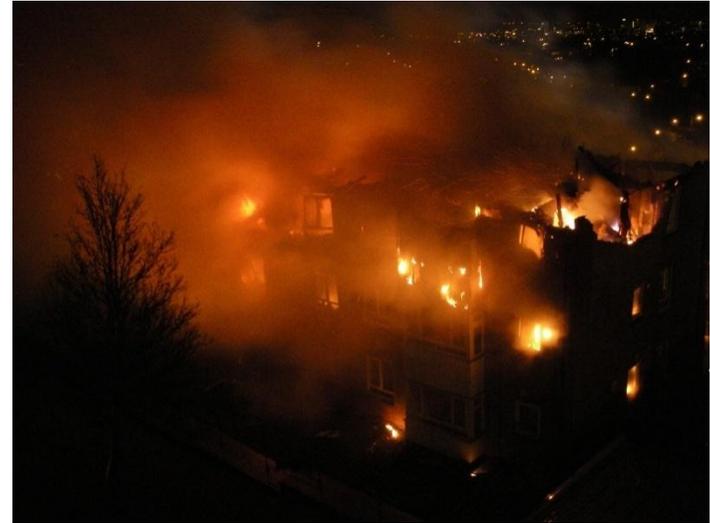
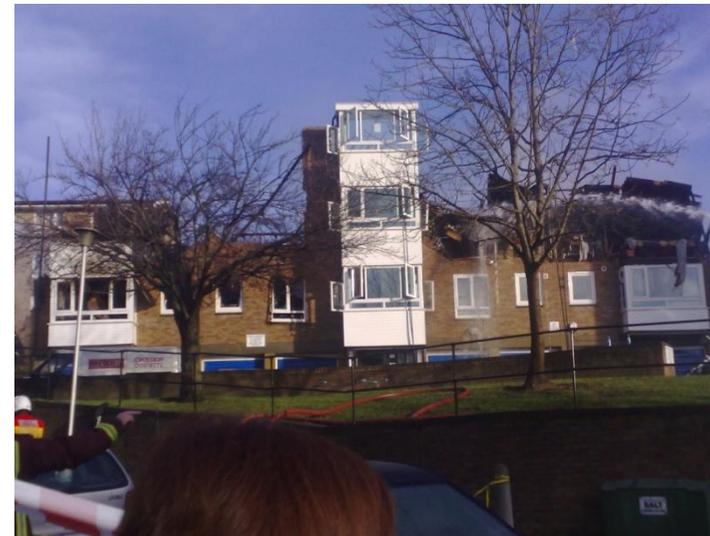
Marston Way, Upper Norwood 25th – 26 December 2007

- Timber frame block of flats
 - Constructed in 1970s
 - Refurbished post 2000 (including
- Fire started deliberately in bedroom
- Initial attendance by fire brigade, fire believed extinguished
- Fire had spread into cavity after burning through uPVC window frame
 - Smouldering bitumen impregnated fibre board
- Fire spread throughout structure, eventually requiring demolition

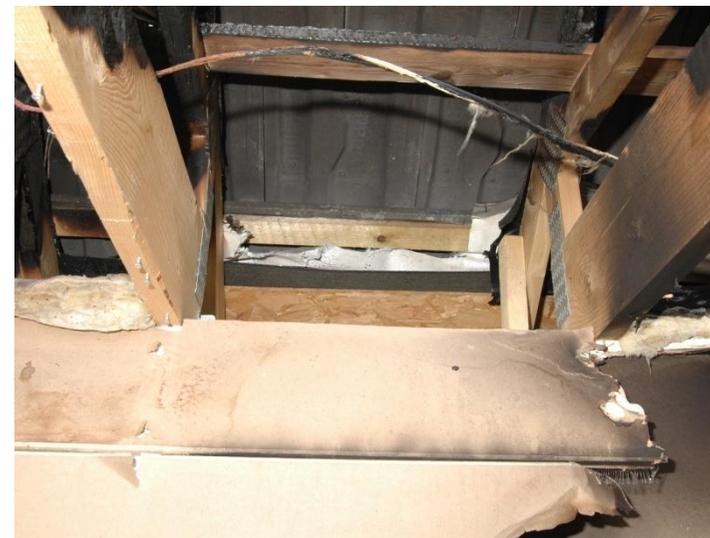
Bennett Close, Hounslow 10th June 2008

- Timber frame block of flats
- Fire started from discarded cigarette outside
- Spread up through timber frame
- Building collapsed from central staircase
- Brigade decision to evacuate immediately upon arrival meant no casualties
 - Learnt from experience at Marston Way

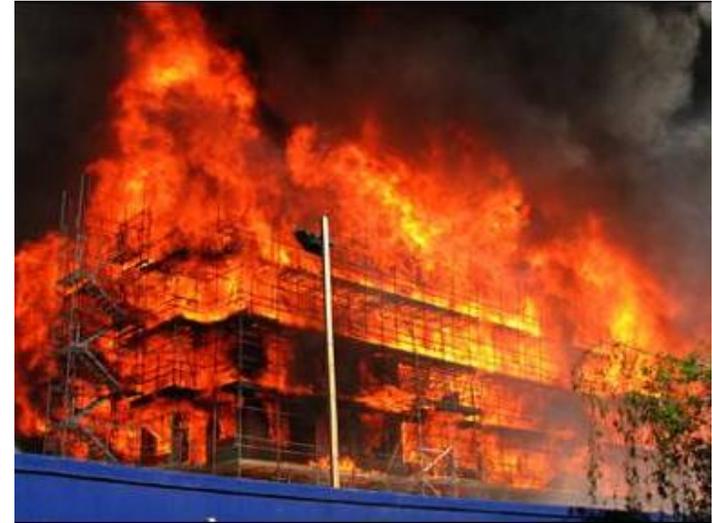
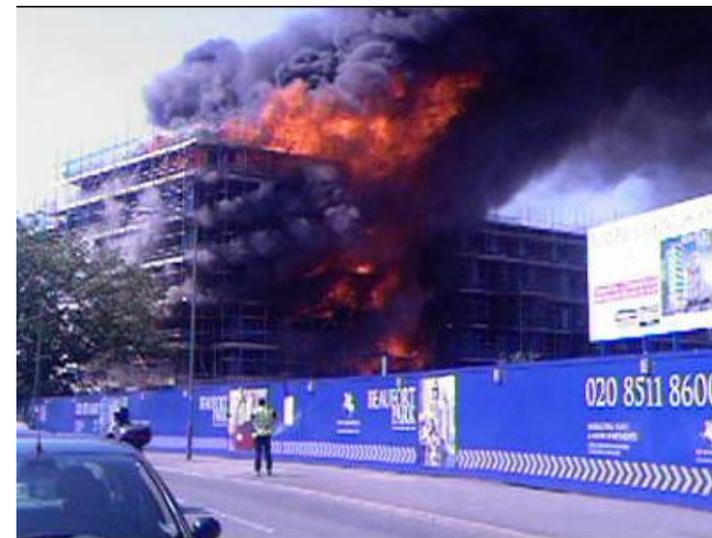
Beaufort Park, Colindale 12th July 2006

- Timber frame flats under construction
- Fire started in lower floors
- Cause unknown
- Timber frame engulfed and consumed in 6 minutes
- Due for occupation two days later

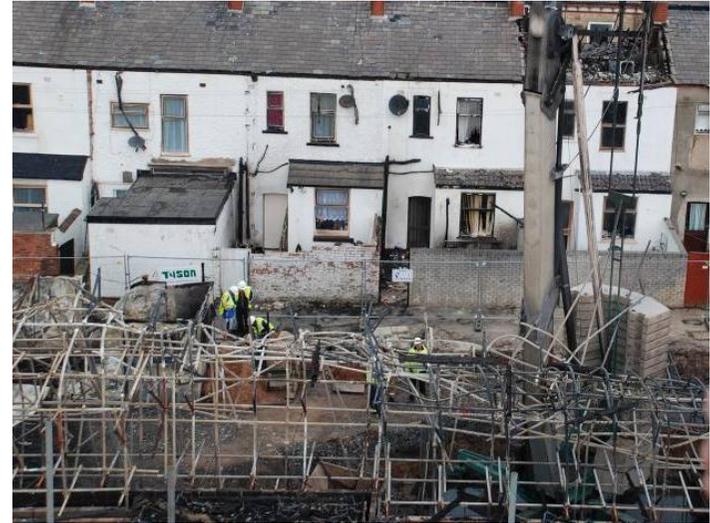
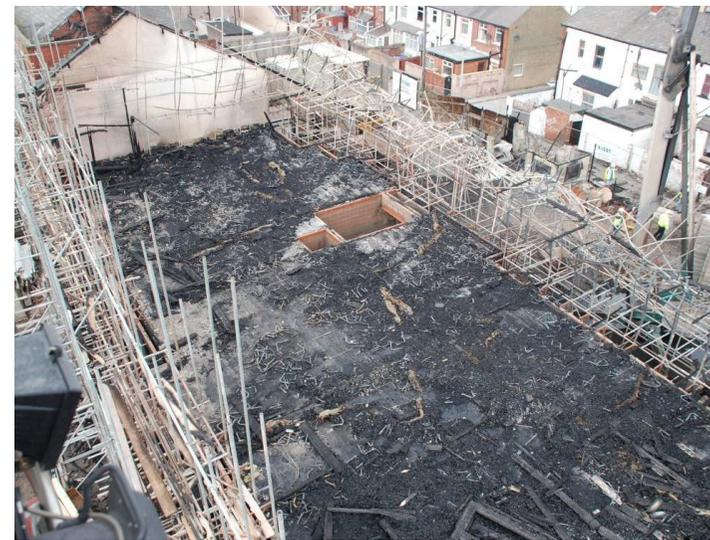
Talbot Road, Blackpool 24th April 2009

- Timber frame flats under construction
- Fire started on ground floor
- Deliberate ignition
- Timber frame fully involved in 6 minutes
- 20 surrounding properties involved in the incident
 - BA teams had to be deployed to each
 - LFRS nearly overwhelmed

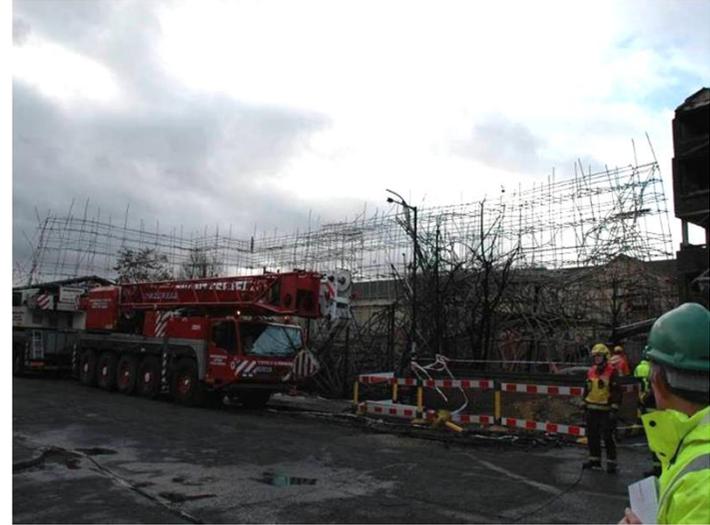
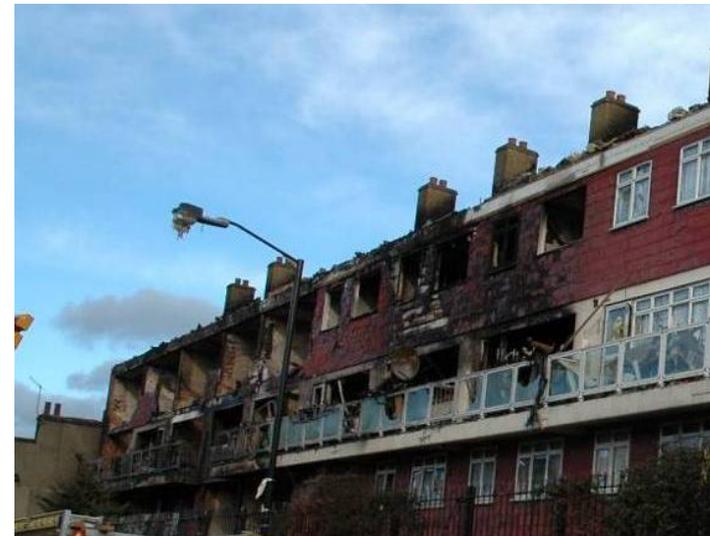
Carisbrooke Gardens, Peckham 26th November 2009

- Timber frame flats under construction
- Fire started on ground floor
- Cause under investigation
- Wind driven fire
- 5 additional premises involved
- Significant radiated heat emitted by fire
 - Difficult for LFB
 - Escape routes could have been affected

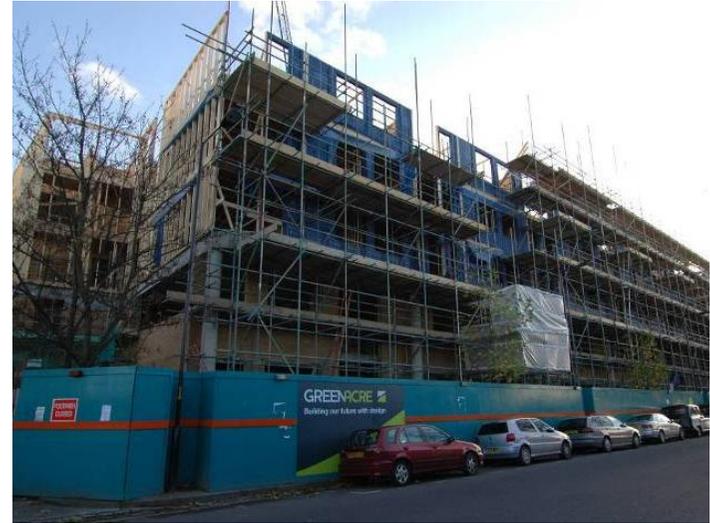
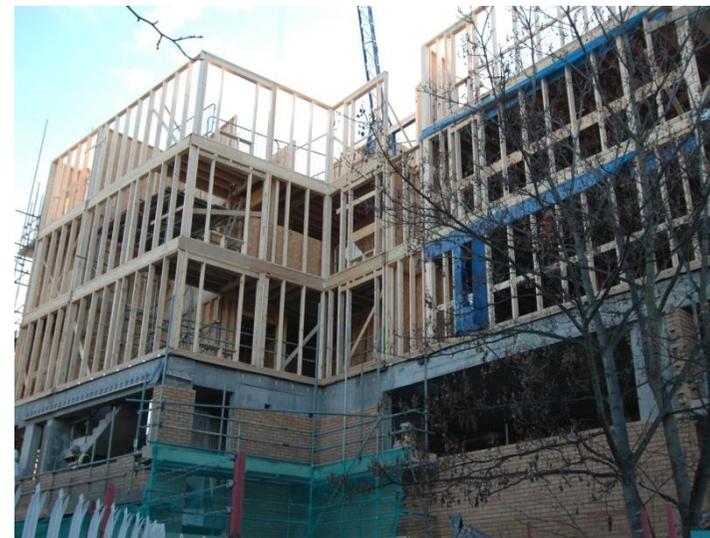
Camberwell Station Road, Camberwell 6th January 2010

- Mixed material flats under construction
- Fire started on second floor
- Cause under investigation
- No significant wind involved
- Significant radiated heat emitted by fire
 - Difficult for LFB
- Nearby premises suffered heat damage only

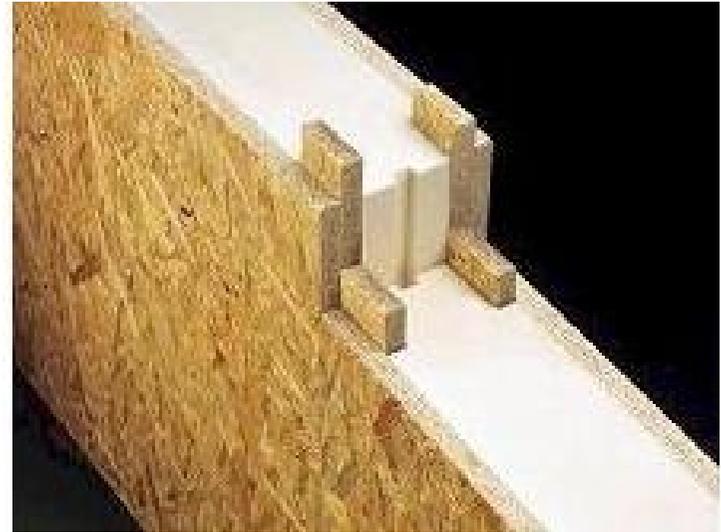
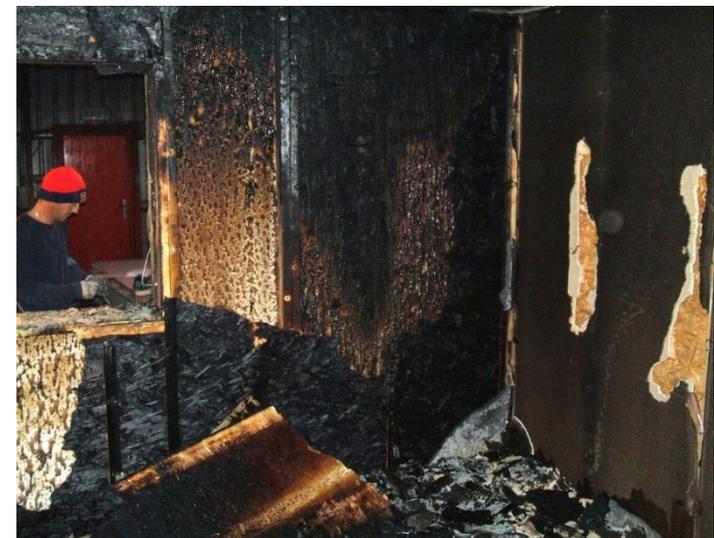
Structural Insulated Panel systems (SIPs)

- Experimental research programme
 - Full scale tests
- Compared PUR and EPS filled panels
- Both capable of meeting recommendations of Approved Document B
- EPS more reliant on fire resistance of plasterboard than PUR
- Need to consider impact of service penetrations into panels

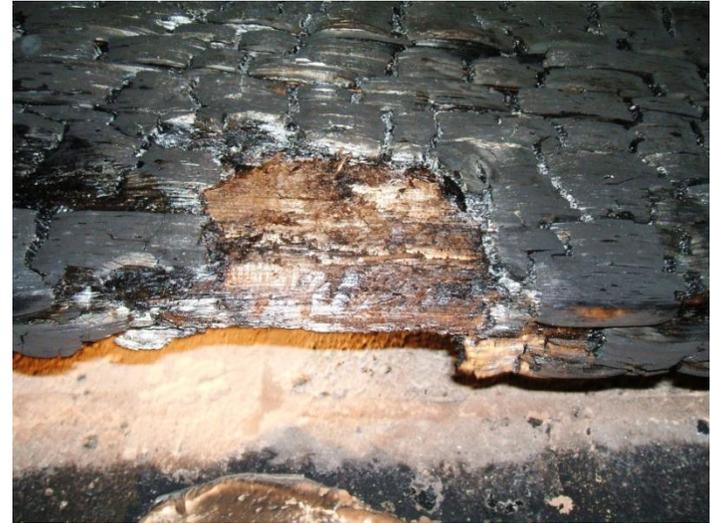
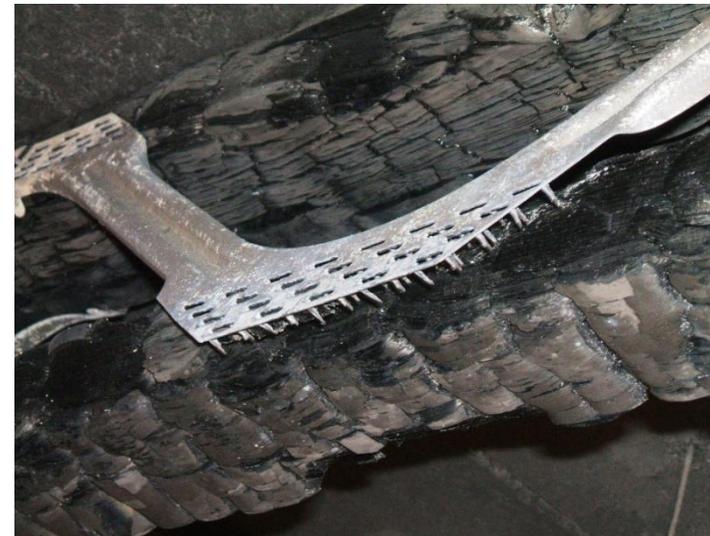
Engineered timber floor joists

- Experimental research programme
- Failure of engineered floor joists will occur more rapidly than in traditional timber
- Performance is dependent on the thickness of plasterboard specified for the required fire resistance period
 - Capable of surviving burnout provided suitable fire resistance of plasterboard
