The Rosepark Fire: Ignition and early development

Stuart Jagger
Health & Safety Laboratory

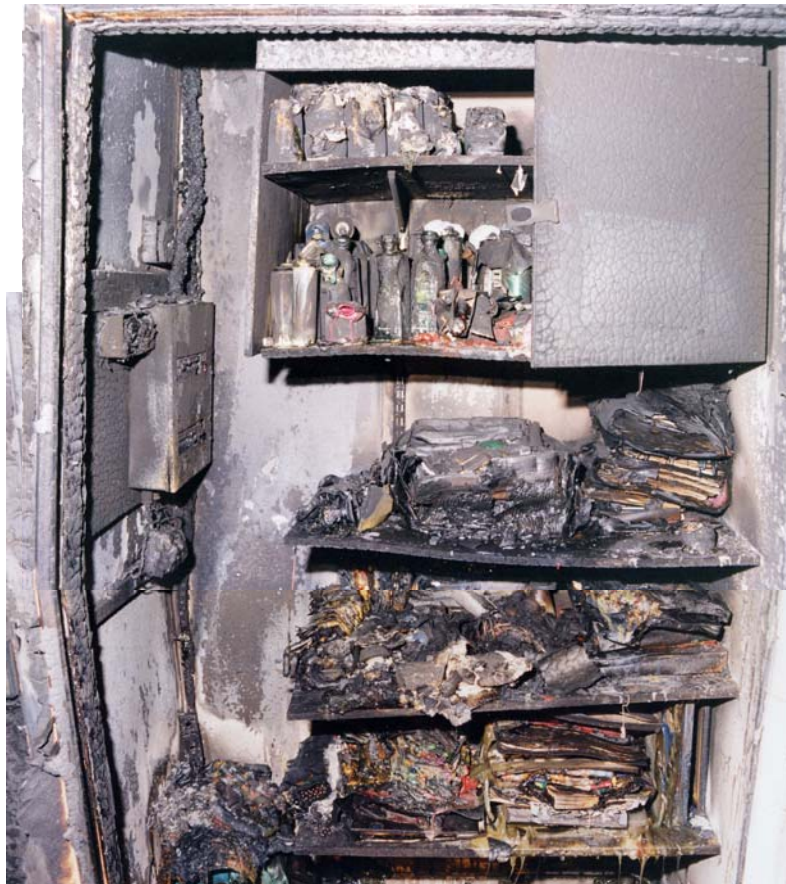
Damage to incident cupboard

**Doors not totally consumed
but greater damage higher
up**

**Major damage on lower LHS
– evidence for fire in plastic
items**

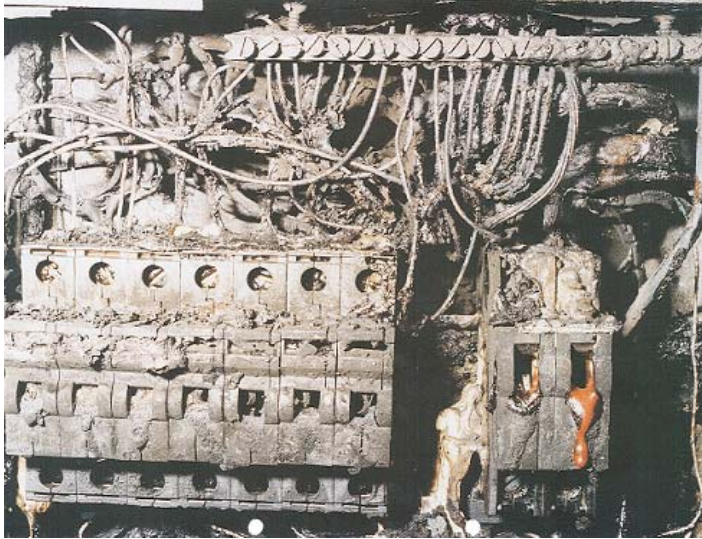
Incident distribution board

Some evidence for damage to electrical wiring in distribution board casing

Some erosion of copper bus bar

Erosion of a rear cable entry point

Coincident with cable melting/erosion

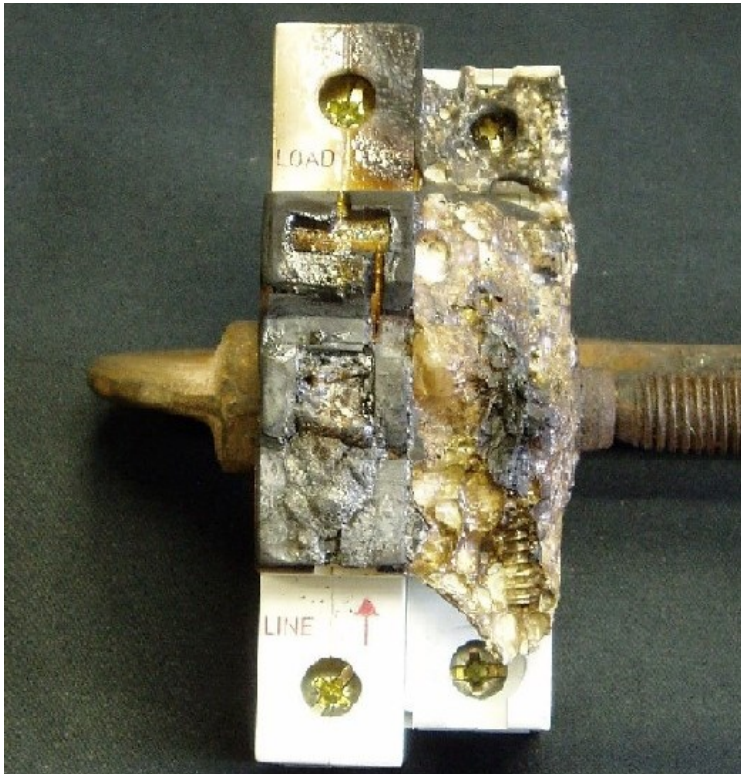
MCB flame impingement tests

- Test to examine behaviour of mcbs to open flaming
- Merlin Gerin and MEM mcbs under load
- Exposed to 2 of BS No 7 cribs
- Both mcbs tripped
- Damage consistent with incident mcbs

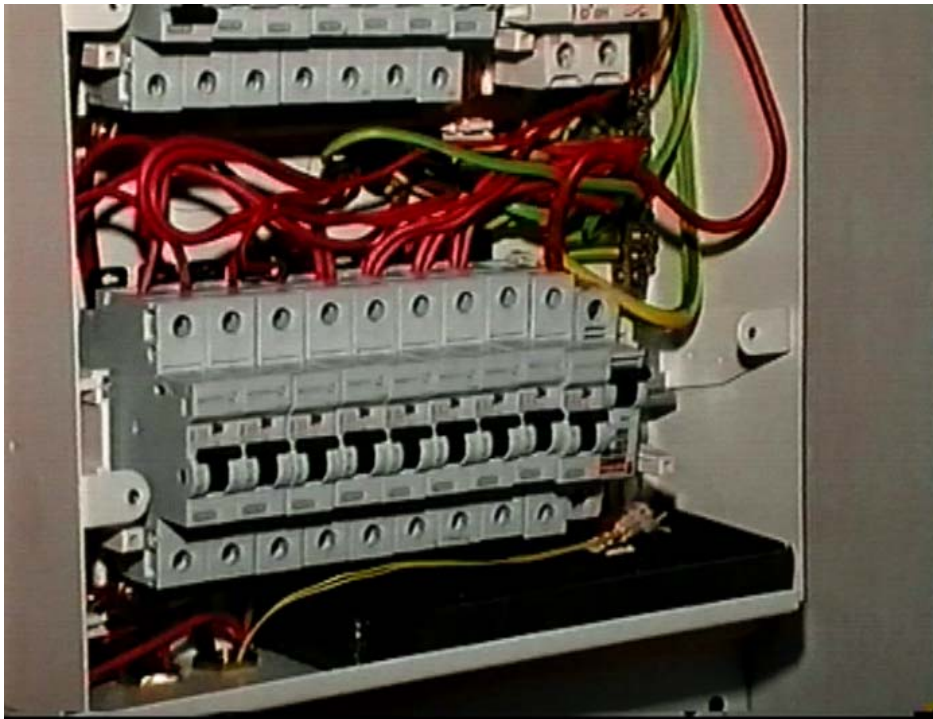
Fires inside distribution board 2

- 2 tests carried out
- Test 1- fire broke out of box after ca 4 minutes
- Caused melting of mcbs
- Fire extinguished
- Damage unlike that of incident
- Initiating fire deemed too large

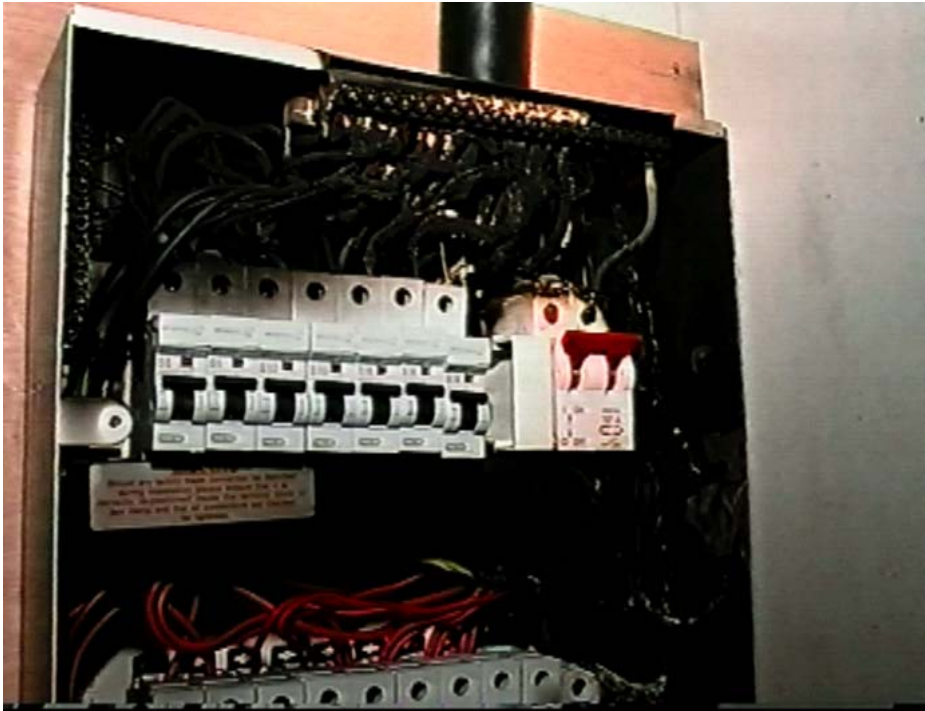
Fires inside distribution board 3

- **Smaller initiating fire – 4cm² diesel soaked pad**
- **Pad placed close to erosion damage on top of lower row of mcbs**
- **No spread of fire, died out after 2 minutes**
- **Damage very confined and unlike that seen in incident**

Conclusion: Unlikely fire started in casing & spread out

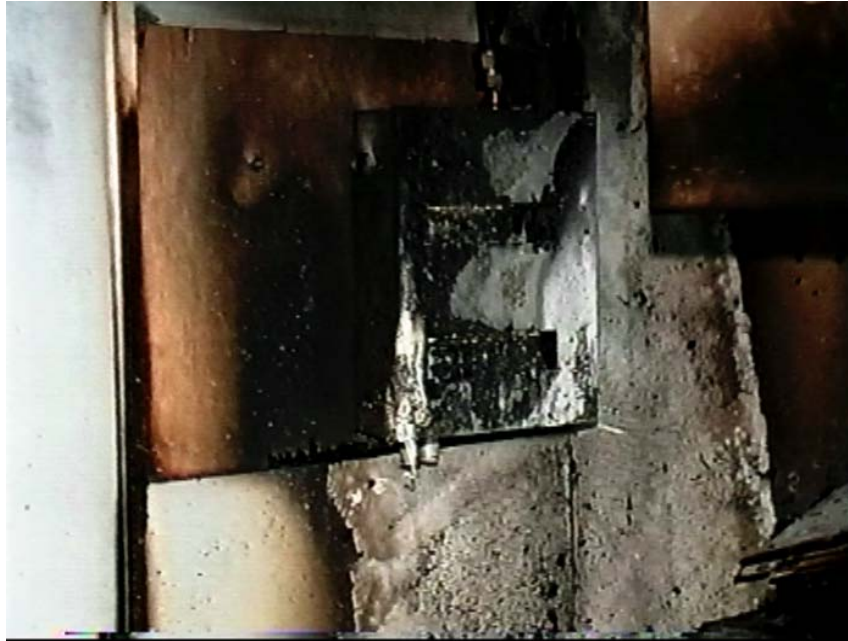
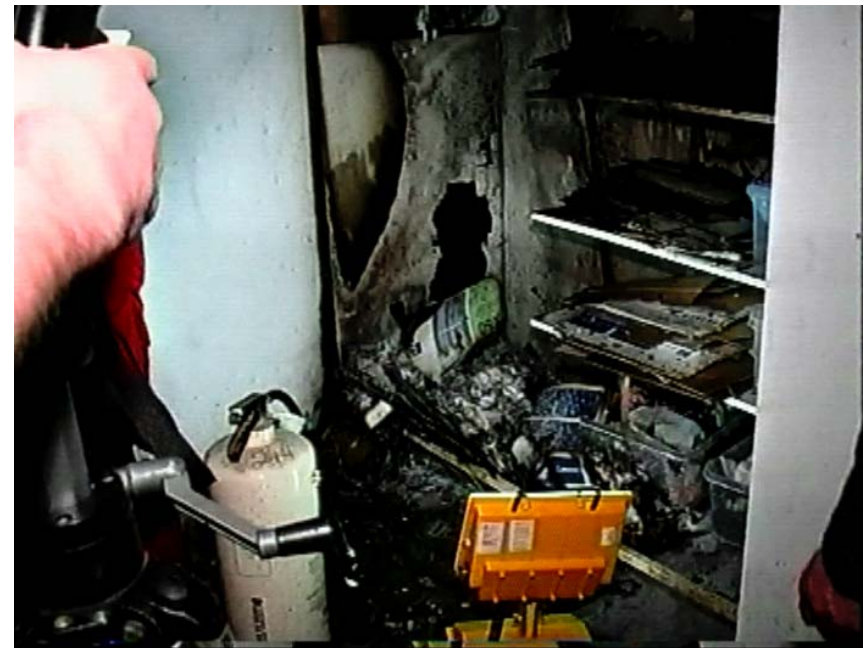
Fires with cupboard mock-up 4

Damage similar to incident cupboard in terms of pattern and extent

Damage to mcbs and shelf contents similar

Some wooden components exhibited only minor crocodiling possibly due to a less severe test fire

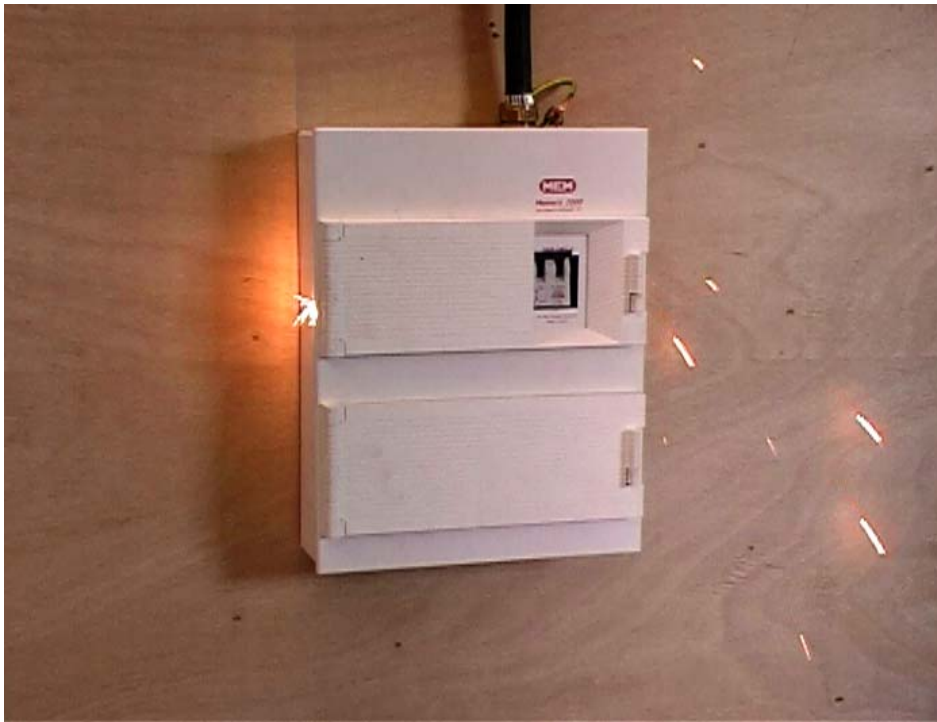
Potential for sparks to ignite cupboard combustibles 2

- Sparks escaped from a nominally closed case
- Sparks escaped from both induced faults
- More sparks escaped from short circuit to case fault rather than earth to bus bar fault
