**Effectiveness of sprinklers in
residential premises**

Section 5: Experimental
programme (Appendix 5B)

Project report number 204505

Appendix 5B – House fires damage assessment photographs

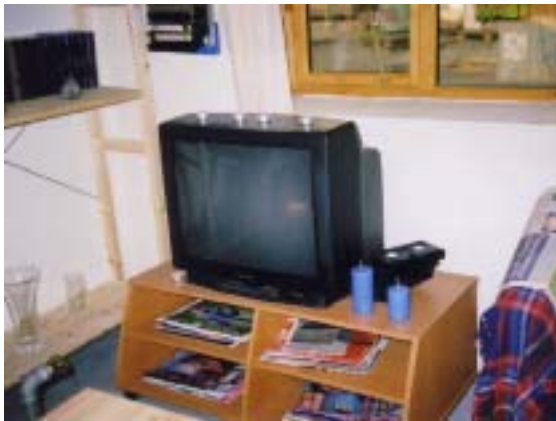
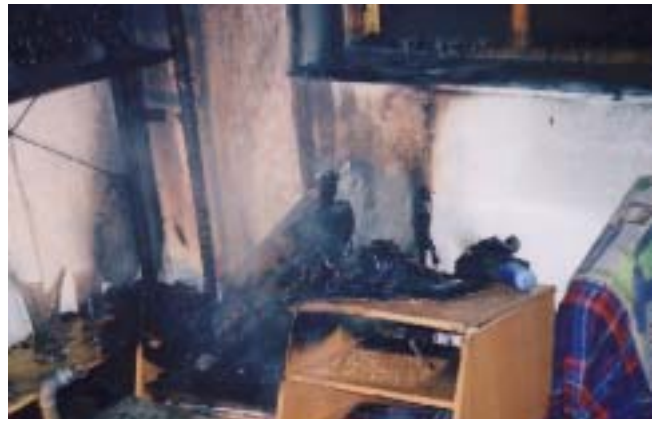
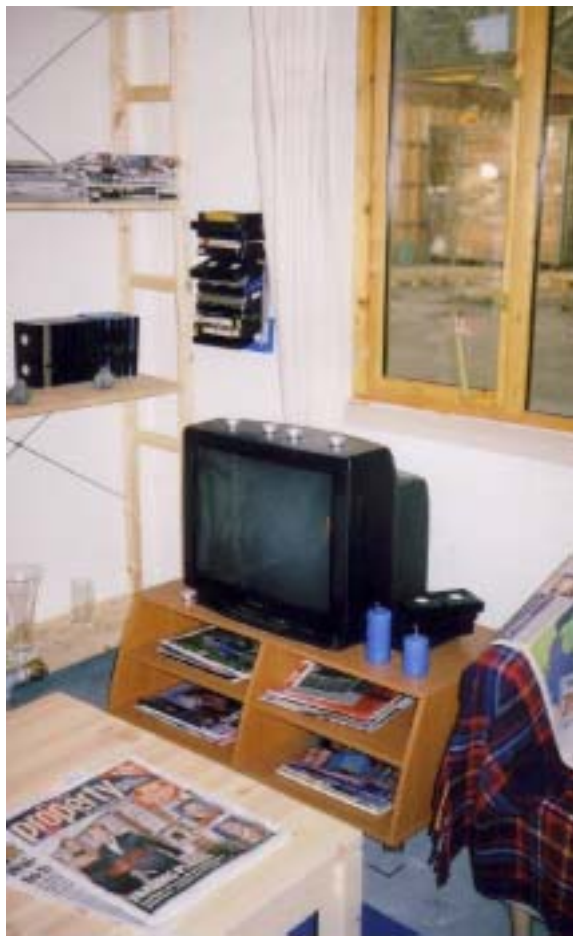
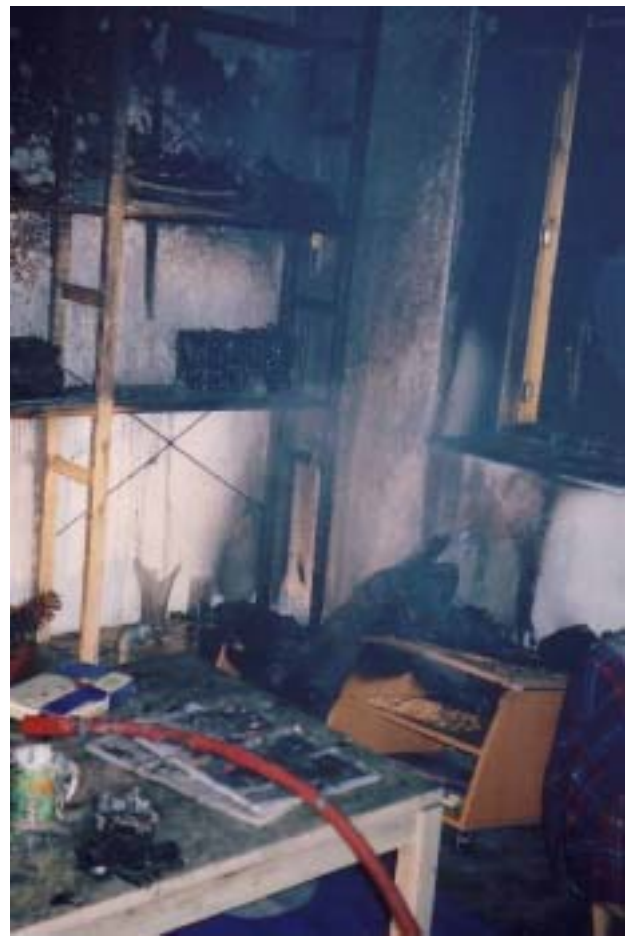
Figure 5B.1 Unsprinklered, open lounge door: Test 1

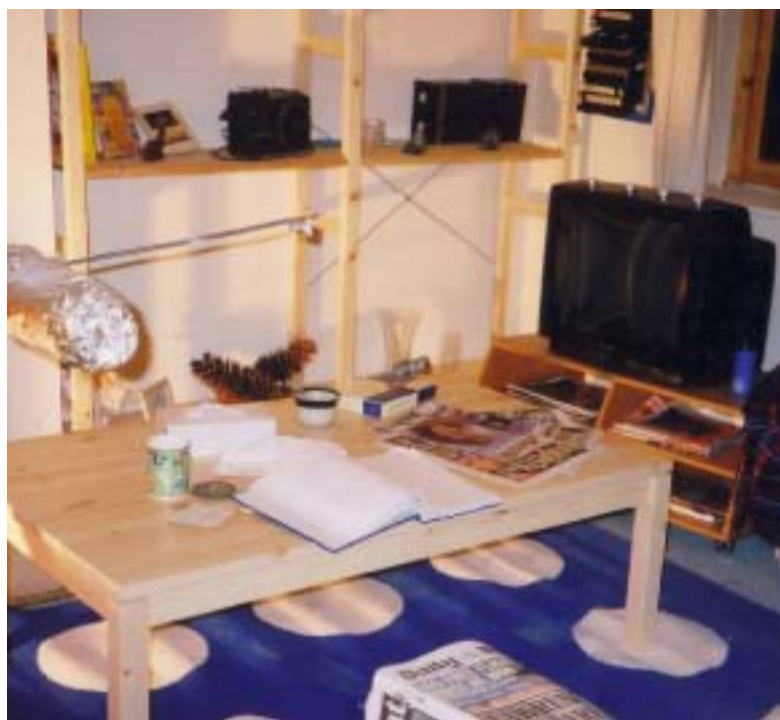
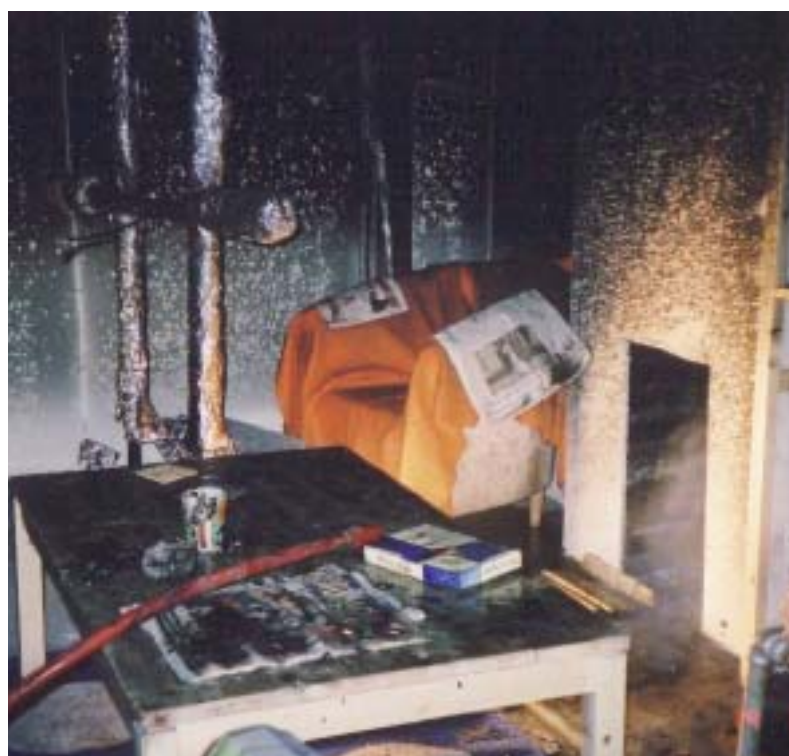
Figure 5B.2 Smoke damage: Test 1

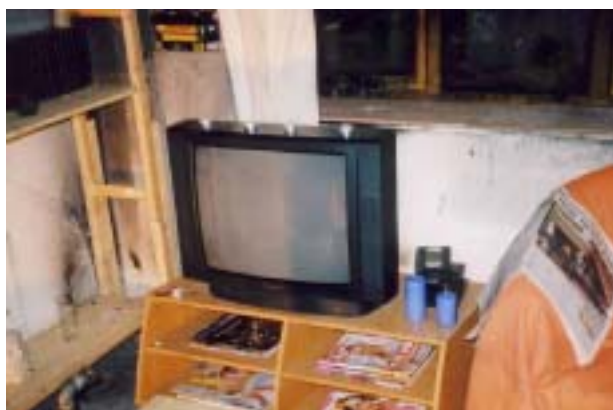
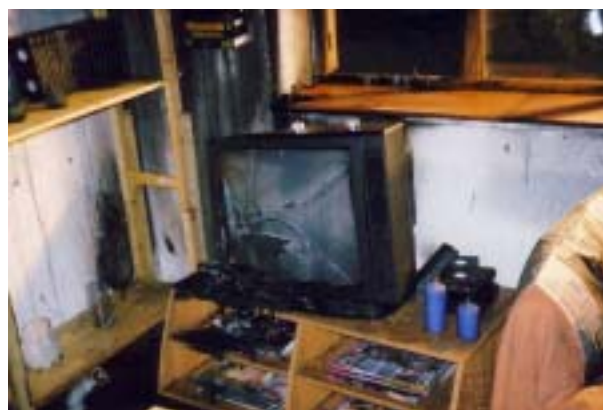
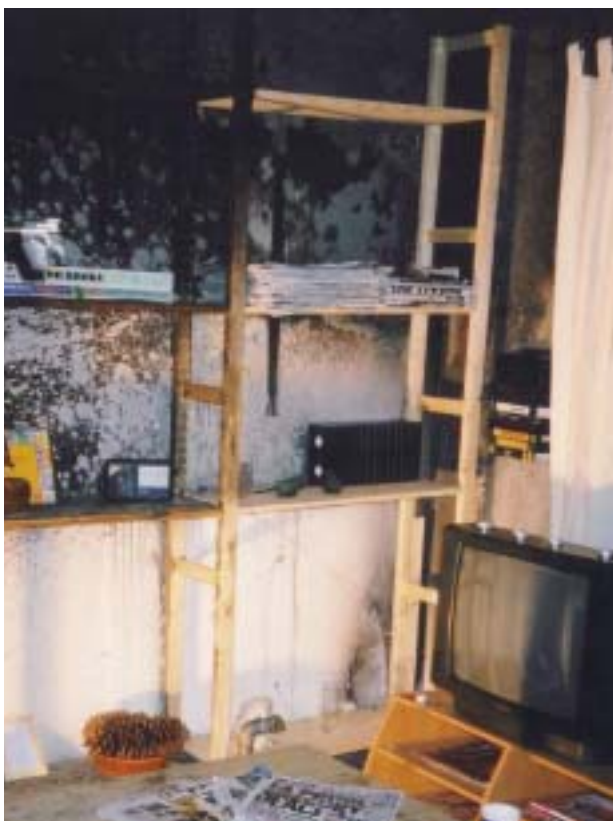
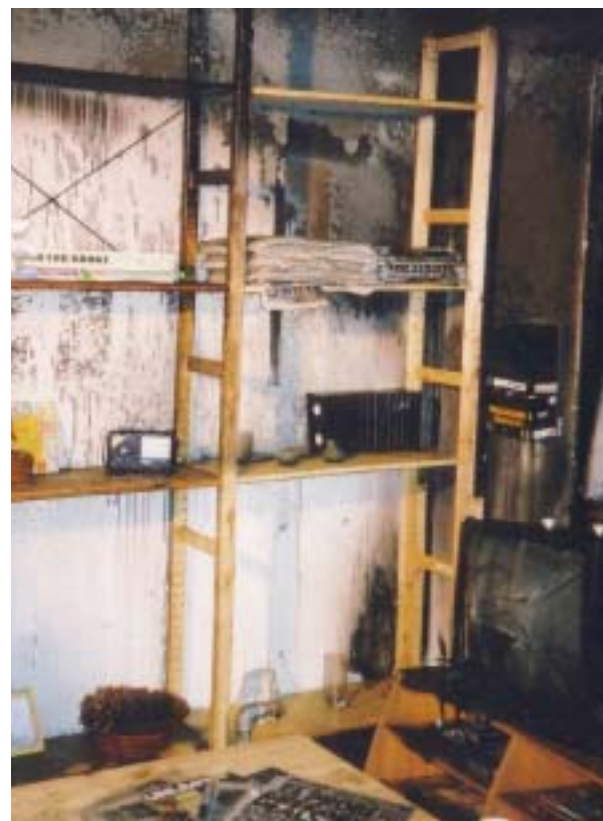
Figure 5B.3 Sprinklered, open lounge door: Test 2

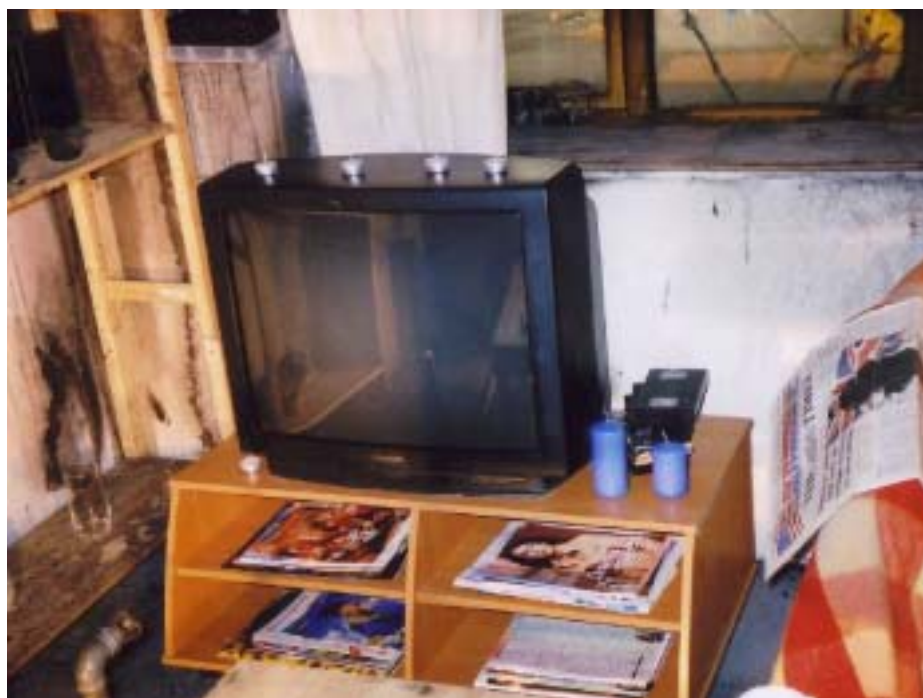
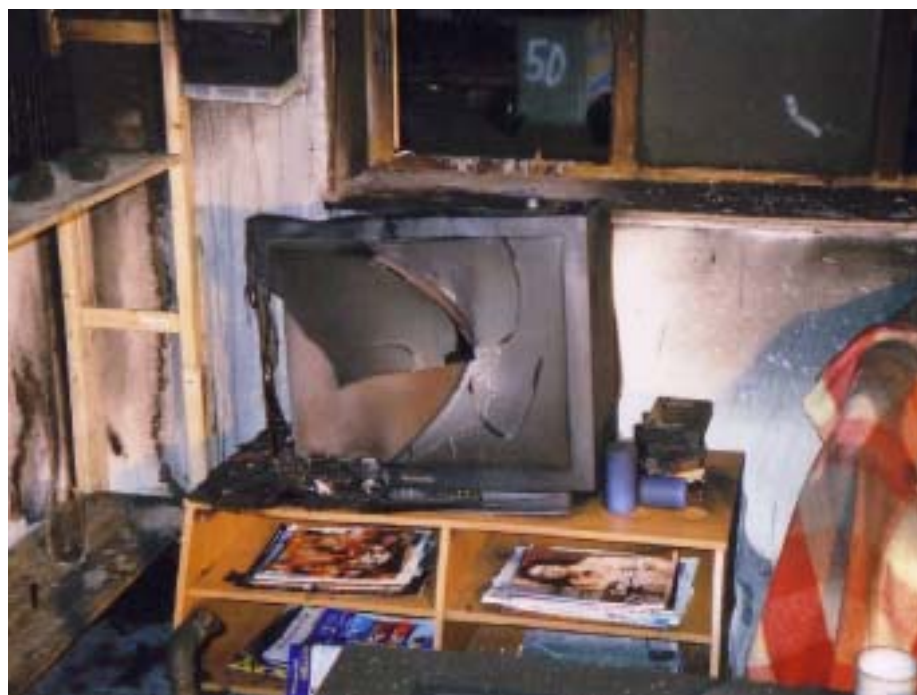
Figure 5B.4 Unsprinklered, closed lounge door: Test 3

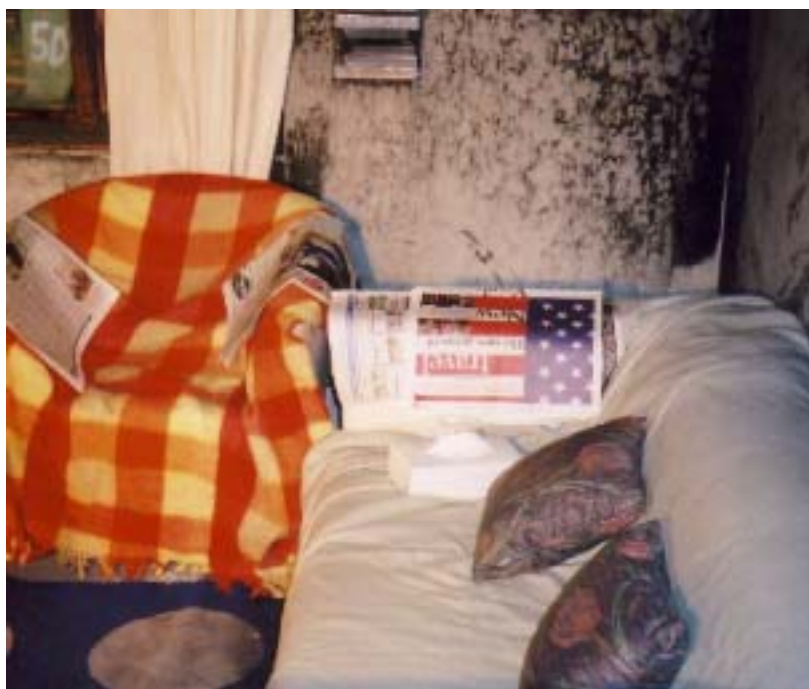
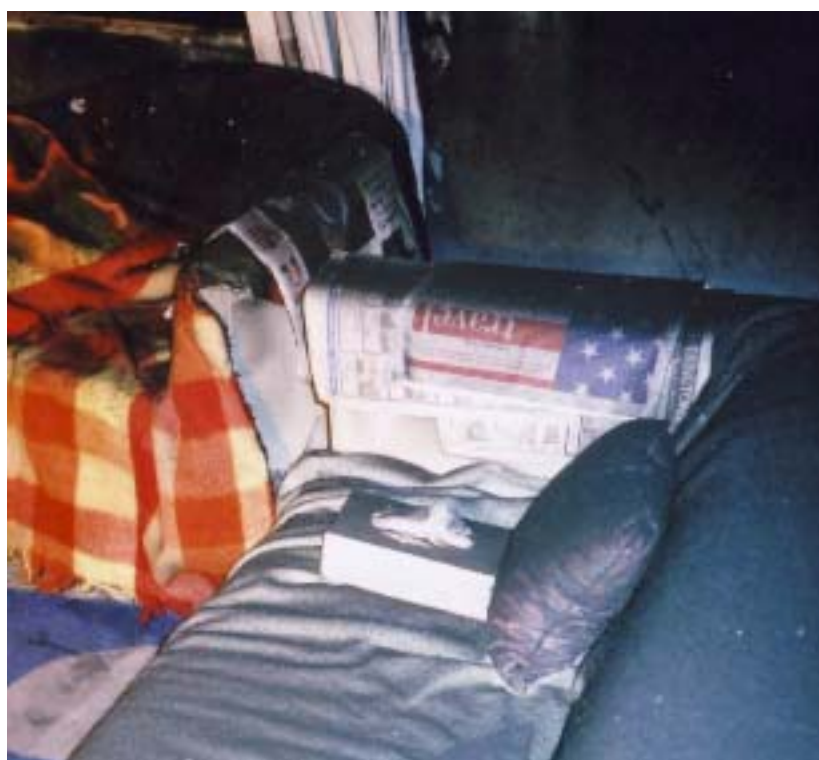
Figure 5B.5 Soot damage: Test 3

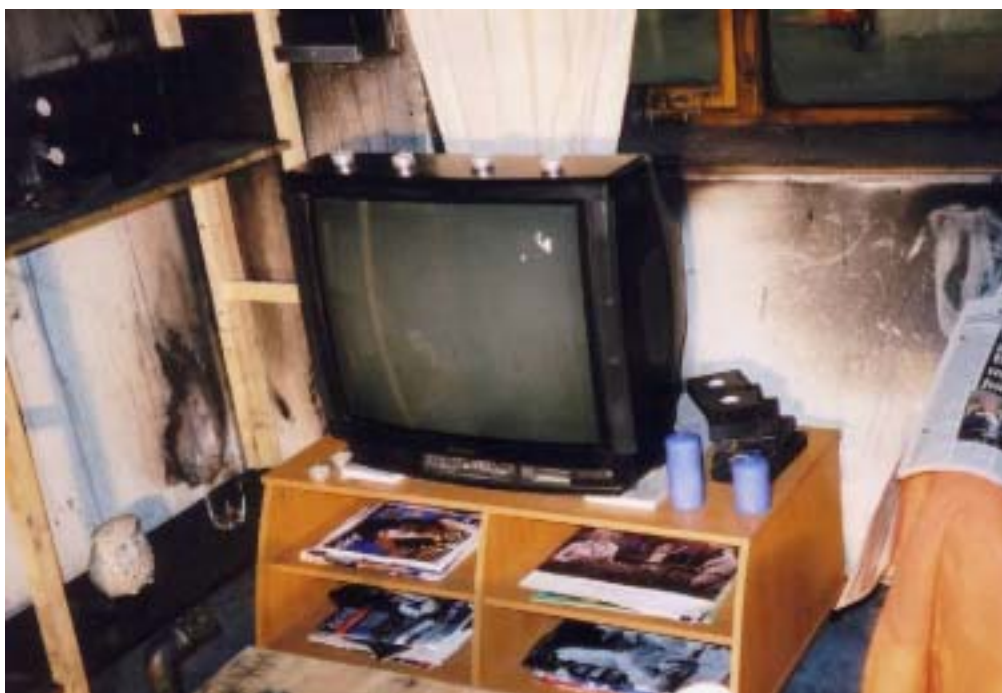
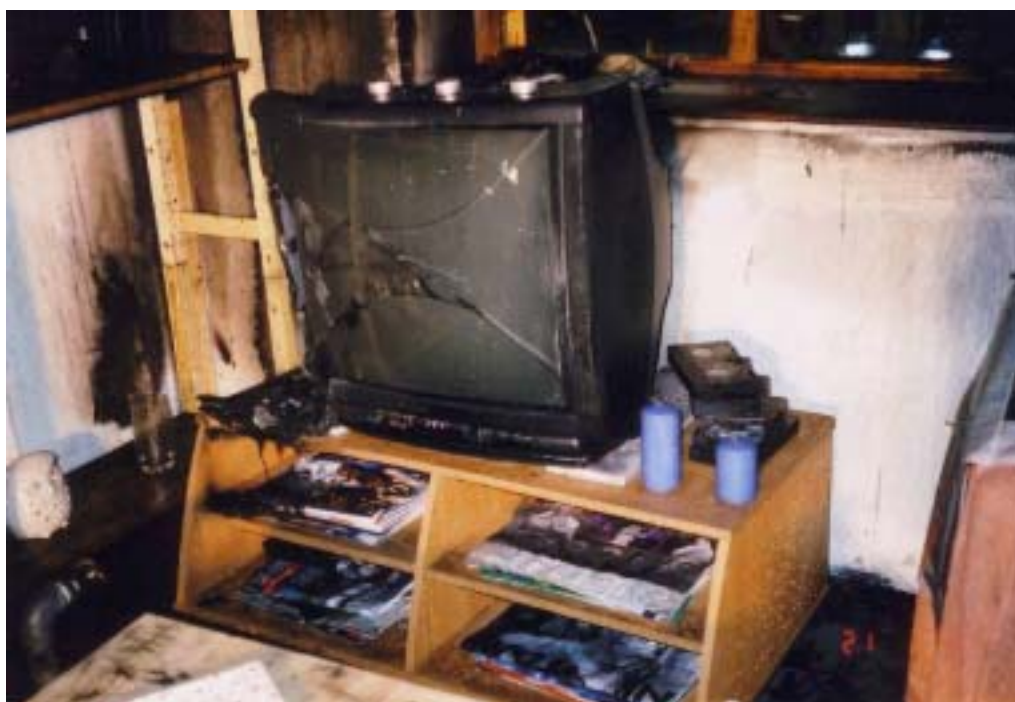
Figure 5B.6 Sprinklered, closed lounge door: Test 4

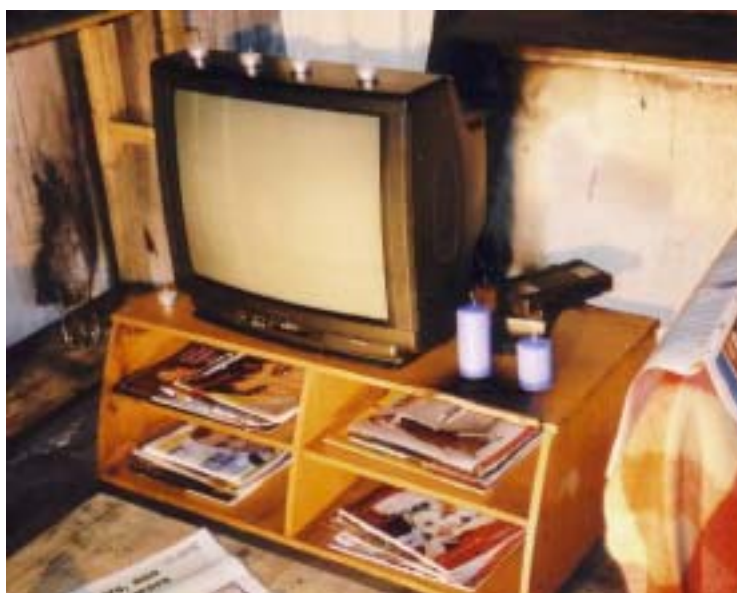
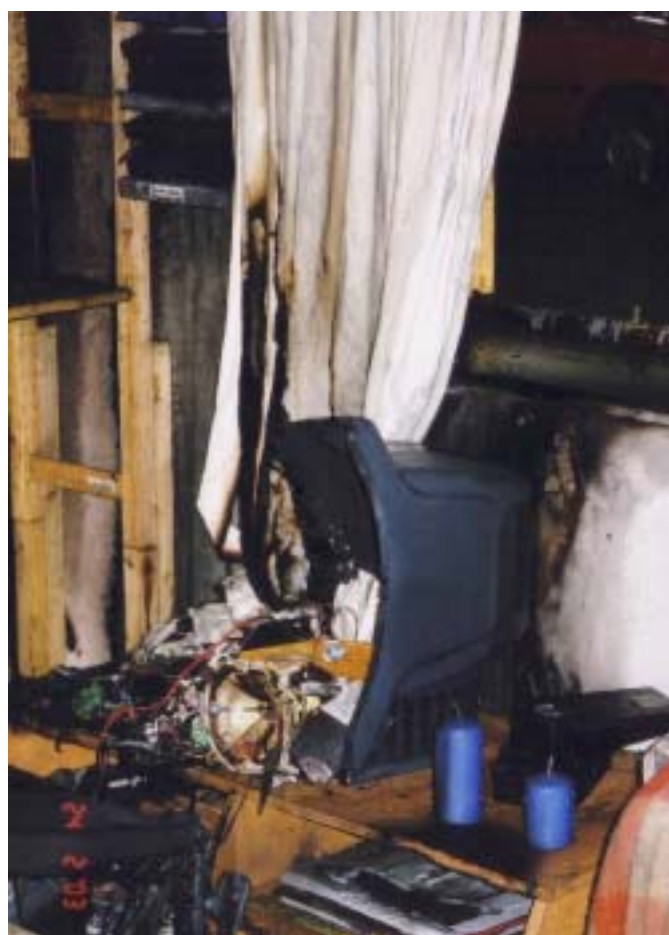
Figure 5B.7 Sprinklered (sprinkler B), open lounge door: Test 5

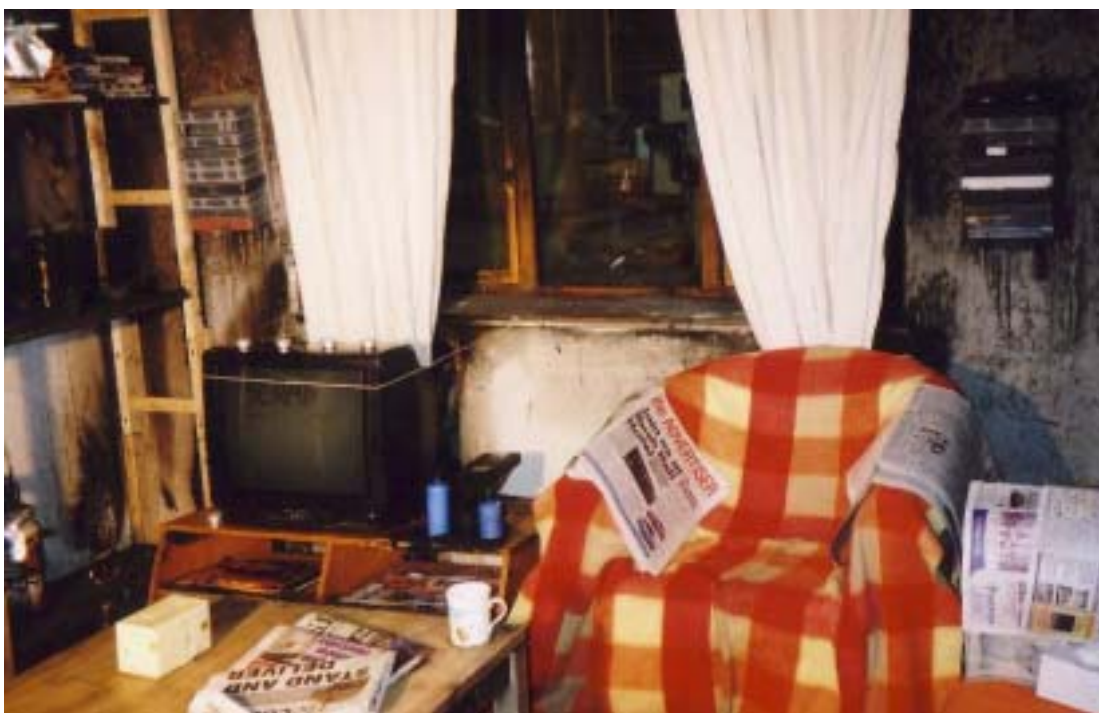
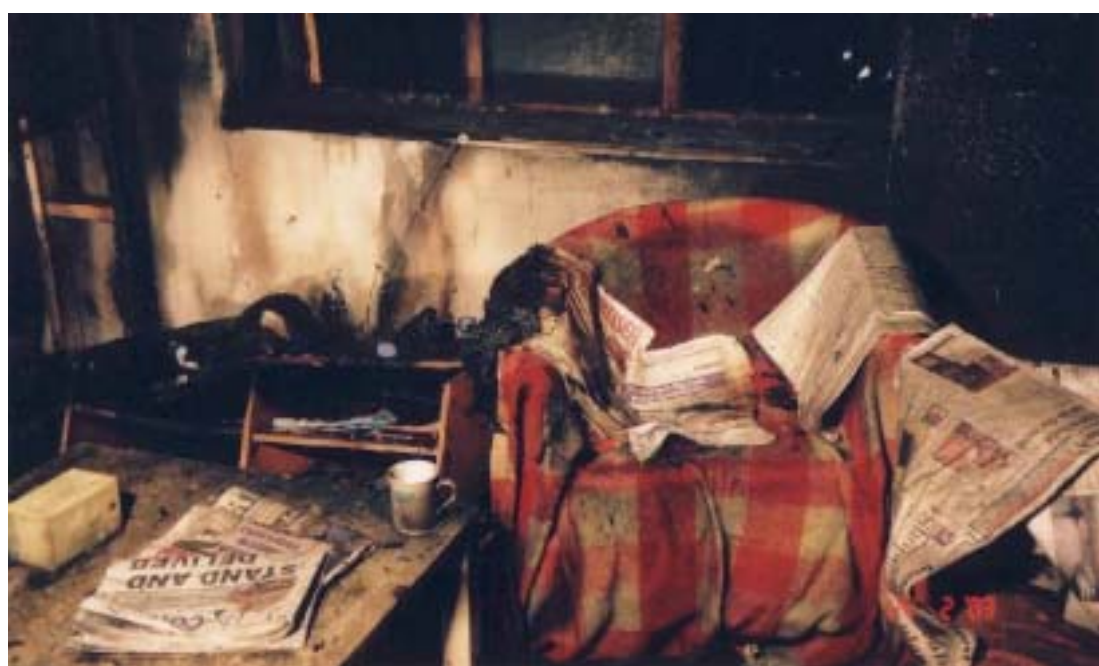
Figure 5B.8 Unsprinklered, open plan lounge: Test 6

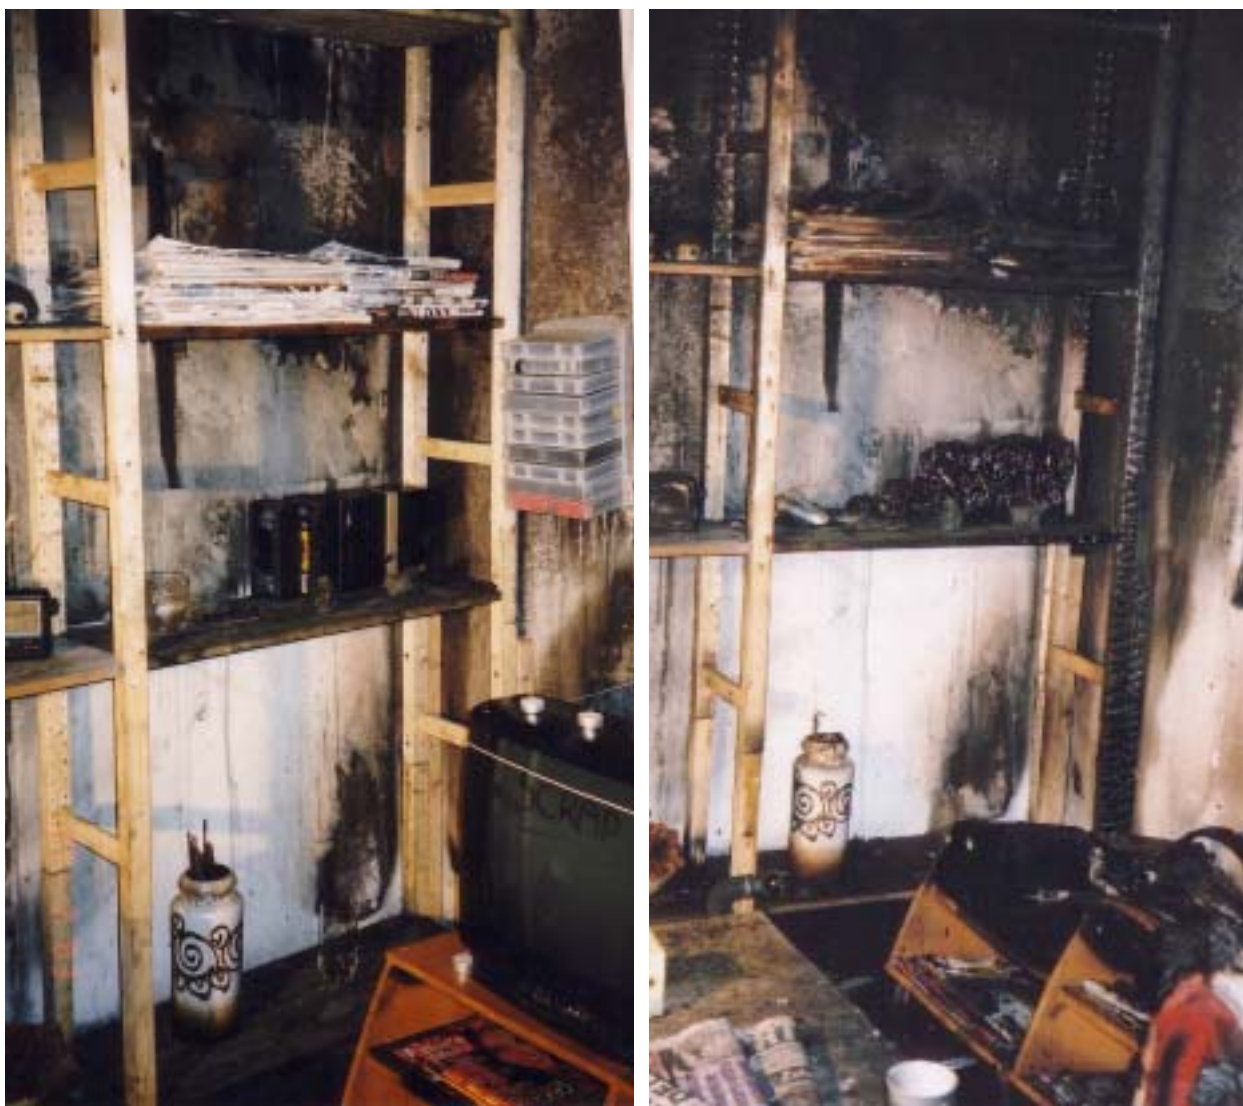
Figure 5B.9 Sprinklered, open plan lounge: Test 6

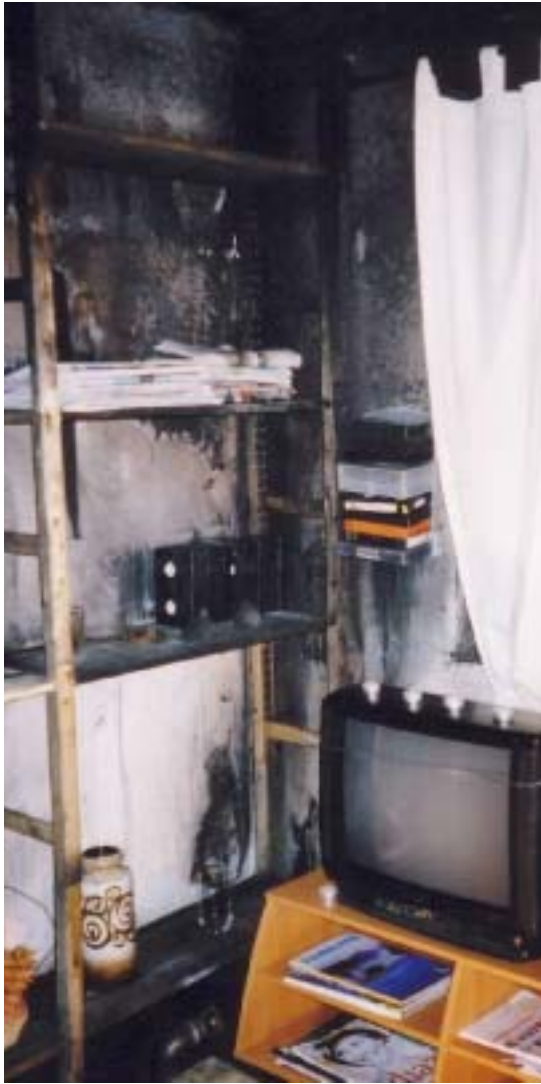
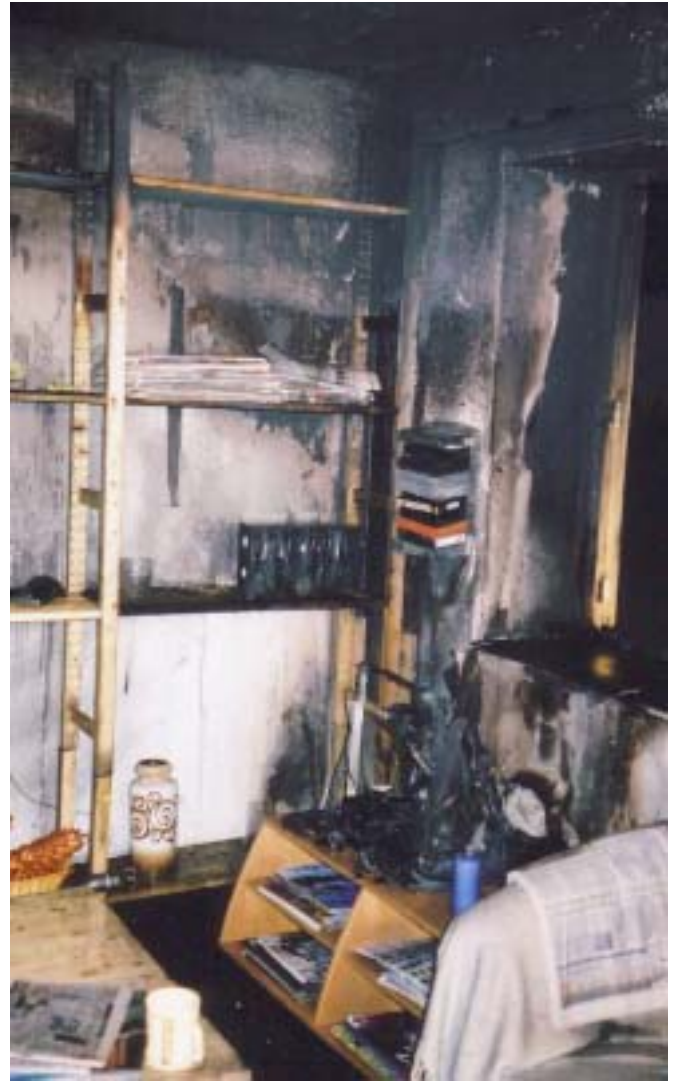
Figure 5B.10 Sprinklered, open plan lounge: Test 7

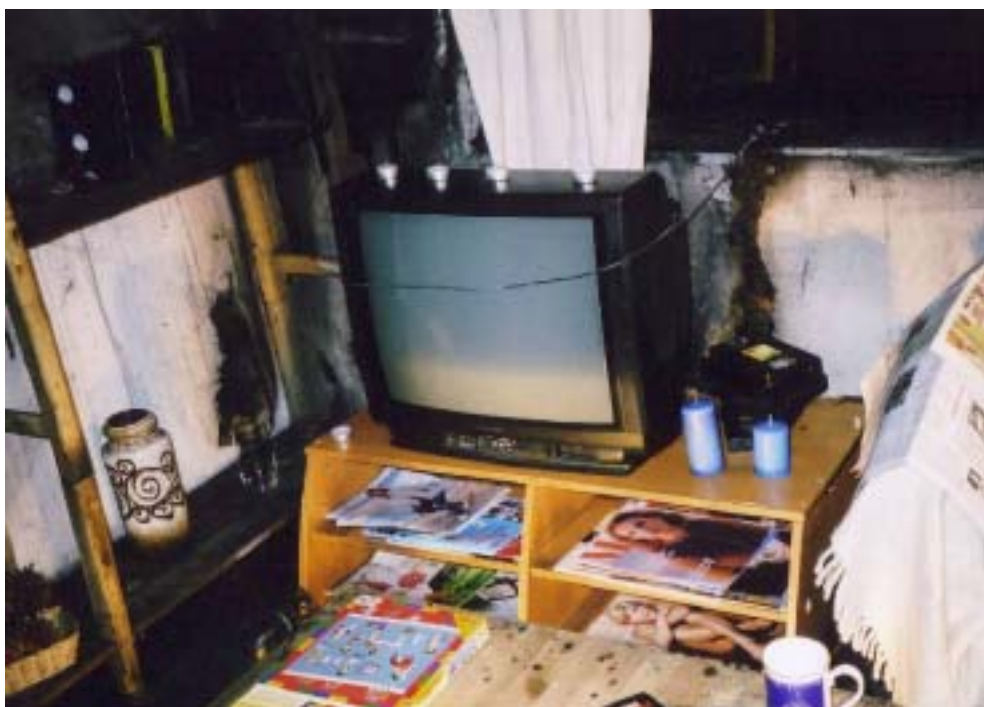
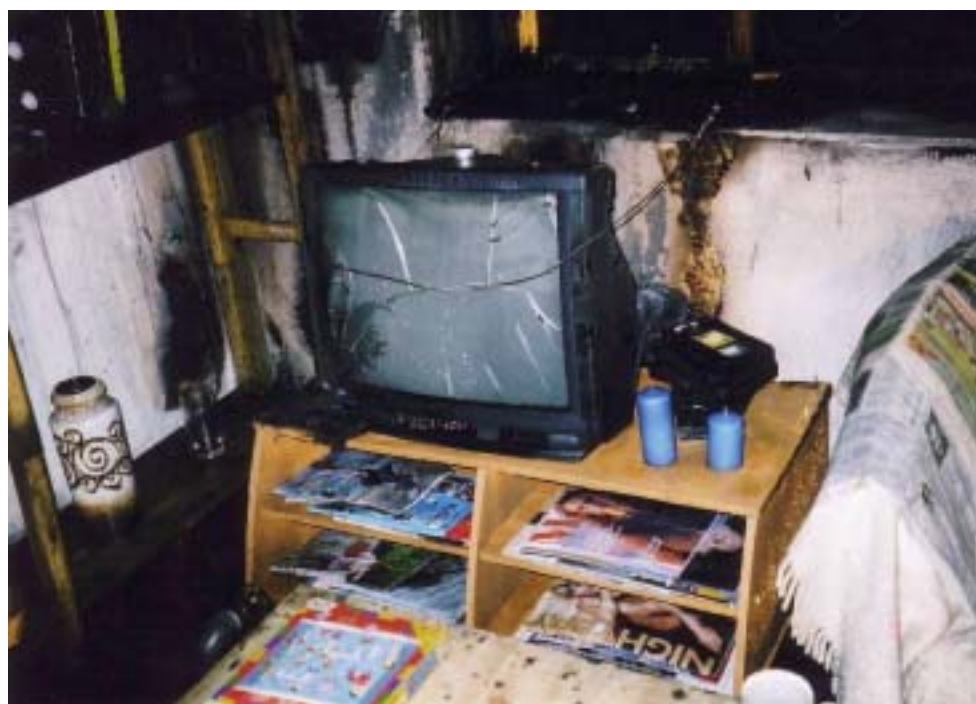
Figure 5B.11 Sprinklered open plan lounge: Test 8
