Annex C – Cavity Closures

The objective of this study was to investigate the effectiveness of different types of window frame constructions at mitigating the entry of fire into a timber frame cavity.

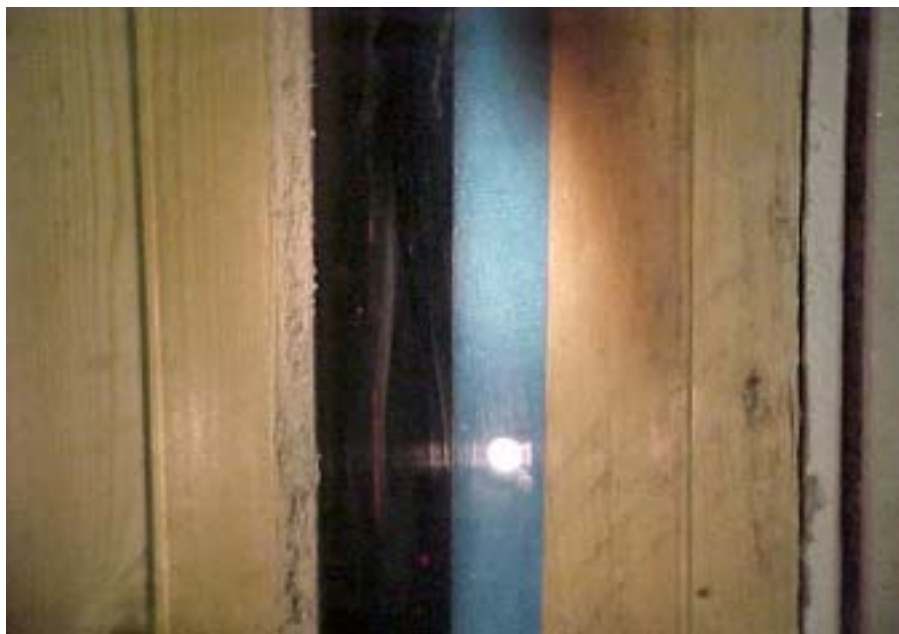
PVCu without timber bead

Photograph C3. Showing distortion of the window frame.

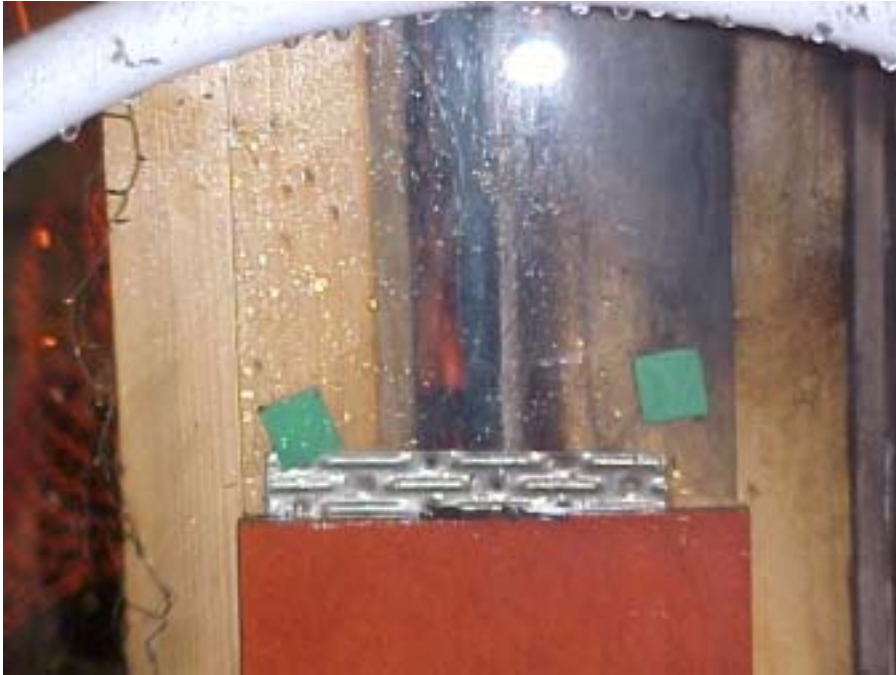
Aluminium with timber bead

Photograph C4. Showing flaming entering the cavity.

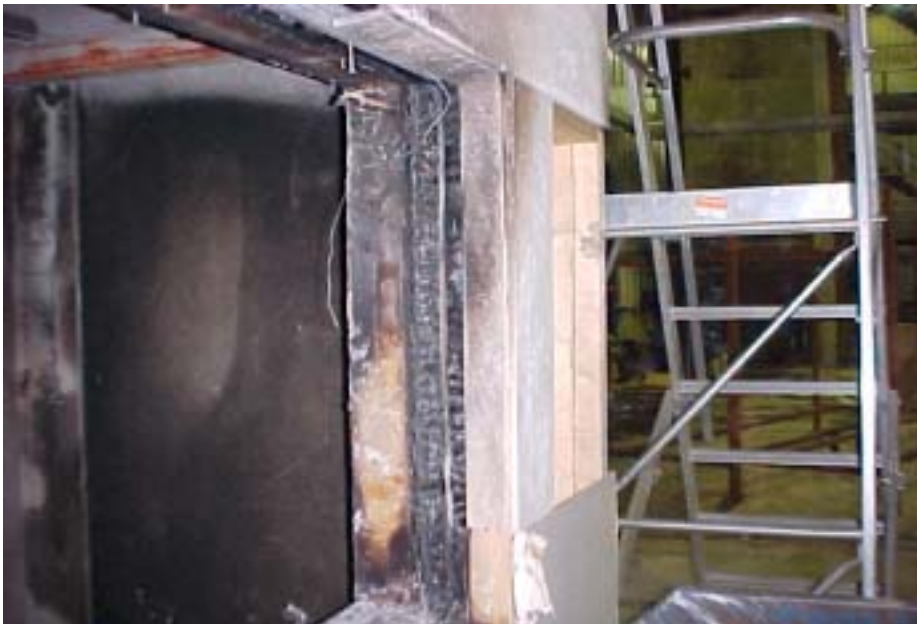
Photograph C5. Showing post test damage.

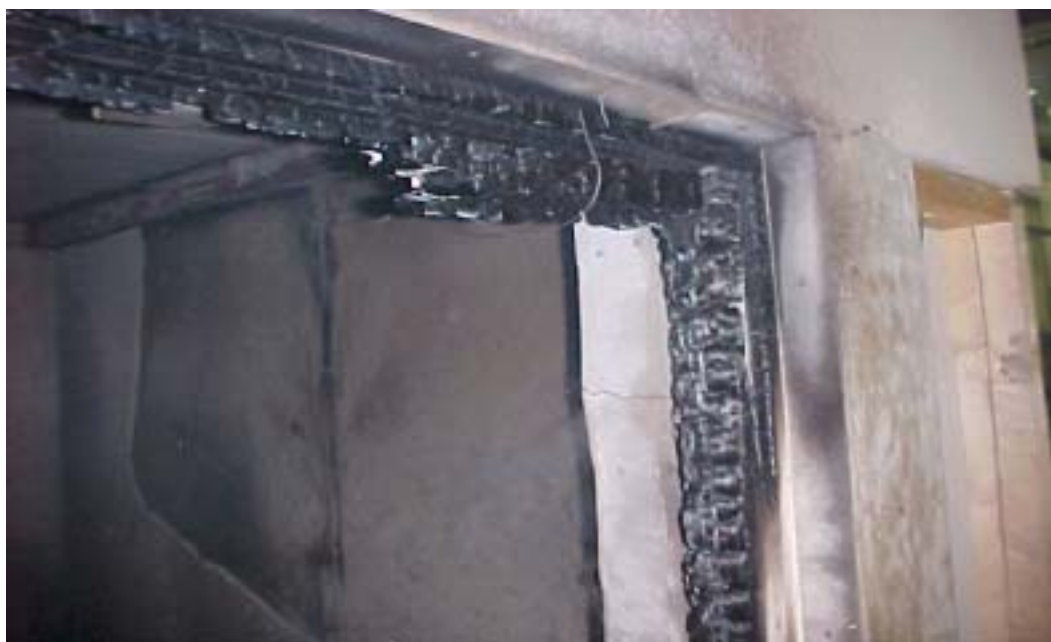
Photograph C10. Showing post test damage.

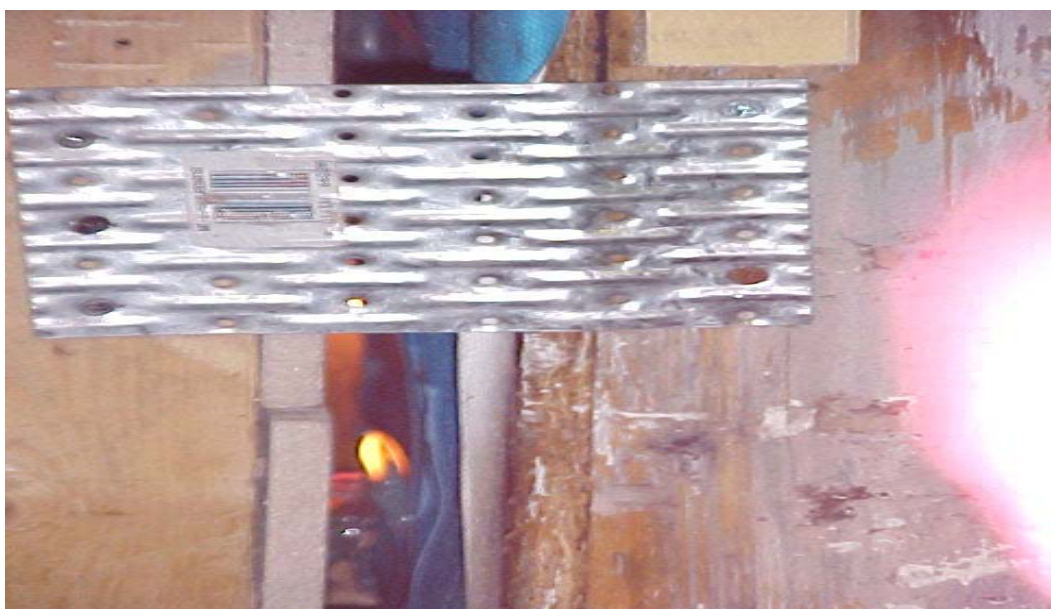
Softwood with timber bead

Photograph C11. Showing flames entering the cavity

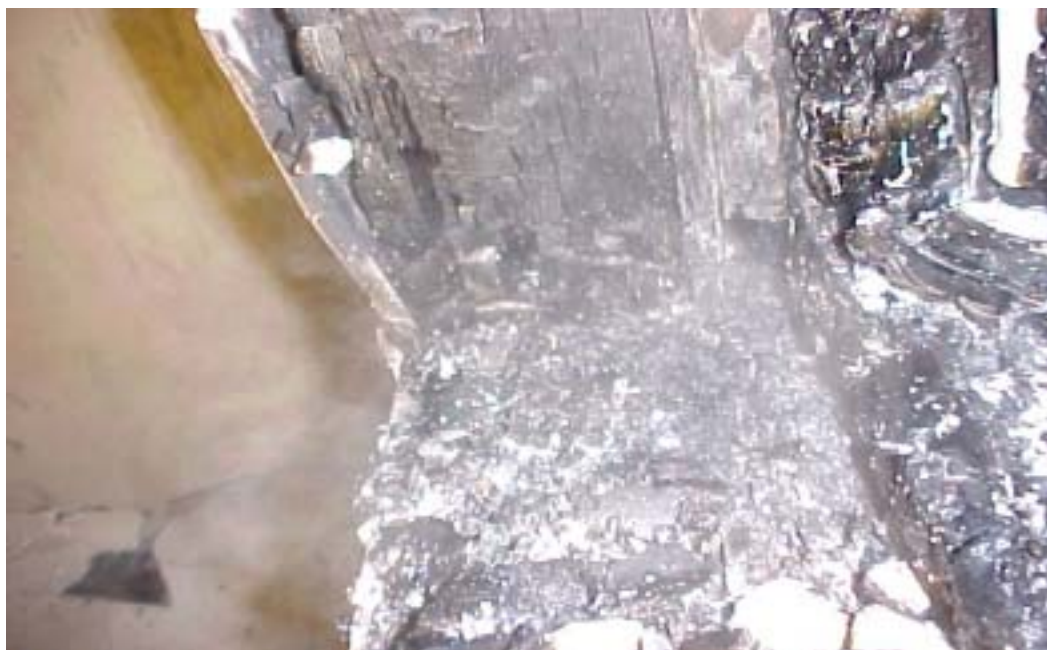
Photograph C12. Showing post test damage.

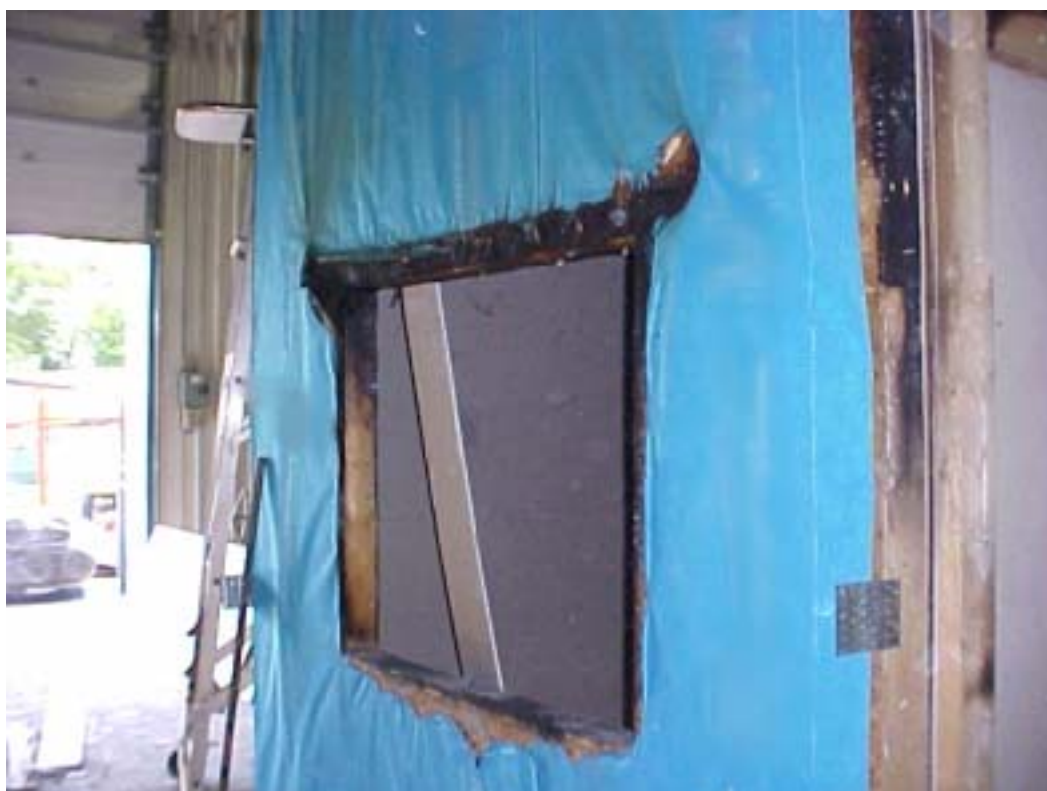
Softwood without timber bead

Note 1: post test inspection suggested that the window frame systems were still intact and that the breach may have been due to the failure of the joint detail between the enclosure and the window framework.

Photograph C13. Showing post test damage.
