Examination of the fire resistance requirements for ducts and dampers

Executive Summary

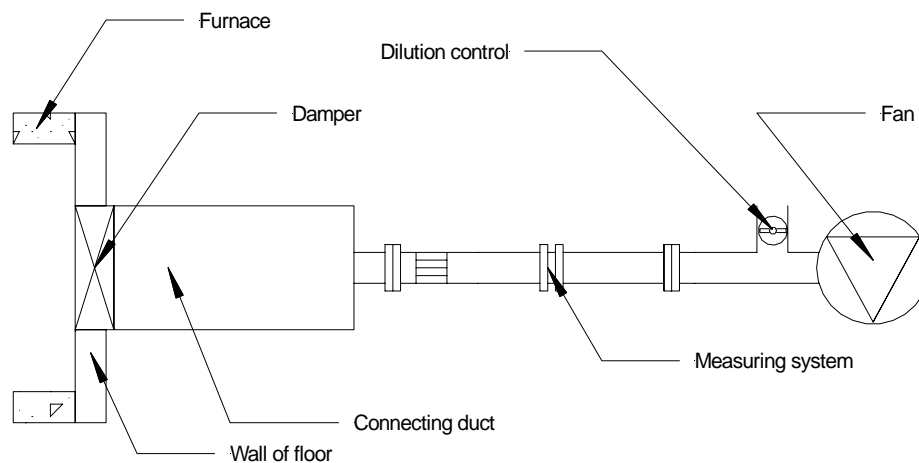
Figure 1 Example of general test arrangement used in ISO 10294-1 and BS EN 1366-2

The basic concept is illustrated below:

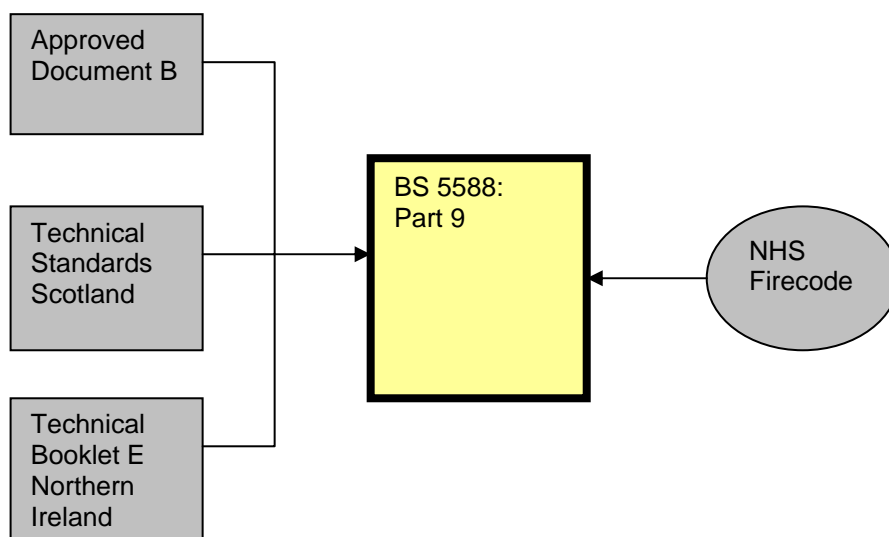
Approved Document B relies on BS 5588 part 9:Code of practice for ventilation and air conditioning ductwork to provide details of appropriate methods for protection of ducted systems for Heating, Ventilating and Air-conditioning (HVAC).

Figure 2. Regulatory Framework

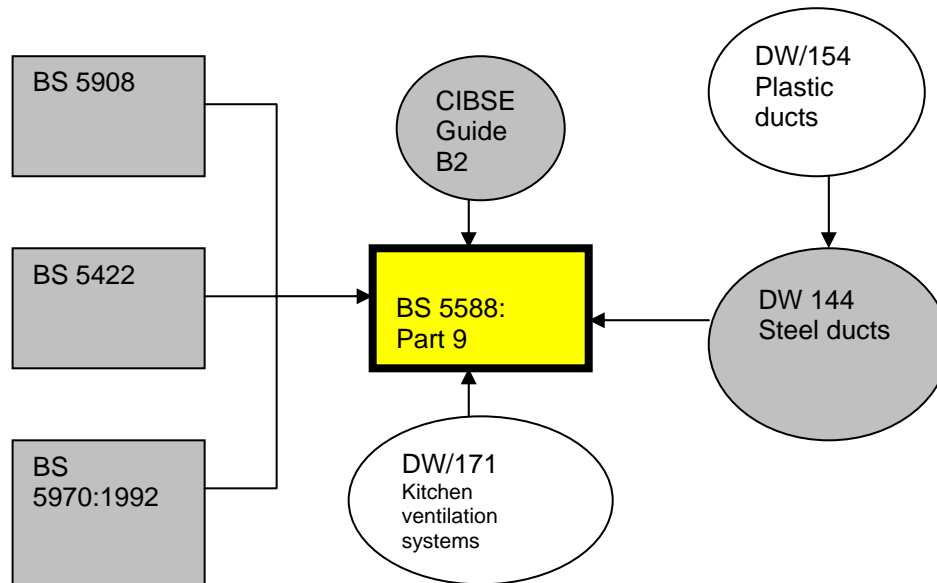
In addition, the principle codes relating to HVAC also refer directly to this code.

Figure 3. Basic Code framework for HVAC systems

There are three alternative systems for the fire protection of HVAC systems that are provided within BS 5588 part 9. These are not mutually exclusive and very often combinations of the methods are found in ductwork systems. The three methods are as follows:

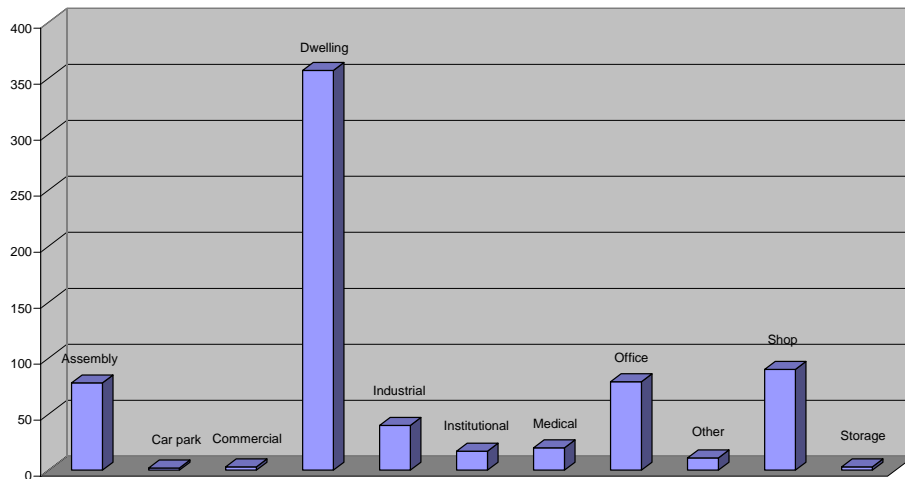
Figure 4 Breakdown of fires involving HVAC system-LFB data

Property type	Number of fires involving HVAC system	Number of fires that spread beyond room of origin
Assembly	78	17
Car park	2	0
Commercial	3	2
Dwelling	357	43
Industrial	40	5
Institutional	17	2
Medical	20	2
Office	79	0
Other	11	1
Shop	90	18
Storage	3	1
Total sample	700	73

Number of fires in each type of building where fire involved HVAC system
London Fire Brigade data

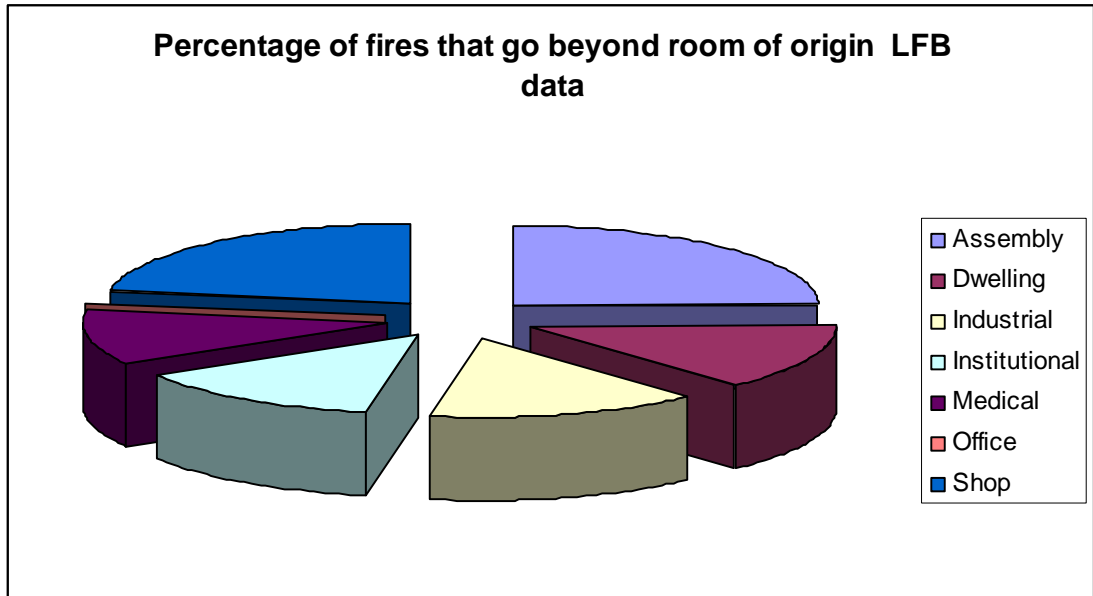
The data presented in figure 5 show the proportion of fires where it was reported that fire involved more than one room, and ignoring the purpose groups where less than 15 fires occurred, the data supplied yielded the following:

Figure 5. Breakdown of fires that go beyond room of origin based on purpose group

It should be noted that in relation to offices, no fire appeared to have gone beyond the room of origin. The reason for this is not clear, but it could possibly be associated with the current trend to open plan office types.

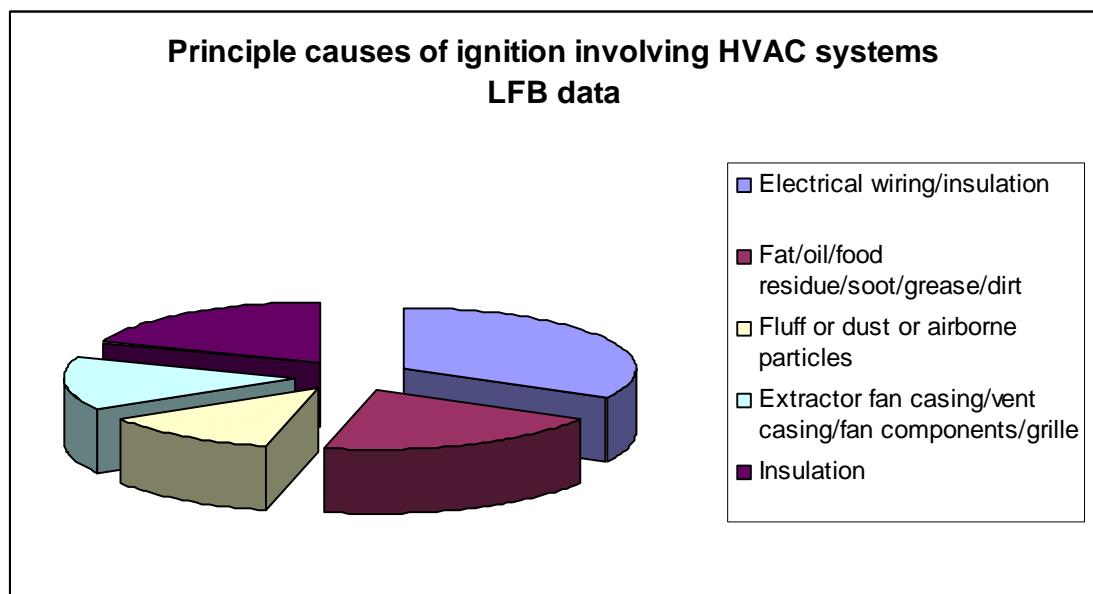
Figure 6. Principle causes of ignition involving HVAC systems

Figure 6 ignores causes below 9% of the total sample and gives principle first material ignited that subsequently involves the air distribution system through the extract duct system.

Table 4 Causes of ignition involving ductwork			
Group ref	Material first ignited	Number of fires	% of total sample
1	Electrical wiring/insulation	169	24
2	Fat/oil/food residue/soot/grease/dirt	105	15
3	Fluff or dust or airborne particles	64	9
4	Extractor fan casing/vent casing/fan components/grille	73	10
5	Accumulated debris/refuse/rubbish	22	3
6	Electrical equipment/component	39	6
7	Flammable vapours, propellant	9	1
8	Air filter/dust filters	11	2
9	Insulation	99	14
10	Flooring, joists, timber boarding, plastic sheet, building components, sealants, wall panel, adhesive	14	2
11	Paint particles, paint	2	0.3
12	Natural gas	1	0.15
13	Furnishings, fittings	22	3
14	Storage, paper, tissue, tyres, scaffold boards	11	2
15	Unknown or not easily categorised	59	8
Total		700	100

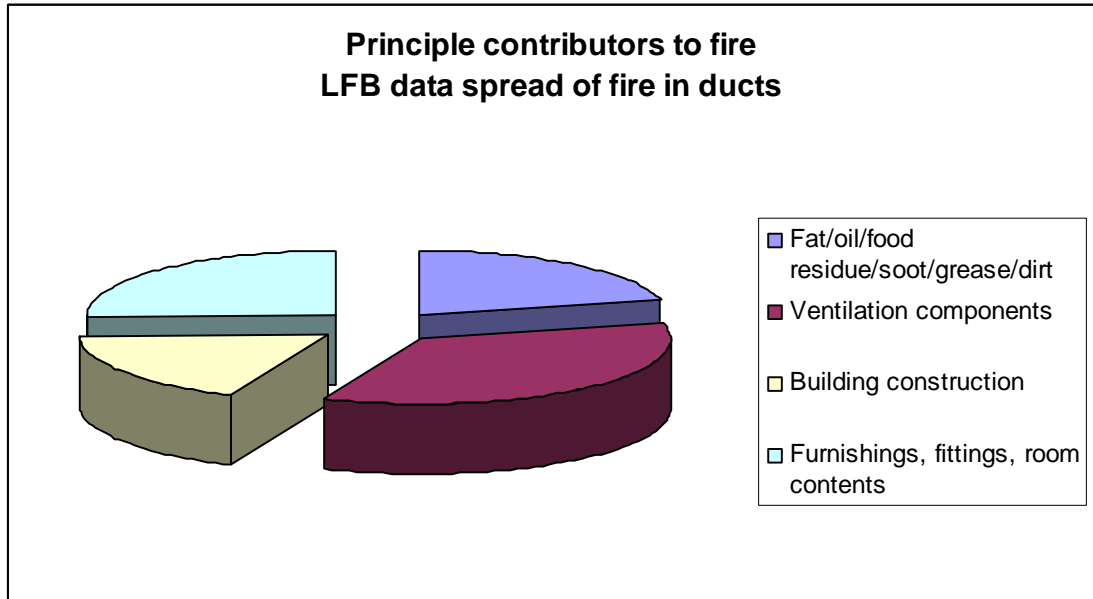
Figure 7 is for those materials that were stated to have been mainly responsible for fire spread, ignoring those that contribute less than 10% of the total sample and those where the material could not be identified.

Figure 7. Principle causes of fire spread in ducts

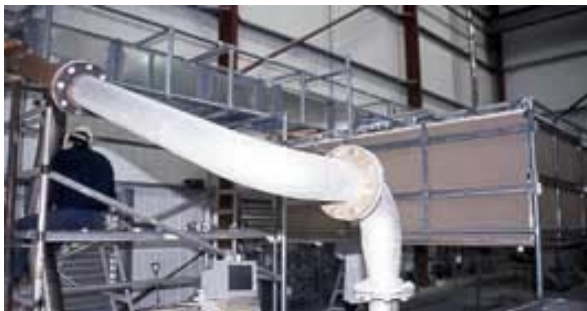
Plate 1 Activation rig

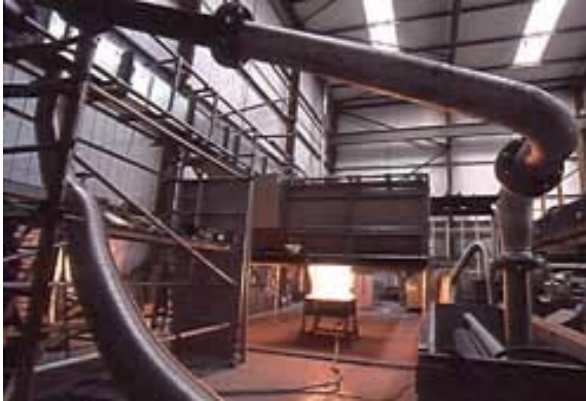
Plate 2. Photograph of a test to determine the activation time of a damper showing the fire source under the ceiling area with downstand.

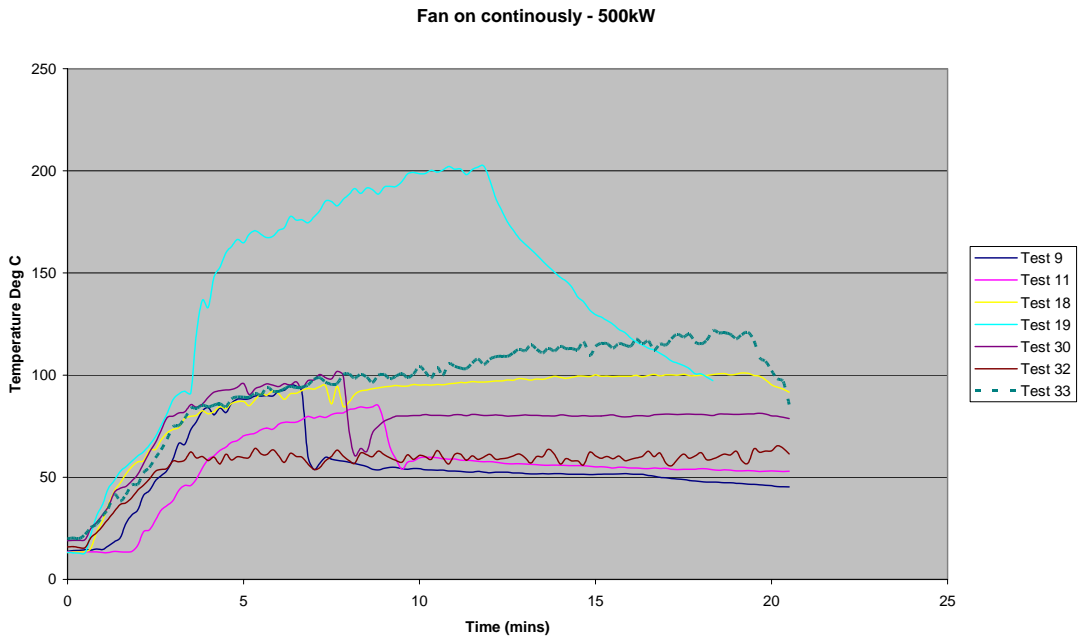
Figure 8. Temperatures near damper for the fan on and 500kW fire exposure.

The average time to activate for the dampers that did activate in the tests was 406 seconds. Figure 8 is a graph of the temperatures (°C) measured close to each of the dampers during the tests, as a function of time (minutes).

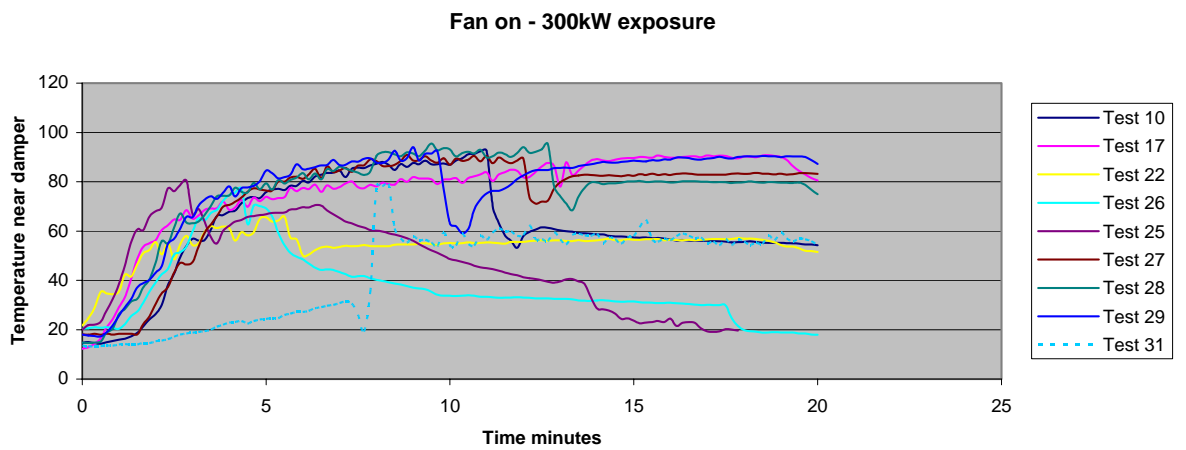
Figure 9. Temperatures near damper for the fan on and 300kW fire exposure.

Figure 9 is a graph of the measured temperatures (°C) close to the dampers as a function of time (mins).

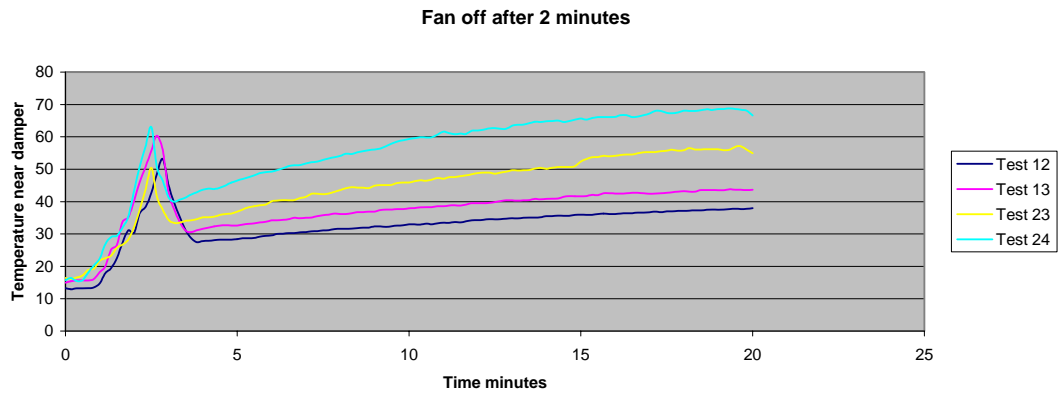
Figure 10. Temperatures near damper for the scenario in which the fan is shut off after 2 minutes.

From table 15 it can be seen that in all cases none of the dampers operated. Figure 10 shows the measured temperatures (°C) close to the dampers as a function of time (mins). It can be seen that the measured gas temperatures were below the typical operating temperature of fusible links (circa 70°C). It was possible that the baffles in the extract vents, which were made from steel, might have contributed to reducing the amount of hot gases that entered the main duct in these particular tests. In practice, the baffles may be made from plastic or aluminium. It was therefore decided to undertake some additional experiments with the baffles removed after a period of time into the test to examine the role of the baffles in the extract vents on the temperatures within the duct and therefore, the operability of the dampers. The results of these additional tests are detailed in section 5.2.4 below.

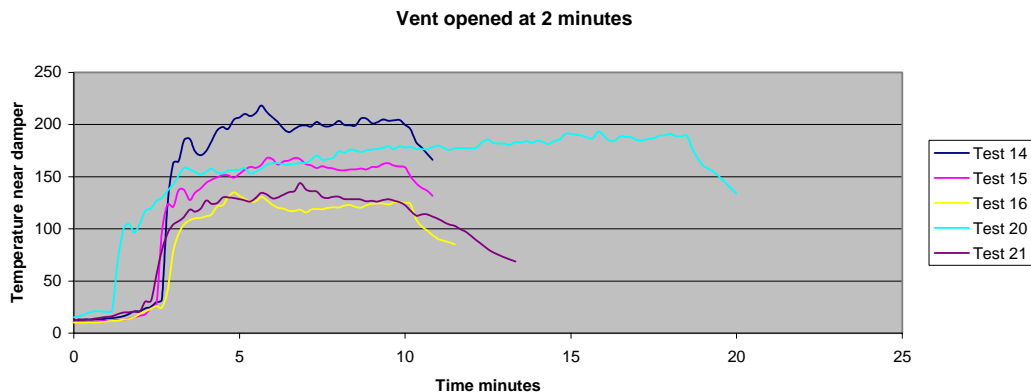
Figure 11. Temperatures near the damper with the vent open at 2 minutes.

Figure 11 shows the measured temperatures (°C) close to the dampers as a function of time (mins).

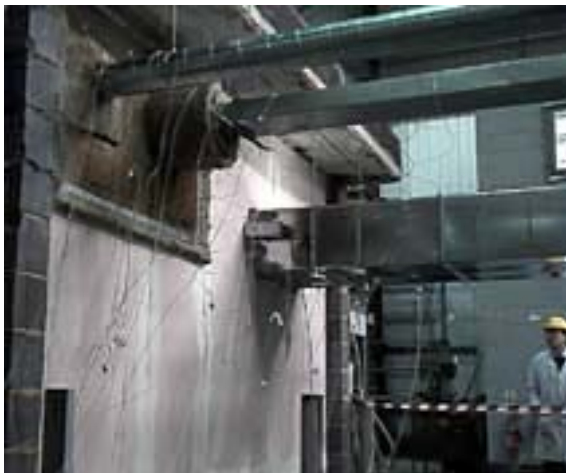
Plate 3. Photograph of the furnace test set up showing the arrangements of ducts/dampers through the wall of the furnace.

For the fire resistance test, the performance of a test construction comprising an uninsulated horizontal steel ventilation duct connected either side of a damper installed in a dry-lining partition, when exposed on one side of the partition to the hot gases of a furnace both inside and outside the duct, was examined (see plate 3 – right hand side of wall). Generic details of all of the components in the fire resistance test are provided in table 17. The furnace was controlled to follow the heating conditions specified in BS EN 1363-1, during the course of the test the performance of the damper was evaluated by adopting the procedures and criteria of BS EN 1366-2. In addition, the behaviour of two small duct systems each carrying a damper and passing through a rock fibre fire barrier installed in a portion of the partition assembly was examined (see plate 3 – left hand side of wall).

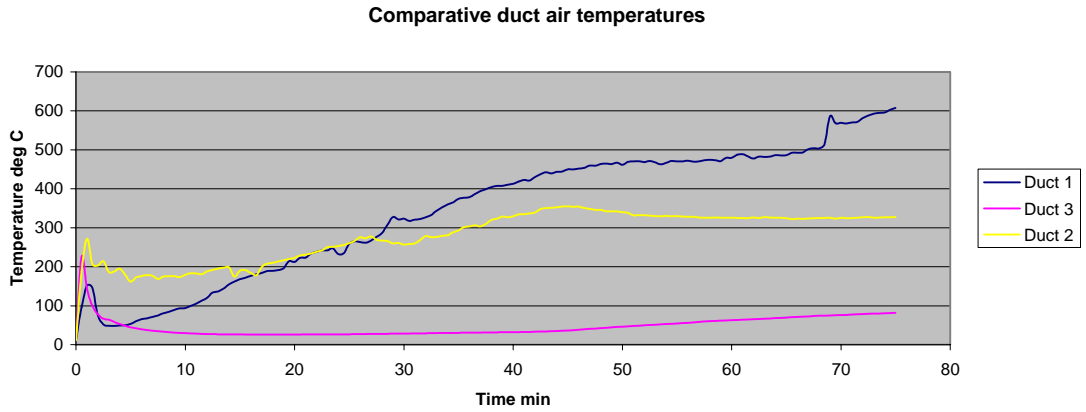
Figure 12. Temperatures 500mm from damper during test

Duct 1 = 1200mm x 400mm duct with multi-blade damper

Duct 2 = 160mm diameter duct with single blade damper

Duct 3 = 300mm x 105mm duct with intumescent damper

The comparative air temperatures (°C) recorded in each duct (position 1, 500mm from damper) are shown in figures 12, 13 and 14 as a function of time (minutes). This data is

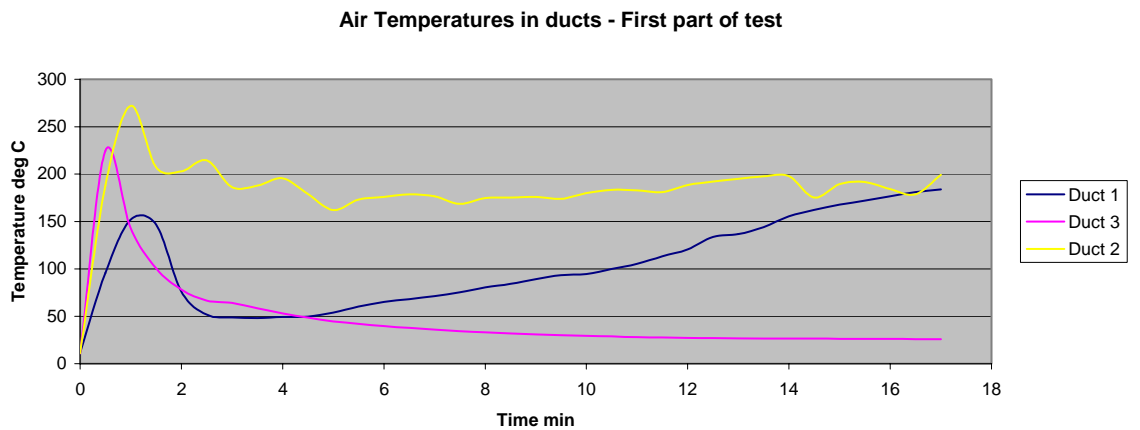
Figure 13. Temperatures 500mm from damper in first 17 minutes of test

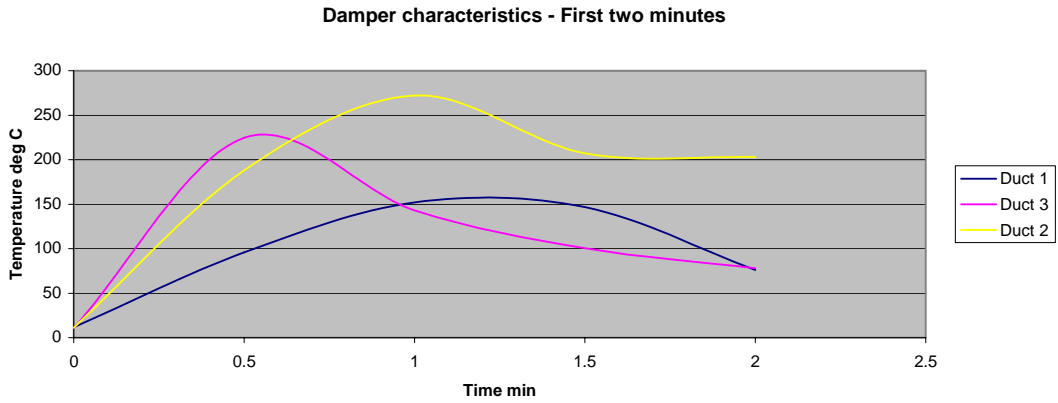
Figure 14. Temperatures 500mm from damper in first two minutes of test

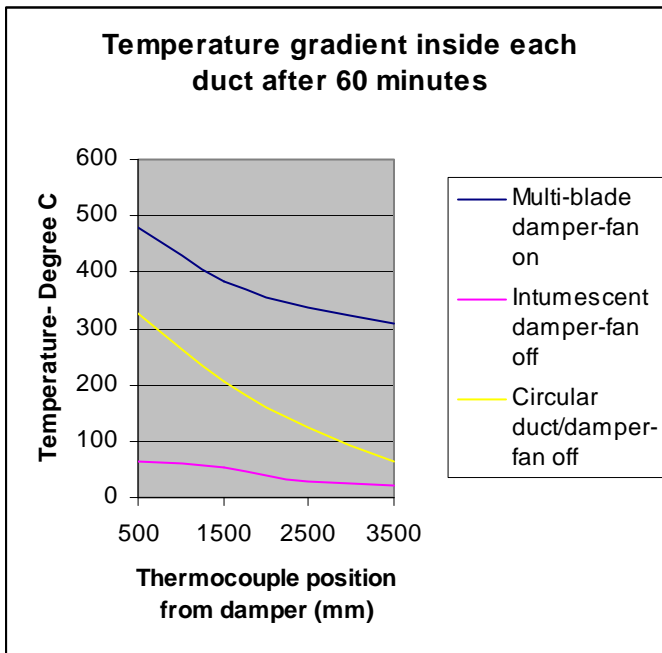
Figure 15. Temperature gradient inside each duct at 60 minutes

The internal air temperature along the length of each duct at 60 minutes is shown in figure 15. It should be noted that the data for the multi-blade damper corresponds to the fan on situation. The data for the other two damper arrangements correspond to fan off situations.

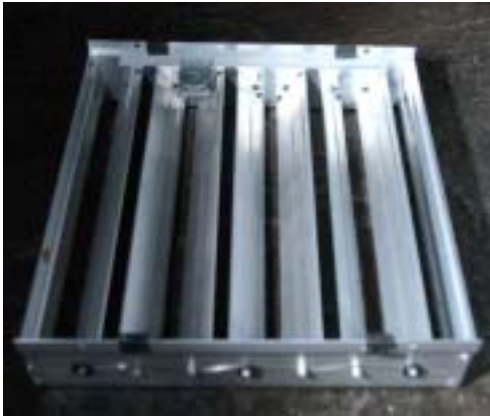
Plate 4 Air velocity control device

This was included to represent a failure of the air velocity control device, which are typically made of plastic or aluminium (for example, see plate 4). In the situation where failure of the air velocity control device was simulated at 2 minutes, the temperature at the damper position reached peak values in the range 130 °C to 210 °C. All of the dampers used in this scenario closed.

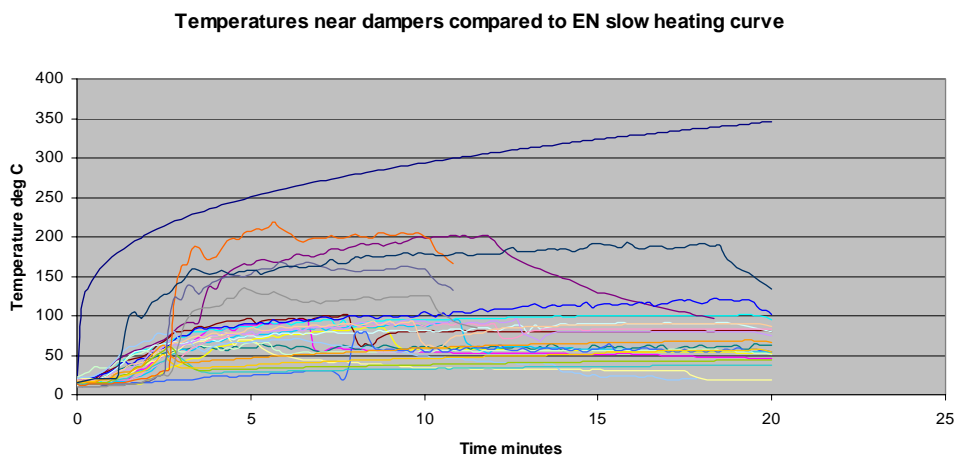
Figure 16. Comparison between temperatures recorded during activation tests and slow heating curve of EN 1363-2.

The results of this work have shown that there may be a need to develop an activation test that is a closer representation of realistic scenarios in addition to the furnace test described in BS EN 1366-2. The results summarised in figure 16 are compared with the slow heating curve of BS EN 1363-2. These data clearly show that the slow heating curve still represents a significantly more rapid temperature-time increase than achieved within the more realistic experiments carried out in this project. As such, any activation test would need to consider a slower temperature-time increase to be representative of realistic fire situations. Such a curve (slower) may differentiate between different types of damper. Further, it appears from the data that the slow heating curve of BS EN 1363-2 does not represent a worst case for testing of dampers. If the slow heating curve described in BS EN 1363-2 were adopted, this would still be exposing the link to a more rapid temperature rise than shown in our experiments. This is illustrated below where the curve is compared with all temperatures measured in the activation tests near the fusible link position.

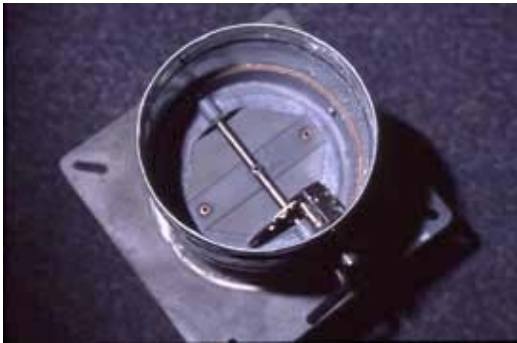
Plate 5. Pivoting blade circular damper

The results showed that both the mechanical dampers (multi-blade fire resistant and pivoting blade circular) activated before the intumescent damper had fully activated. However, the intumescent damper provided a valuable insulation contribution which would reduce the hazard if combustible materials were in contact with the duct.

Plates 5, 6 and 7 are photographs of the three dampers after the furnace test.

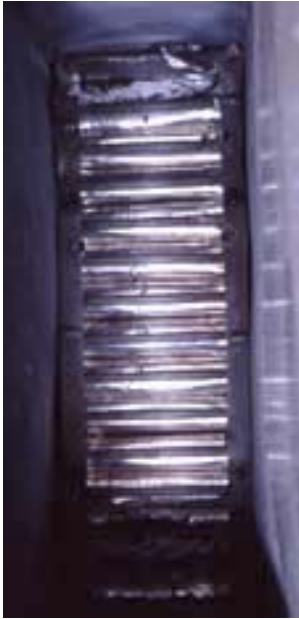
Plate 6. Intumescent fire damper

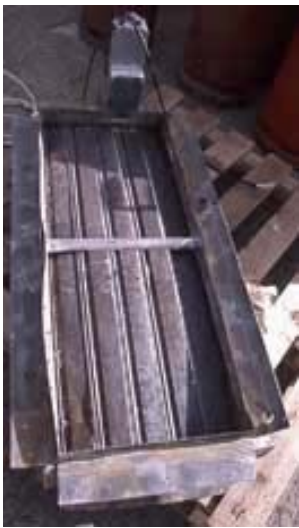
Plate 7. Multi-blade fire resistant damper

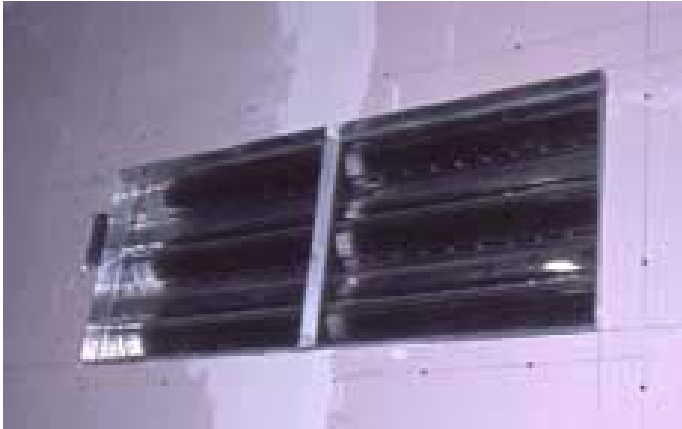
Plate 8. Multi-blade damper mounted in Dry-lined partition

During the installation of the product for test, it was noted that the design of dampers did not provide adequate depth of spigot for dry-lining constructions once the plasterboard was in place (see plate 8). However, this will not be a problem if dampers and ducts are installed before the construction of the partition.

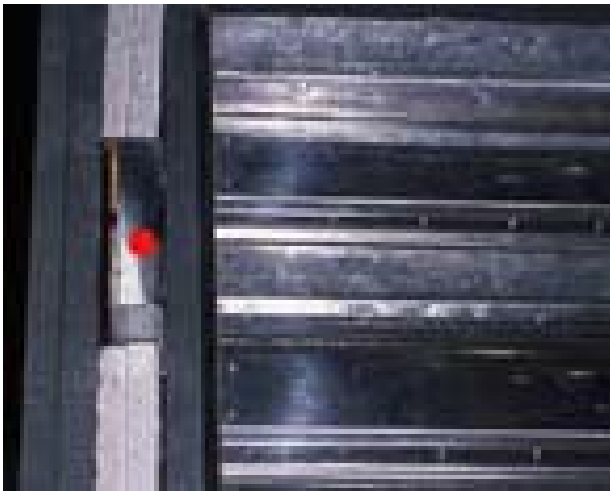
Plate 9. Provision made to accommodate operating device

It was noted during the preparation for the fire resistance test that when designing and installing mechanical dampers, allowance should be made for accommodating the operating device when it is external to the damper body (see for example, plate 9).

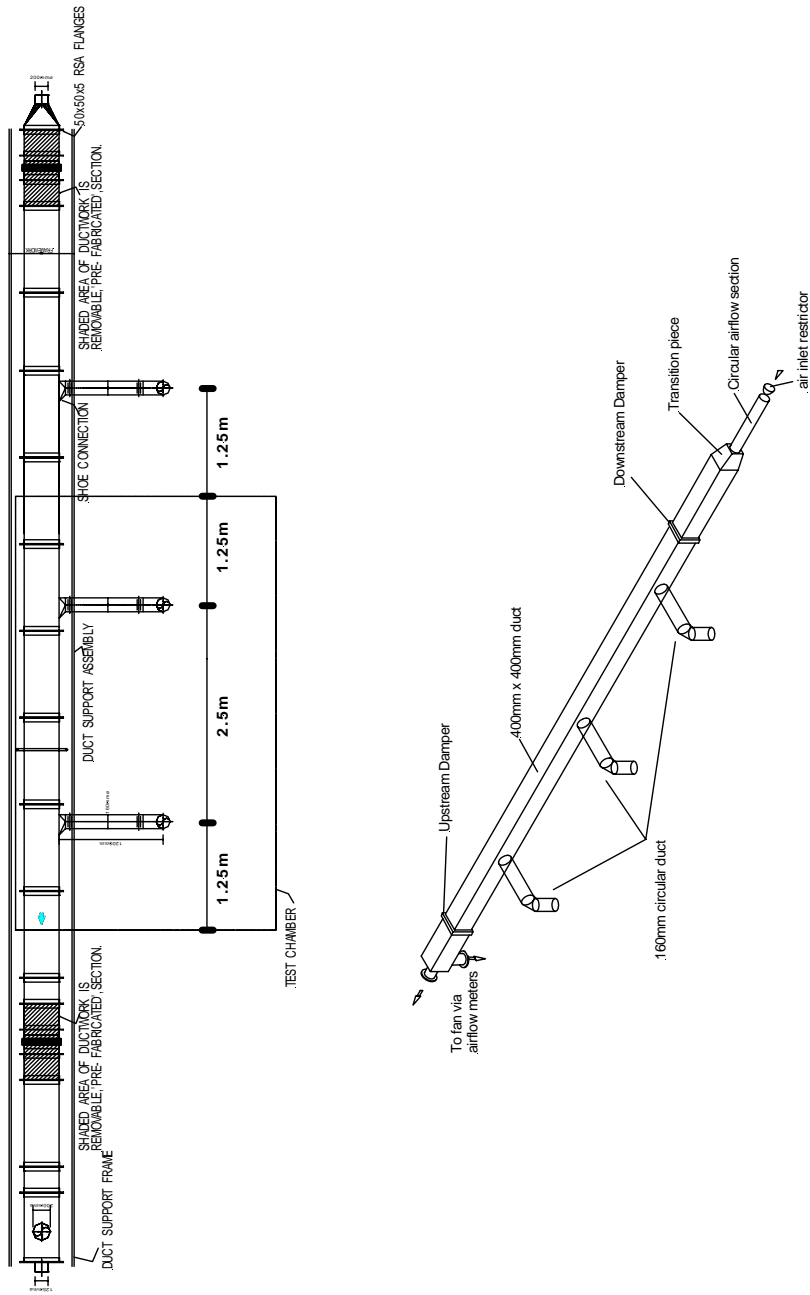
The duct support assembly comprised an open steel framework mounted over the top of the test chamber assembly to support the ductwork and its instrumentation.

The two duct extension assemblies, each comprised a section of open steel framework mounted atop a wheeled scaffold tower. The assemblies, positioned at either end of the test chamber assembly, served to extend to the ductwork beyond the ceiling of the test chamber. As well as supporting the ductwork, the frames also supported the dampers and instrumentation for flow, smoke and temperature measurements. The open frame design of the duct support system made the apparatus flexible in both installing and supporting different damper designs and sizes.
