A series of experiments to assess the effect of fire on a selection of electrical cable supports and fixings

By Ciara Holland, Martin Shipp and David Crowder

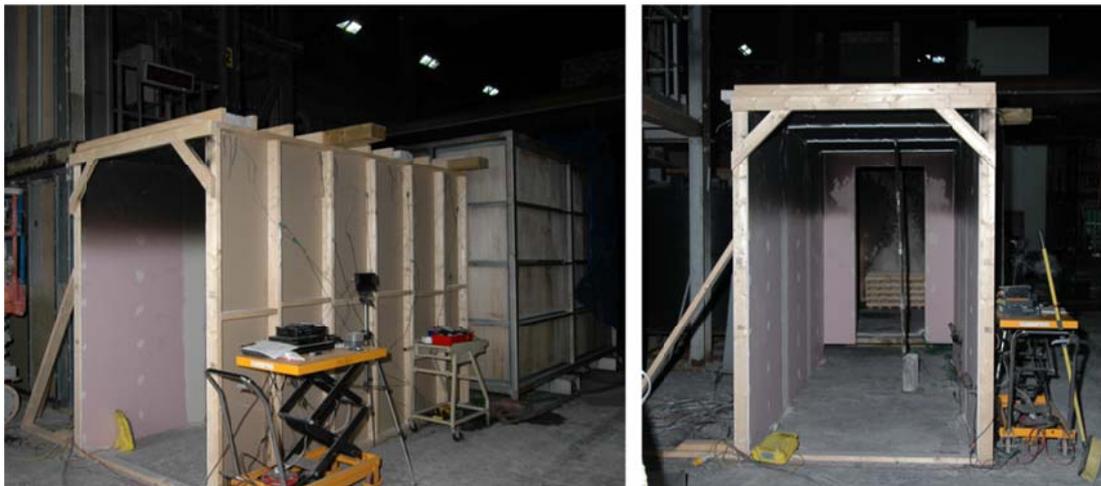
Figure 2 – Images of experimental rig

An experimental rig was designed and constructed using the ISO 9705 fire test room [7] (ISO room) of dimensions 3.6 m x 2.4 m x 2.4 m, extended with a timber-frame and plasterboard (single layer 12.5 mm Type F [8]) lined corridor of dimensions 3.5 m x 1.5 m x 2.4 m attached to the front of the ISO room (see Figure 1 and Figure 2). The walls, floor and ceiling of the ISO room were lined with two layers of 12.5 mm Type F plasterboard. The ISO room used for the experiments is a portable room on wheels which was raised approximately 300 mm from the ground; hence the corridor was not in line with the top of the ISO room (see figure 2).

The timber sleepers and concrete lintels were approximately 220 millimetres wide. For the purpose of this article, these sleepers and lintels will be referred to as lintels. Typical layout of the installation of the cable supports can be seen in Figure 2. For ease of reporting, the lintels have been numbered from 1 to 4, where Lintel 1 is closest to the ISO room and hence closest to the fire.

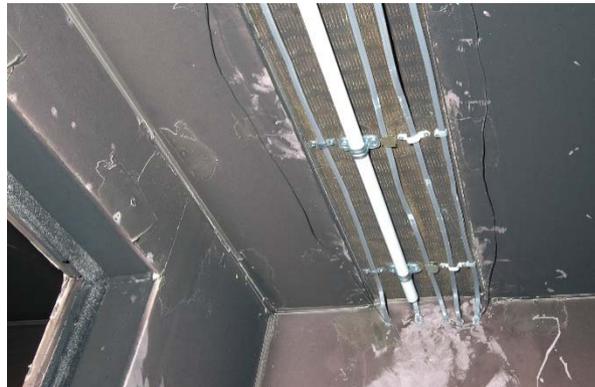
Figure 3 - Close up of cable set fixed to a timber sleeper with the selection of cable supports prior to an experiment

Five types of cable support, one plastic and four metal, were selected for these experiments and represent commercially available “fit for purpose” cable supports. Details of these cable supports are provided in Table 1. The cable supports were fitted approximately 300 mm apart along the cable length with five supports of each type per lintel.

With the exception of Clip 5, all the supports were fixed to the timber lintels using zinc-plated hardened steel 7 x 1¼ inch twinthread wood screws which were screwed directly into the timber. Clip 5 was fixed using its own pin. The same fixings were used for all the supports, including Clip 5, in the concrete lintels although for these lintels the screws were fixed into standard plastic wall plugs.
