## **External Fire Spread – Part 1 Background research**

#### April 2016

## **External fire spread – Part 1**

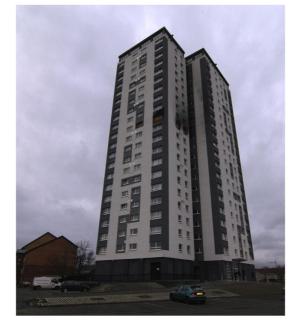
A fire occurred in a flat on the 11<sup>th</sup> floor of a 22-storey block of flats built during the 1960s and refurbished in 2006/7. This refurbishment included the fitting of a new cladding system to the exterior of the building which comprised an insulated render, the insulation for which was mineral wool and had been tested to and passed BS 8414-1. The fire developed to fully involve the flat of origin and broke out of the windows. The damage to the façade was localised to the immediate vicinity of some of the windows but beyond this the damage appeared to have been limited to surface charring and sooting (Figure 3).

Figure 3 – Block of flats showing limited damage to the non-combustible cladding system after a fire
