Annex A – Floor Voids

In order to investigate the potential for unseen fire spread to occur through voids in suspended floor systems, a series of experiments have been undertaken utilising a commercially designed and installed suspended floor system. Work has also been undertaken to look at the potential for unseen fire spread arising from standard timber floor systems and also potential transmission routes for fire spread from radiant heat sources from the room of fire origin into the floor void.

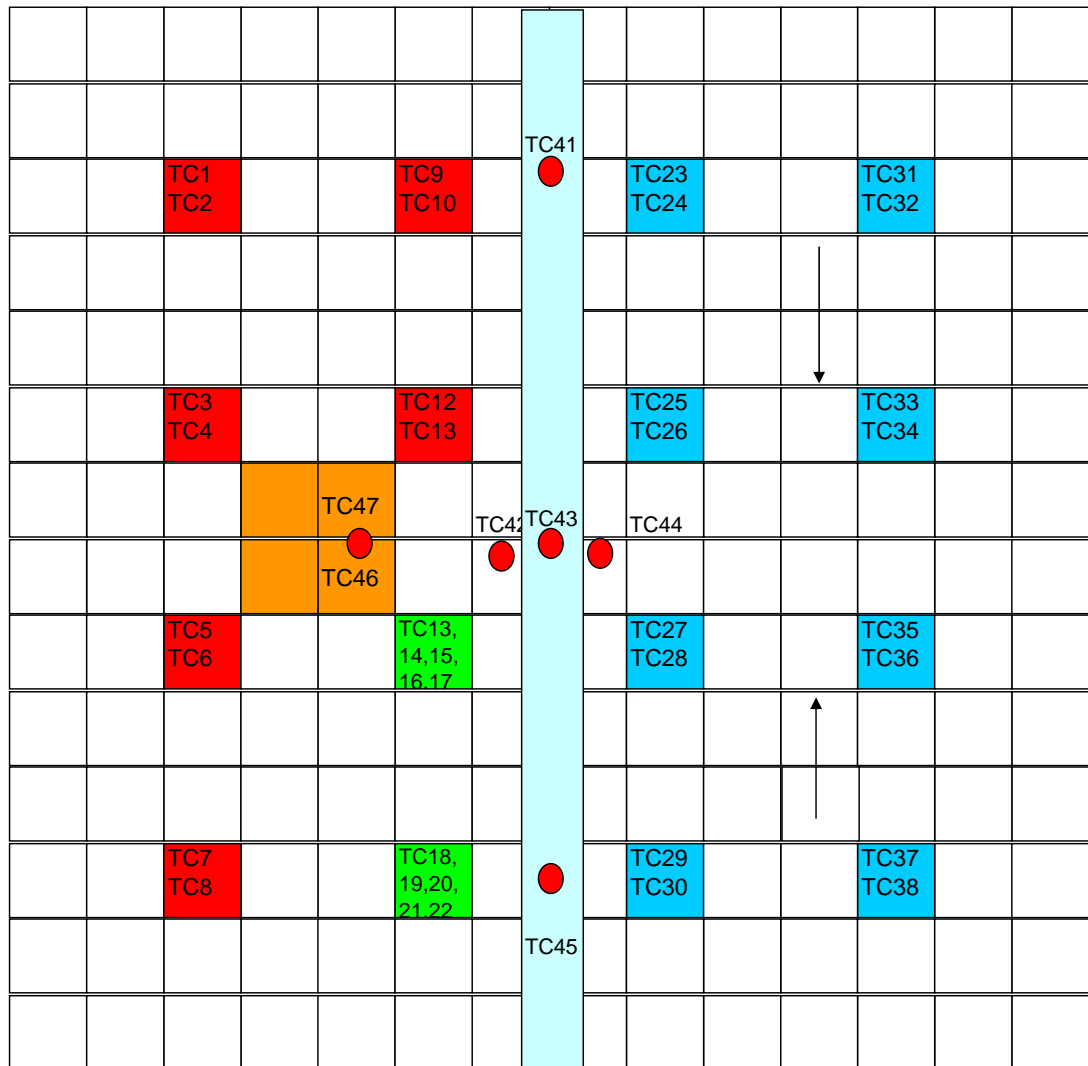
Figure A2. Plan view of instrumentation and experimental set up for phase one tests with the cavity barrier centrally located.

- Thermocouples in centre of panel @ 1.8m centres, 20mm and 80mm from lower surface (Red & Blue squares).
- Five bare wire thermocouples at 30, 60, 90, 190, 230mm and 30, 60, 90, 220 and 270mm spacing (Green squares).
- Burner position (Orange squares).
- Cavity Barrier (light blue rectangle).
- Arrows show position and path length of laser.

Thermocouples were spaced at 1.8m intervals with two thermocouples at each measuring point at heights of 20mm and 80mm from the lower surface of the tile. Further measurements were taken at the cavity barrier with measurements on the fire side, in the core and on the unexposed side of the cavity barrier. A further two measurements were taken over the top of the burner, with one thermocouple at 80mm and one thermocouple in the core of the floor tile. Two thermocouple trees were also installed to determine the temperature profile within the cavity. Figures A1 and A2 show the location of the instrumentation and the experimental set ups.

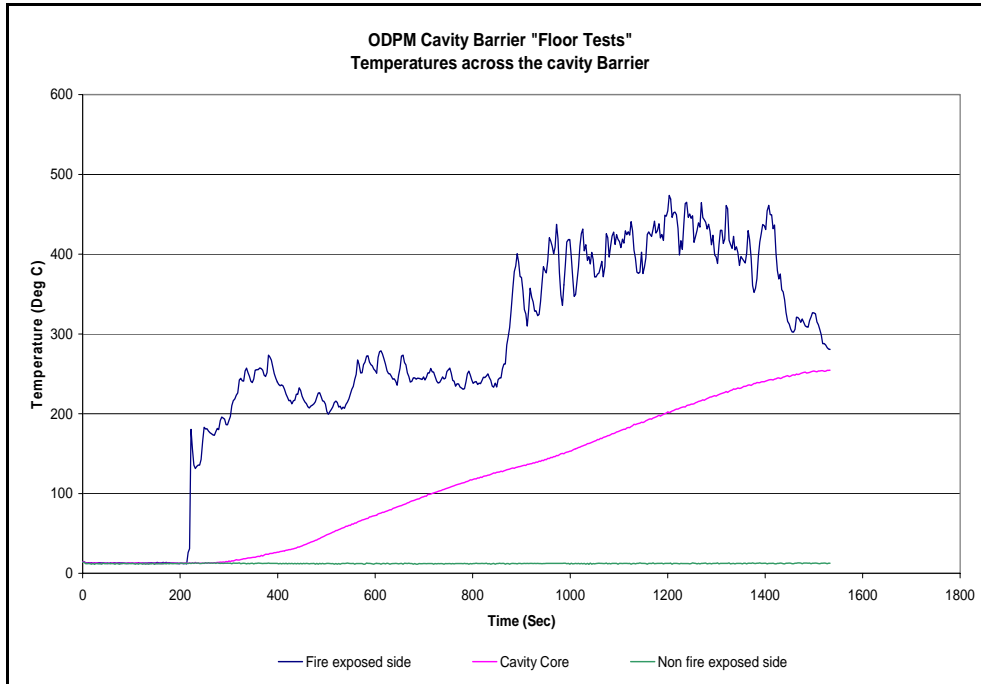
Graph A1. Test 1 temperatures across the barrier

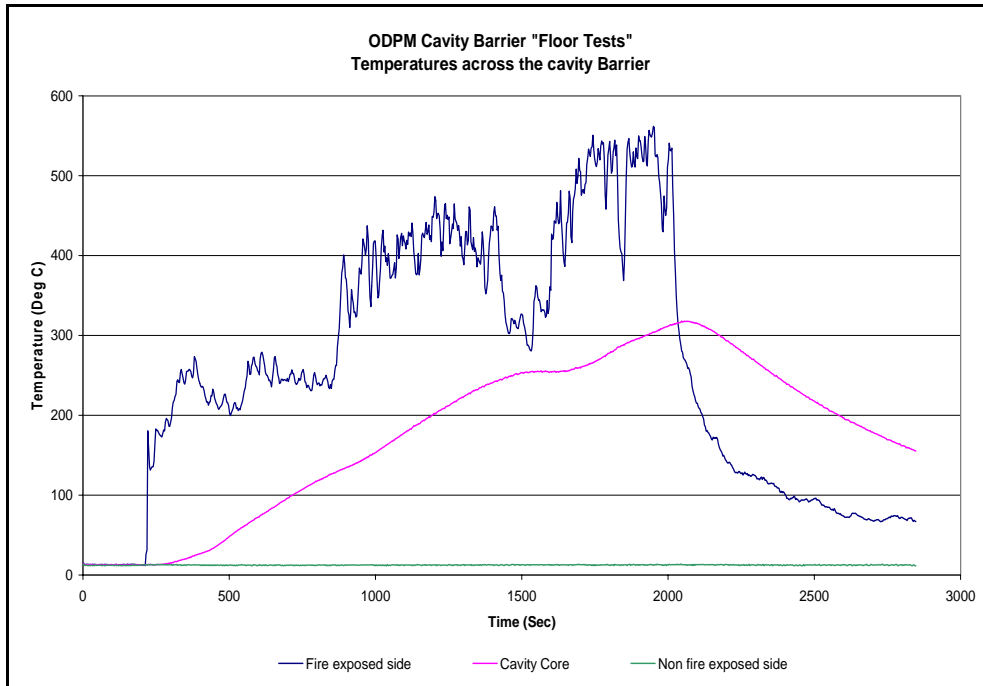
Graph A7. Test 3 temperatures across the barrier

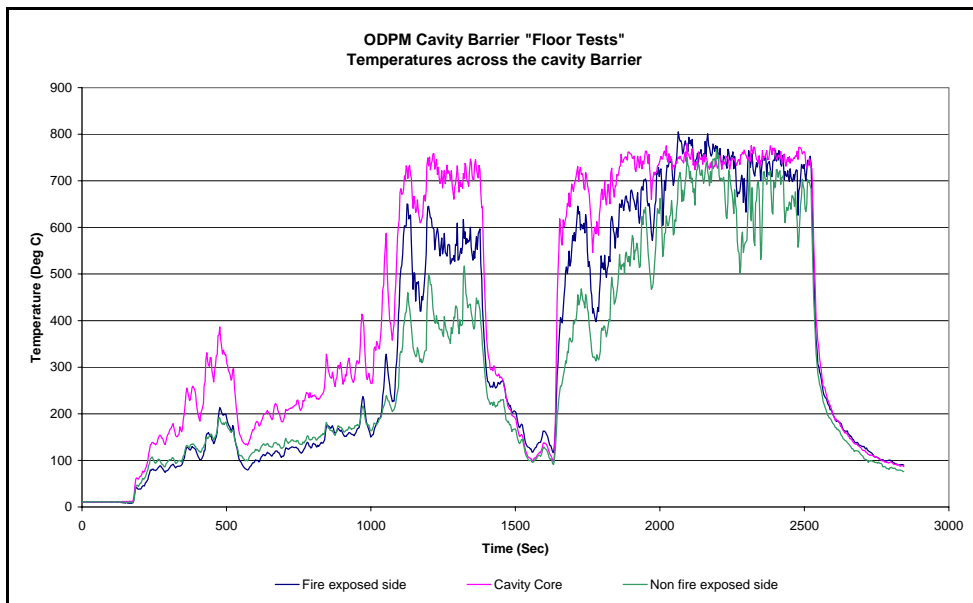
Graph A10. Test 4 temperatures across the barrier

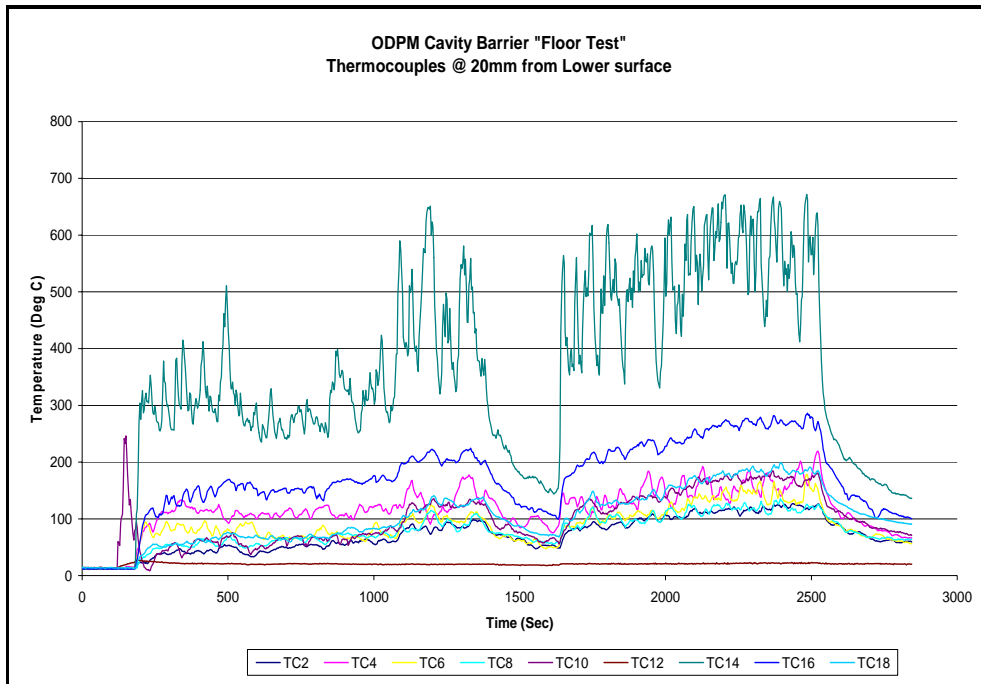
Graph A11. Test 4 temperatures at 20mm

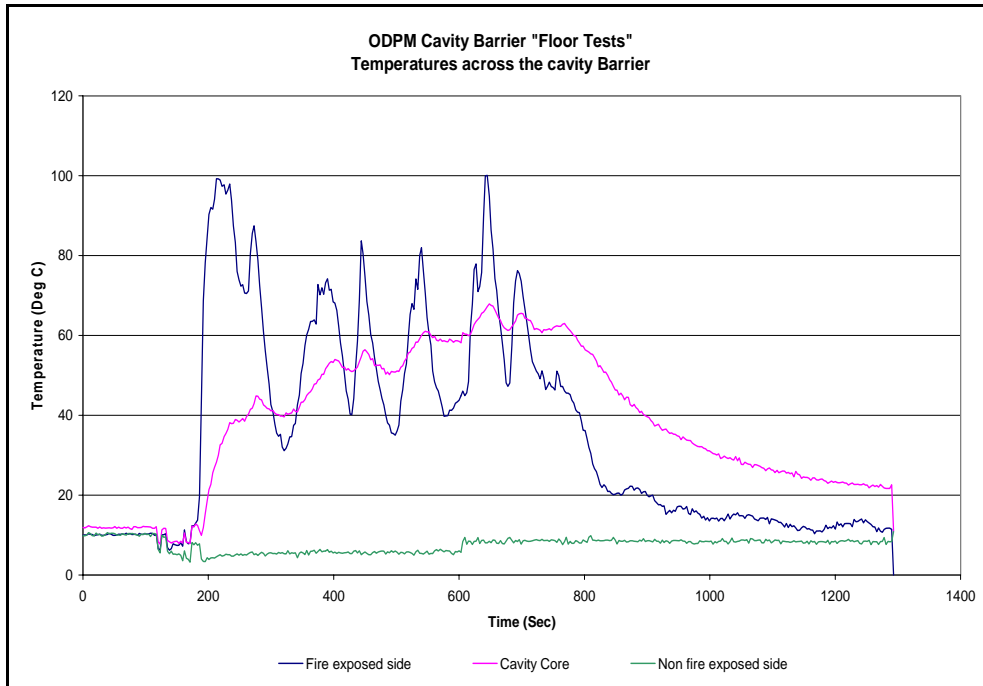
Graph A13. Test 5 temperatures across the barrier

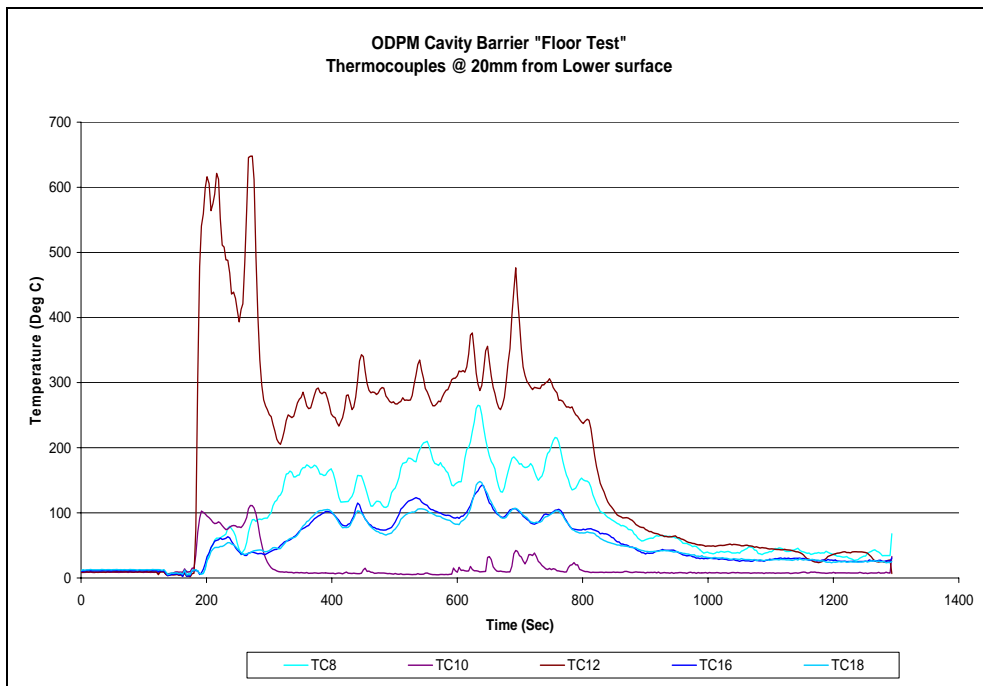
Graph A14. Test 5 temperatures at 20mm

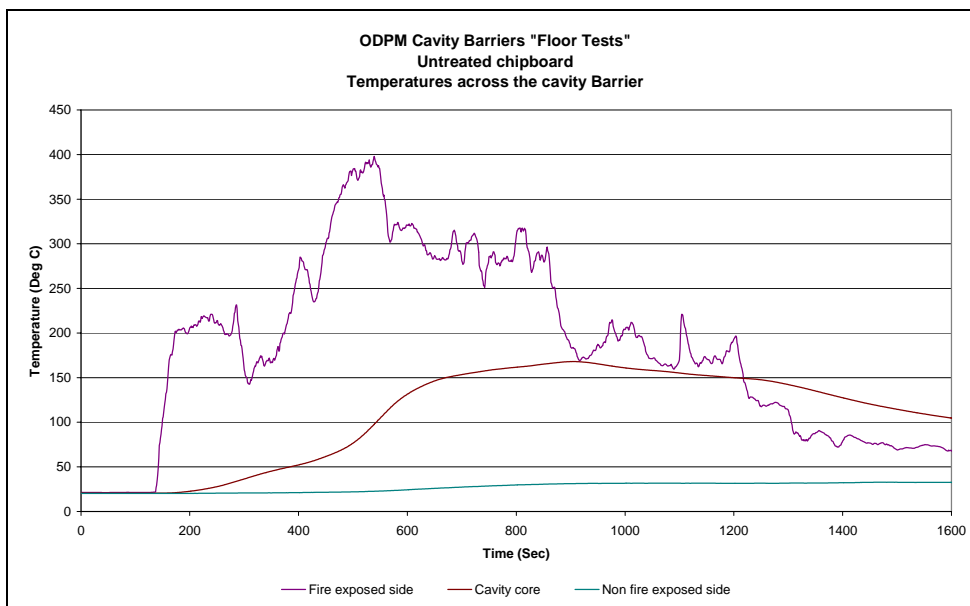
Graph A22. Test 8 temperatures in the cavity barrier

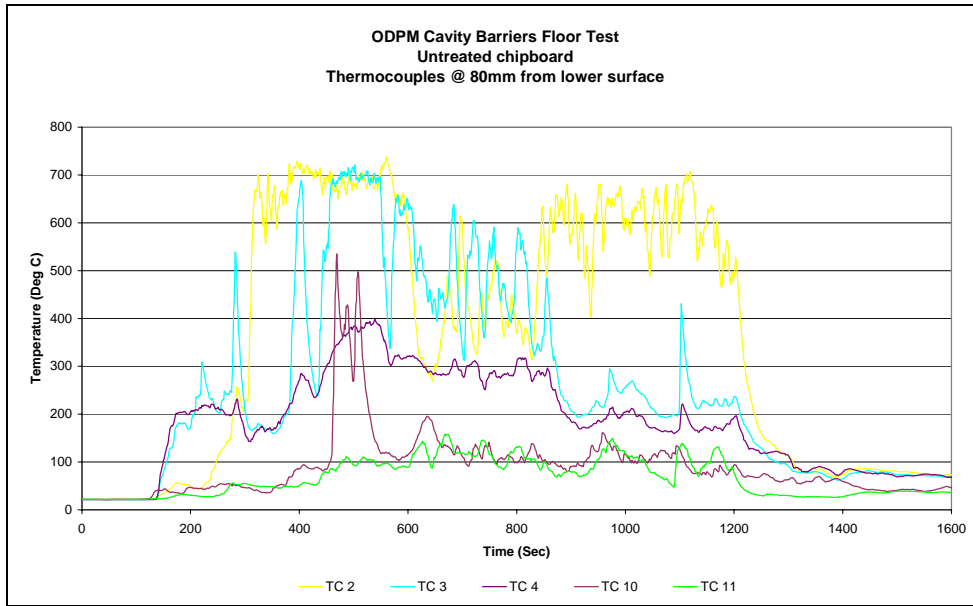
Graph A23. Test 8 temperatures at 80mm

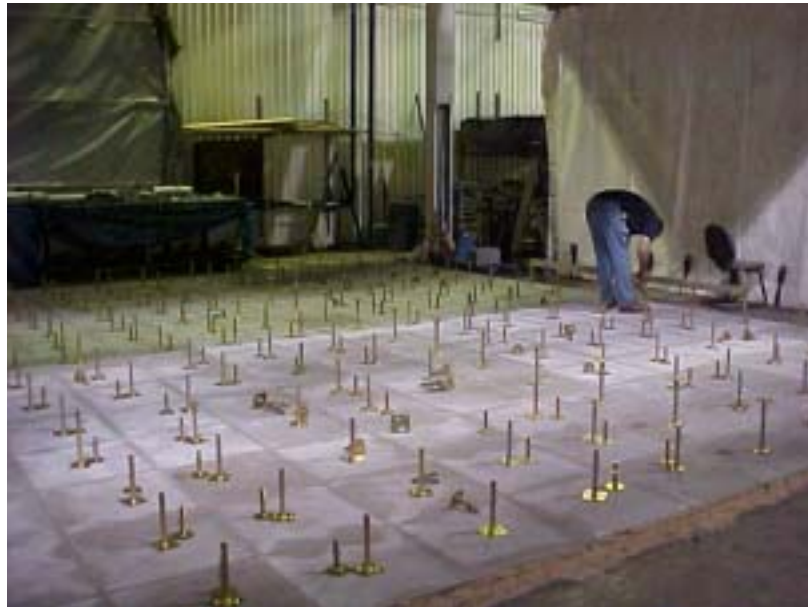
Photograph A1. Suspended floor under construction.

An 8.4m square floor system was designed and installed for this phase of the project, see photograph A1. Table A1 summarises the experimental programme for this phase of the project. Two void heights were considered; 150 and 300 mm together with the location of and performance of a commercially purchased cavity barrier system, see photograph A2.

Photographs A1 and A2 show the design of the steel and chipboard floor panels. The floor was a screw fixed system, comprising of fully steel encapsulated high density chipboard panels of 600mm square and 26 mm thick. The cavity was formed by attaching the panels to height adjustable pedestals, which were set to give the floor an overall height of either 150 or 300mm.

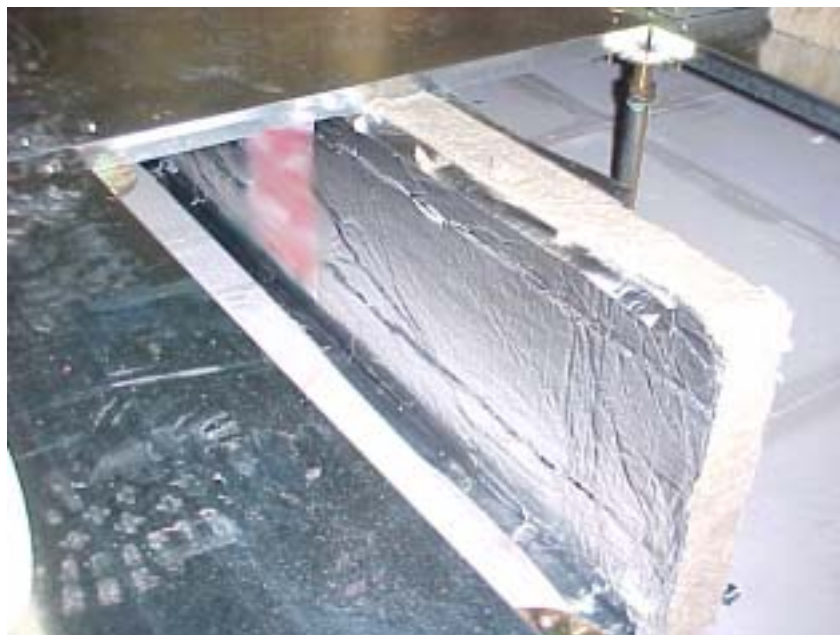
Photograph A2. Cavity barrier in floor void. (Tile removed)

A nominal 50 mm thick foil faced mineral wool cavity barrier was used in these tests. The cavity barrier was oversized to give a tight fit when the floor tiles were placed into position. To ensure a proper seal, aluminium tape was used to seal all the joints and to fix at the top and bottom of the barrier.

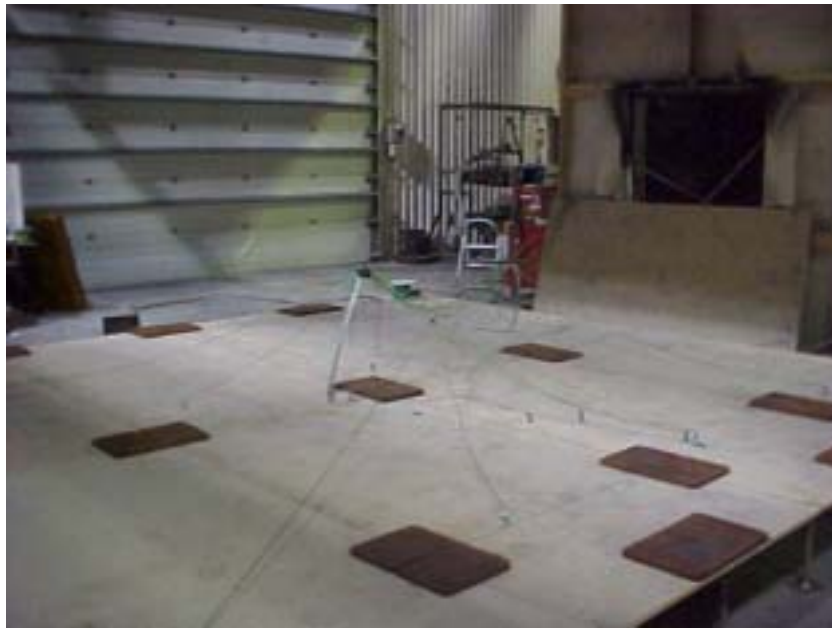
Photograph A3. Chipboard Floor.

For this phase of the work a single test was undertaken using a 300 mm deep void with a Class 2 (as defined in BS 476 part 7) floor grade chipboard, supplied as 1200mm x 2400mm sheets, fitted to the same pedestal system as used in phase one, see Photograph A3. The total area of floor was also reduced to 4.2m square to reduce the quantity of potentially combustible material exposed to the fire source.

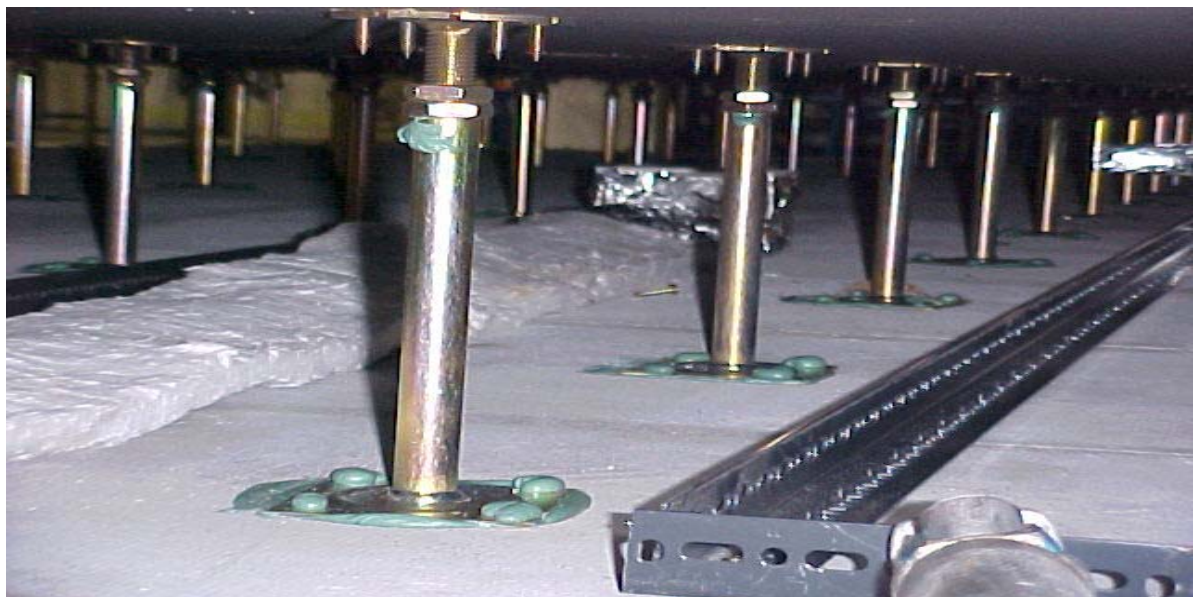
Photograph A4. Shows the layout of the underfloor

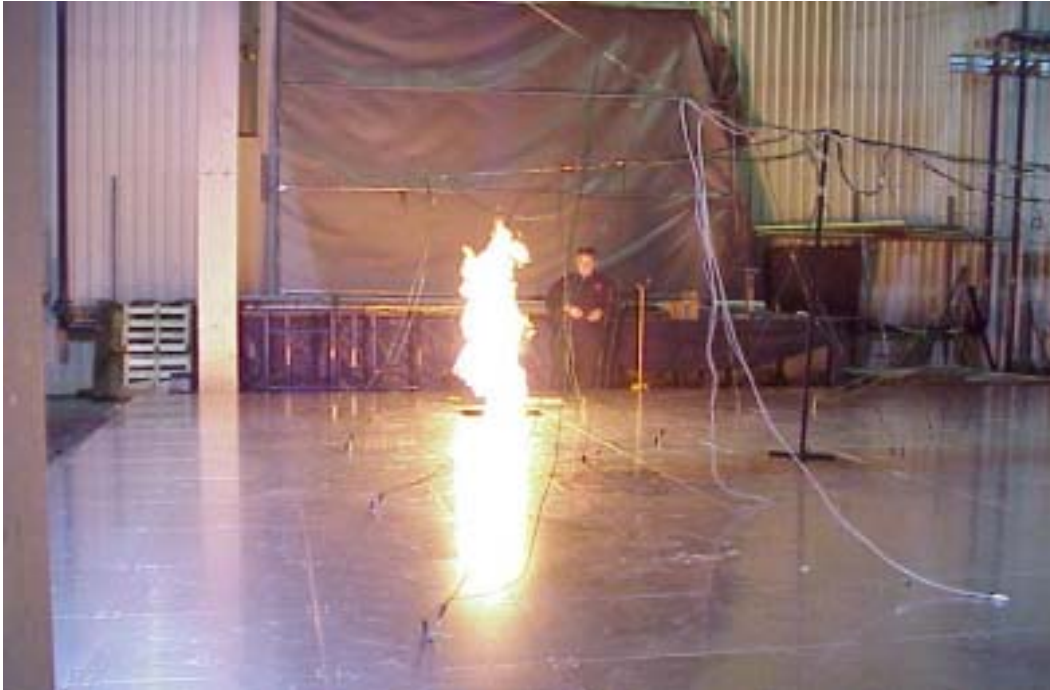
Photograph A5. Shows the burner being ignited, before being pushed under the floor.

A 200 kW ignition source was used for this study, this was achieved by using a 300mm by 300mm gravel box burner, with the propane fuel supplied using a mass flow controller. The burner was ignited under the floor, with the tile above the burner removed. Once ignition of the burner had been established and was giving a steady flame, the burner was pushed into position and the floor tile was replaced. The burn time was defined as thirty minutes from the time the burner was in its final position.

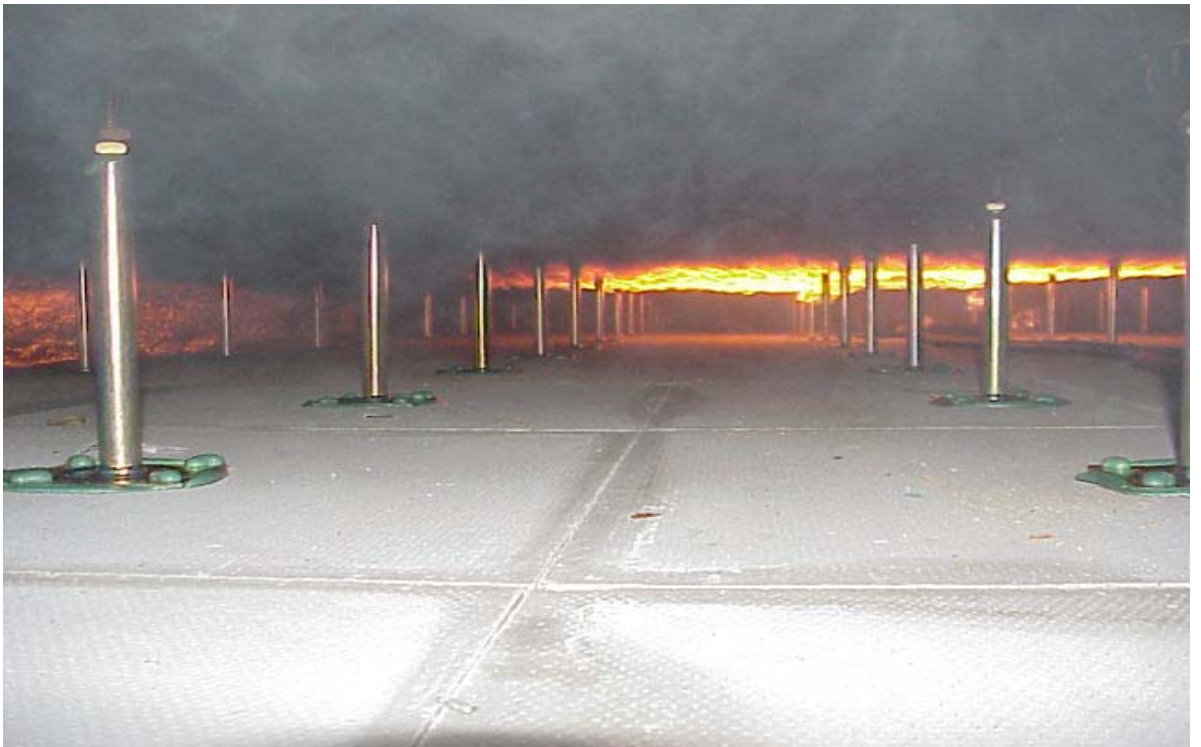
Photograph A6. Shows the flame spread under the floor, the cavity barrier can be seen on the left.

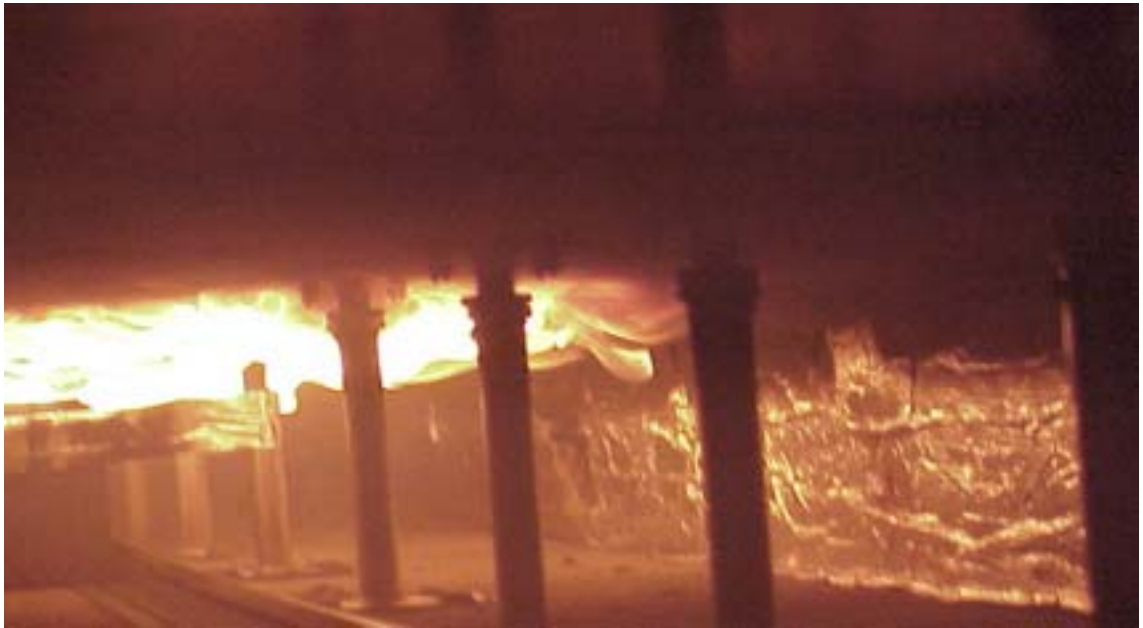
Photograph A7. Shows flames impinging onto the cavity barrier.

The results from the tests on the steel encapsulated panels show, as expected, that the flames are very elongated laterally when restrained within the floor void leading to some spillage around the edges of the floor plate. For both void heights, with both direct flame impingement and solely hot gases acting upon the cavity barrier, the integrity of the barrier was retained for the duration of the test exposure.

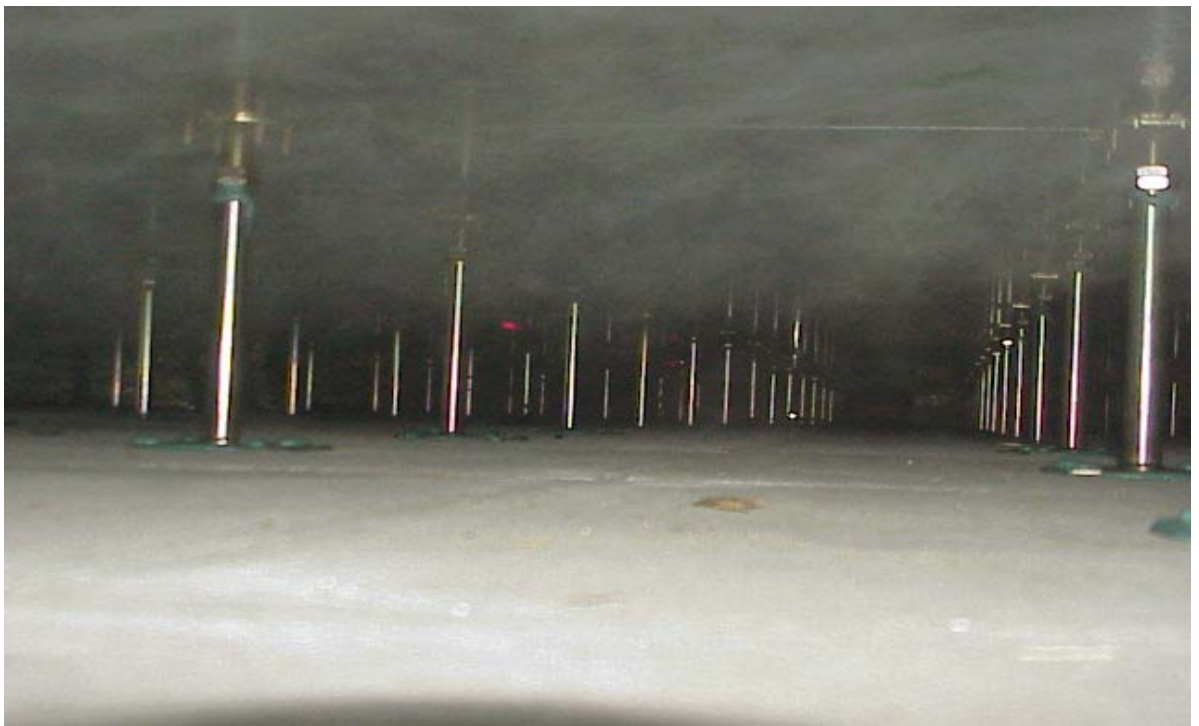
Photograph A8. Smoke on the unexposed side of the barrier.

Smoke production from the floor panel materials was highly visible above the floor plates within the laboratory space, particularly directly above the burner location, see photograph A10. The smoke measurement within the floor void on the unexposed side of the barrier picked up only limited smoke levels, this may be due in part to the fully ventilated conditions within the void area which would not be untypical of those seen in practice and may also be a reflection of the performance of the cavity barrier in restricting smoke movement.

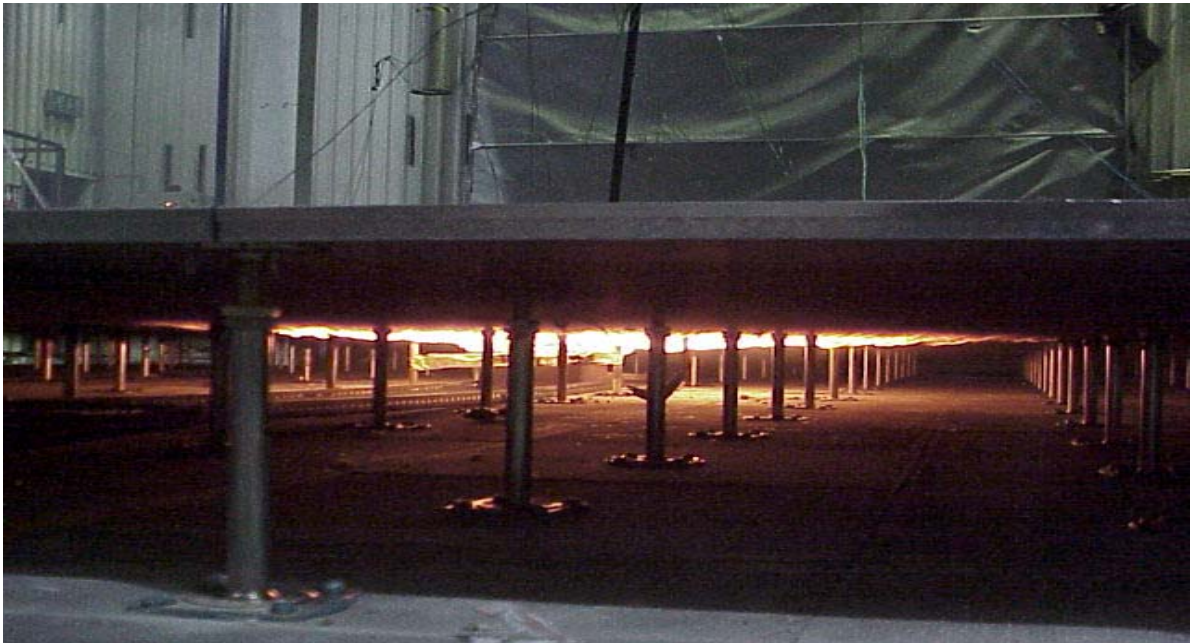
Photograph A9. Shows the flames spread away from the burner.

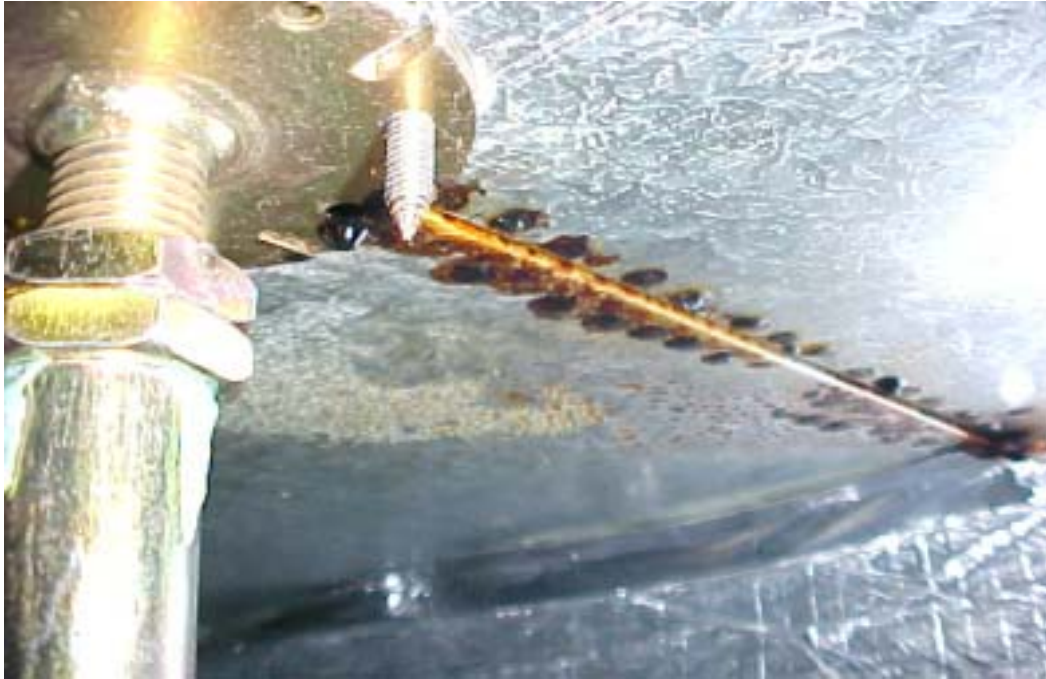
Photograph A11. Shows damage to an exposed floor panel.

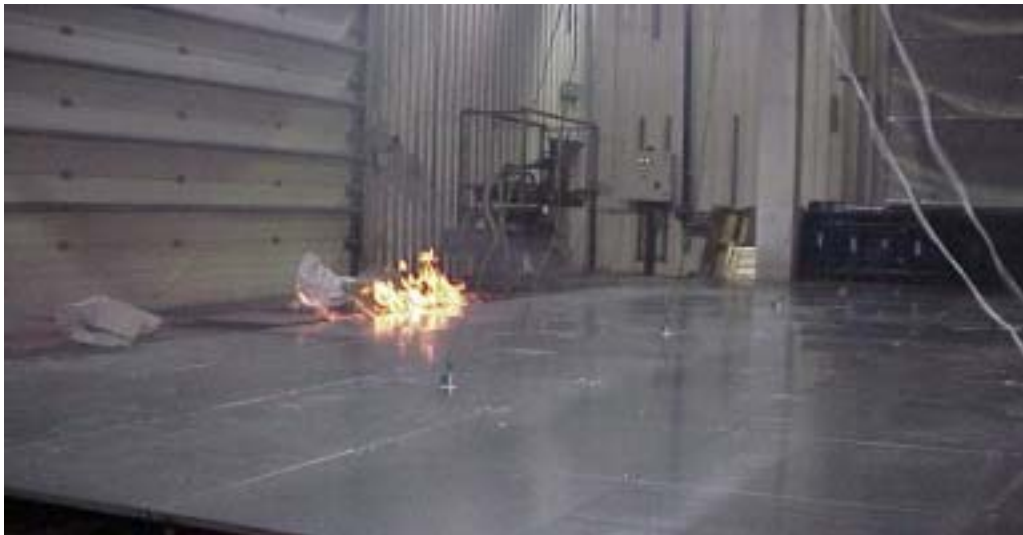
Photograph 12. flames emerging from the edge of the floor.

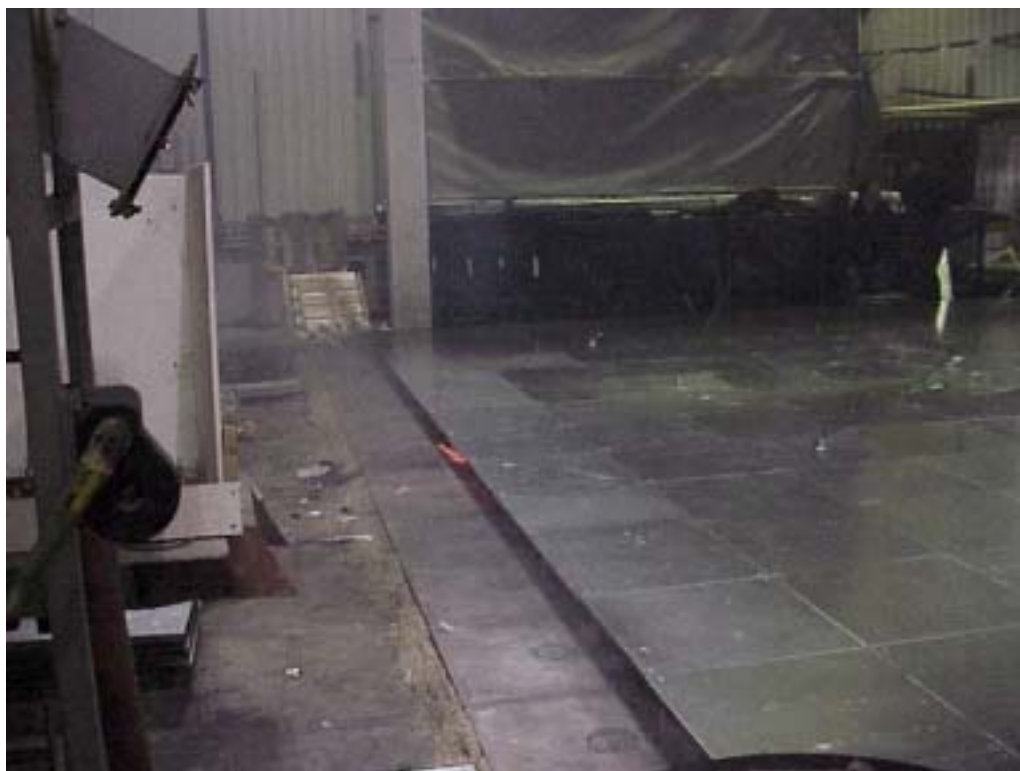
Photograph A13. Shows flames emerging from the edge of the floor.

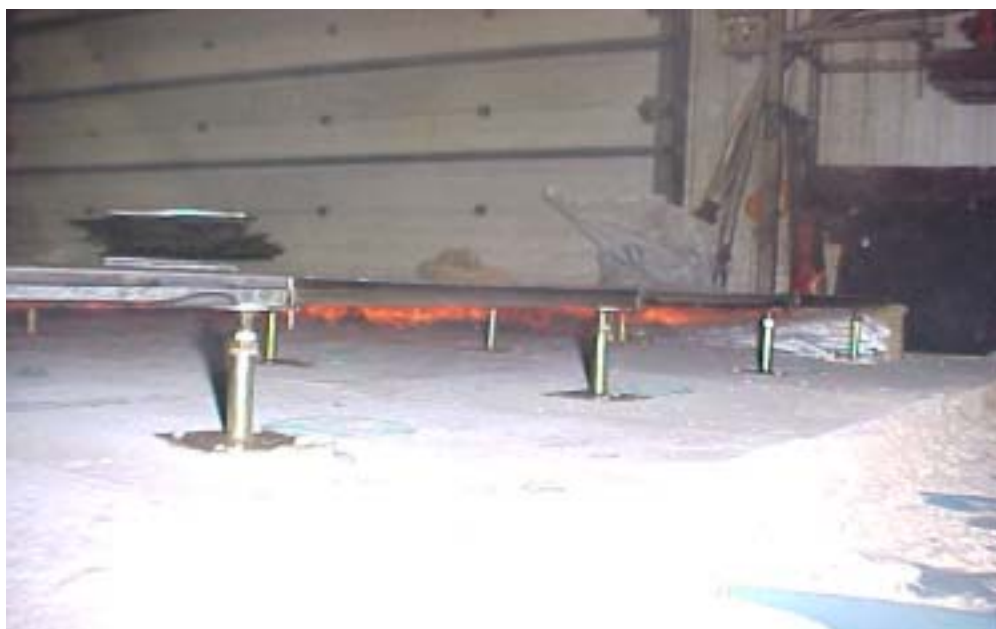
Photograph 14. flames impinging on the cavity barrier.

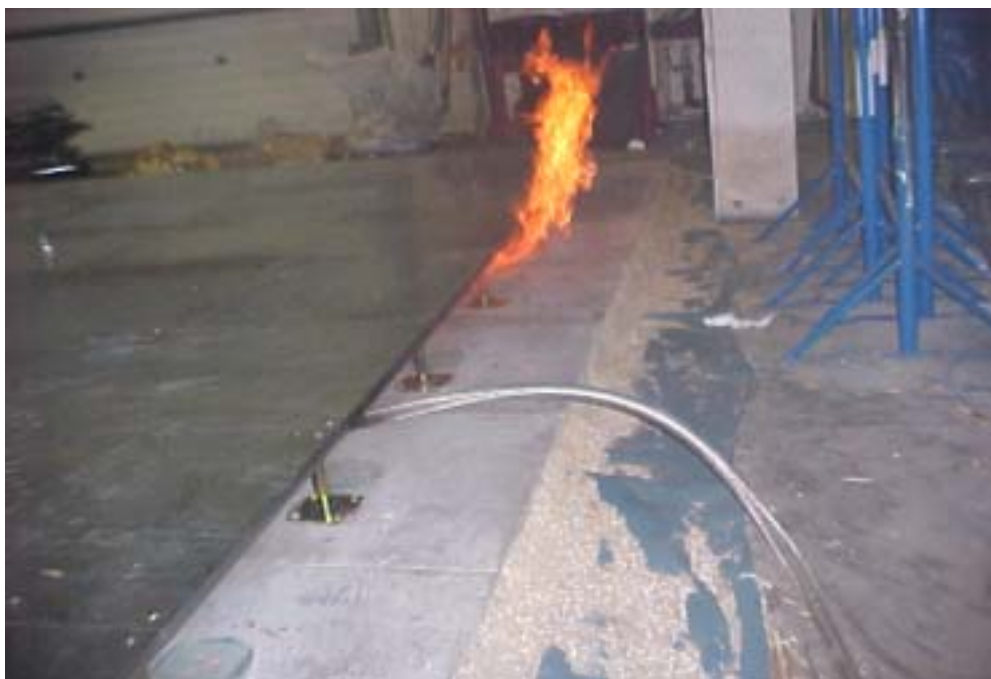
Photograph A15. Shows flames emerging from the edge of the floor.

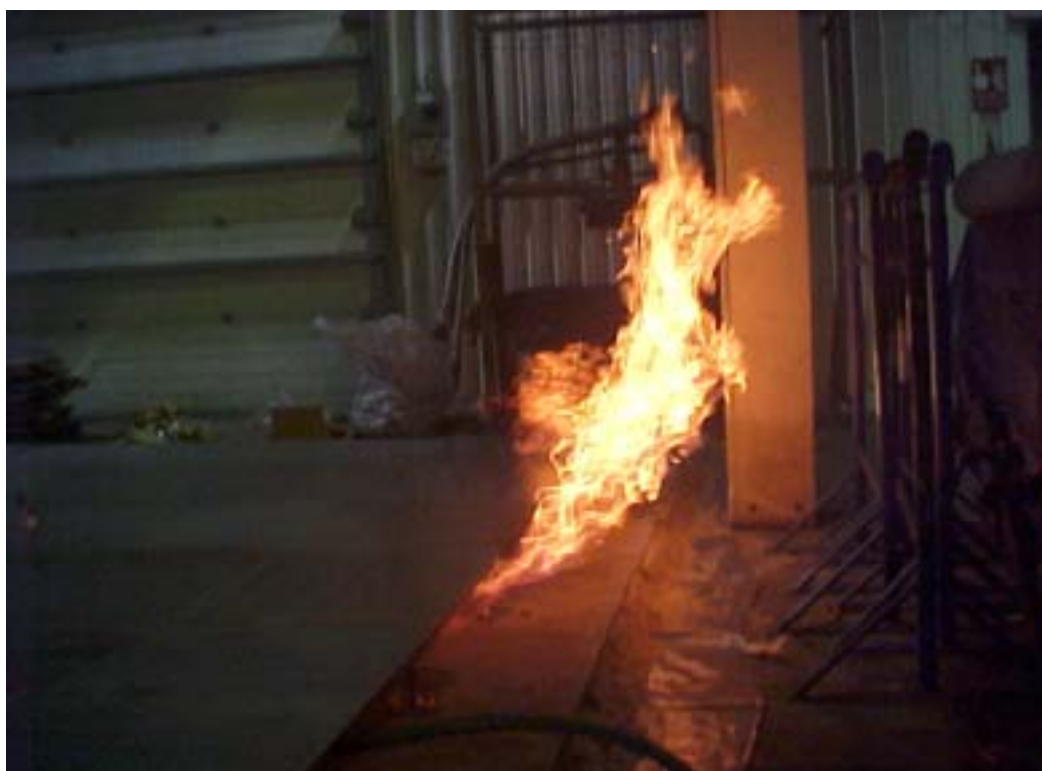
Photograph A16. Shows flames emerging from the edge of the floor.

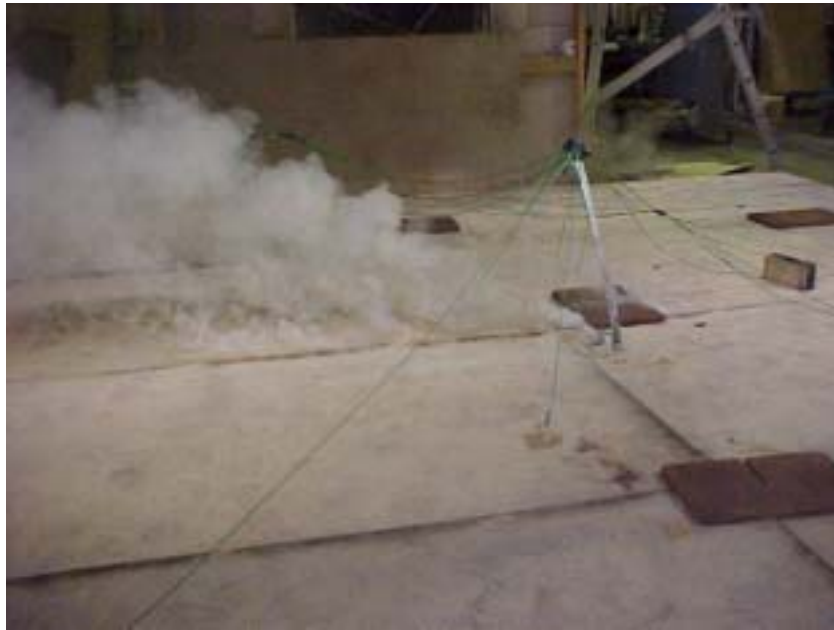
Photograph A17. Smoking from the chipboard floor.

The results from the chipboard floor deck test showed that whilst the flooring material achieved a Class 2 surface spread classification when tested to BS 476 part 7, the exposed surface combustion within the void did not develop to flashover within the cavity during the test, although the fire did break through to the upper surface of the floor deck at around 20 minutes from ignition, leading to the termination of the test. During this test, a significant quantity of smoke was released from the flooring material and again this was observed on the upper surface of the floor plate with the cavity barrier effectively mitigating the transmission of both smoke and flames beyond the barrier within the void space, see photograph A17. It should also be noted that all visible flaming both on the upper and lower surfaces of the timber floor plate ceased once the ignition source was removed, although the material continued to smoulder until it was manually extinguished.

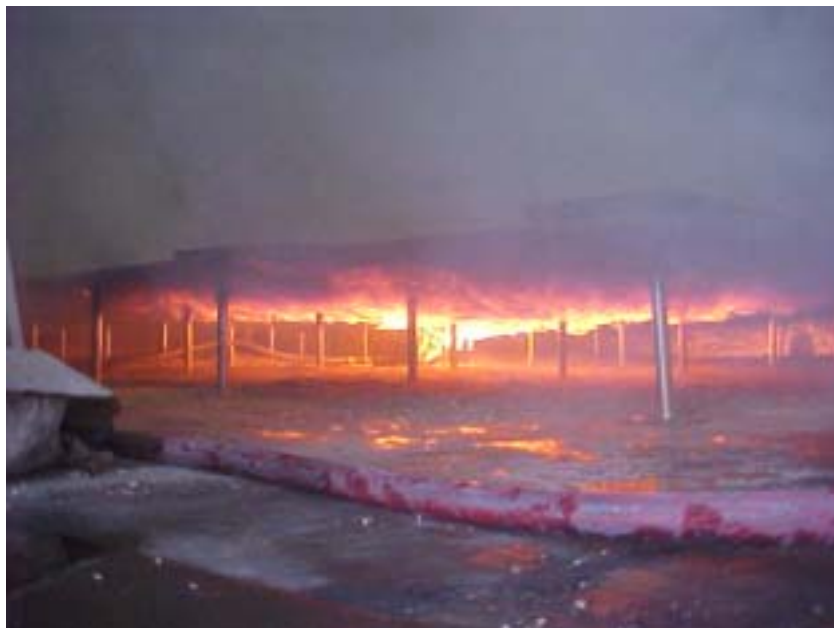
Photograph A18. Shows flames emerging from the edge of the floor.

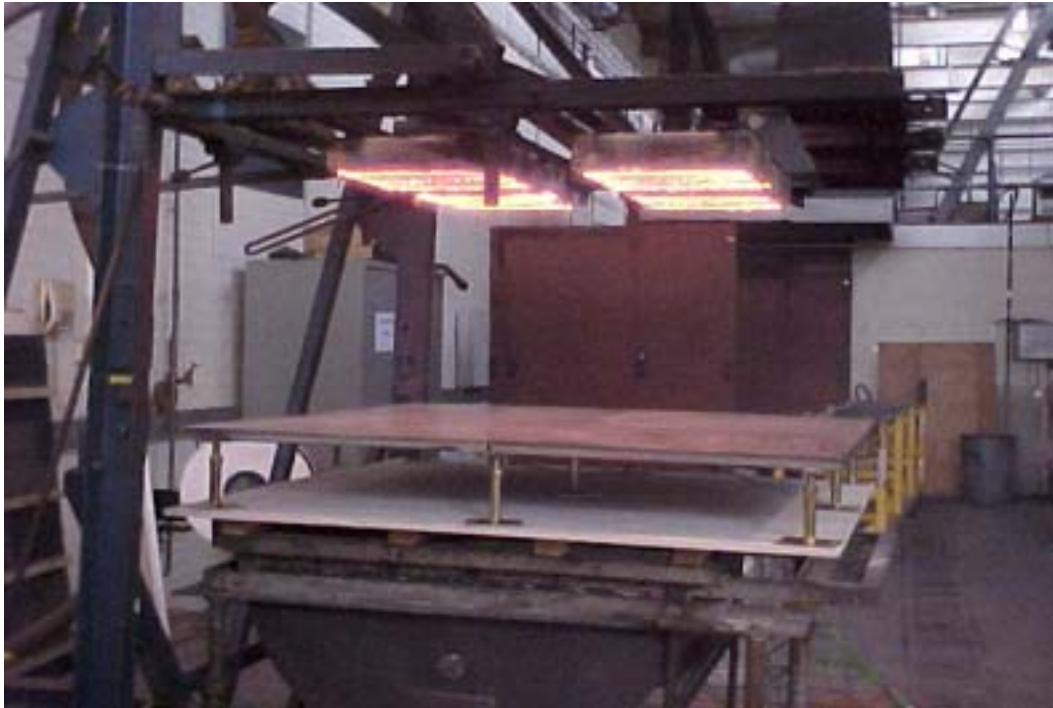
Photograph 19 shows the setup of the floor and the position of the radiant panel.

Photograph A19. Shows setup of test on radiant panel.

A section of floor of area 1.2m by 1.2m with a height of 150mm, consisting of four 600mm x 600mm steel encapsulated chipboard floor tiles, was subjected to heating from a radiant heat source for a period of 30 minutes, using the BS 476 part 3 roof test heat surface. The sample was exposed to a radiant exposure of 12 to 15 kW/m² at a distance of 500mm from the burner surface.

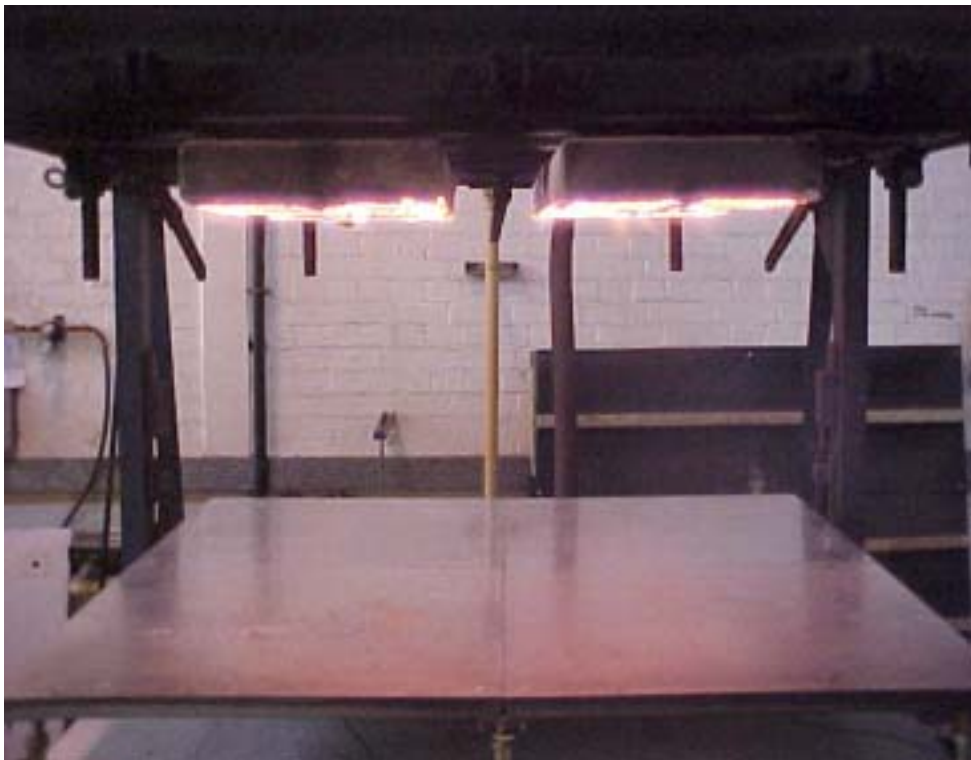
Photograph A20. Shows upper surface of floor being exposed to radiant heating.

The exposure of the floor to radiant heating shows the upper surface experiencing progressive heating through the absorption and re-radiation of heat from the radiant panel. The lower void remained at or around ambient temperature. Throughout the test there was no visible damage to the surface of the floor tiles, with only a small amount of light smoke visible towards the end of the heating process.
