**Effectiveness of sprinklers in
residential premises:**

Section 5: Experimental
programme

Project report number 204505

Dr Corinne Williams
and Dr Stuart Campbell

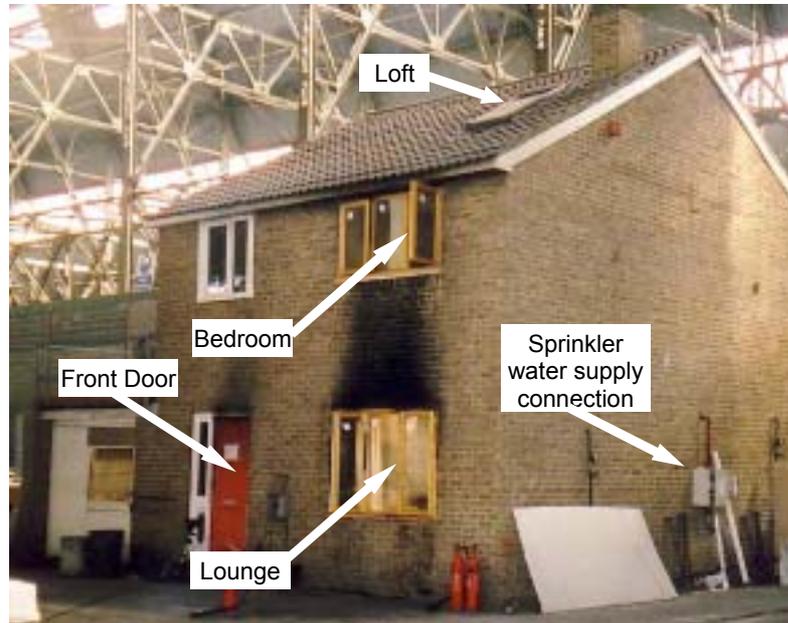
Figure 5.1 The experimental facility

Figure 5.1 shows a photograph of the exterior of the house facility and Figure 5.2 is a schematic diagram showing the internal layout of the house.

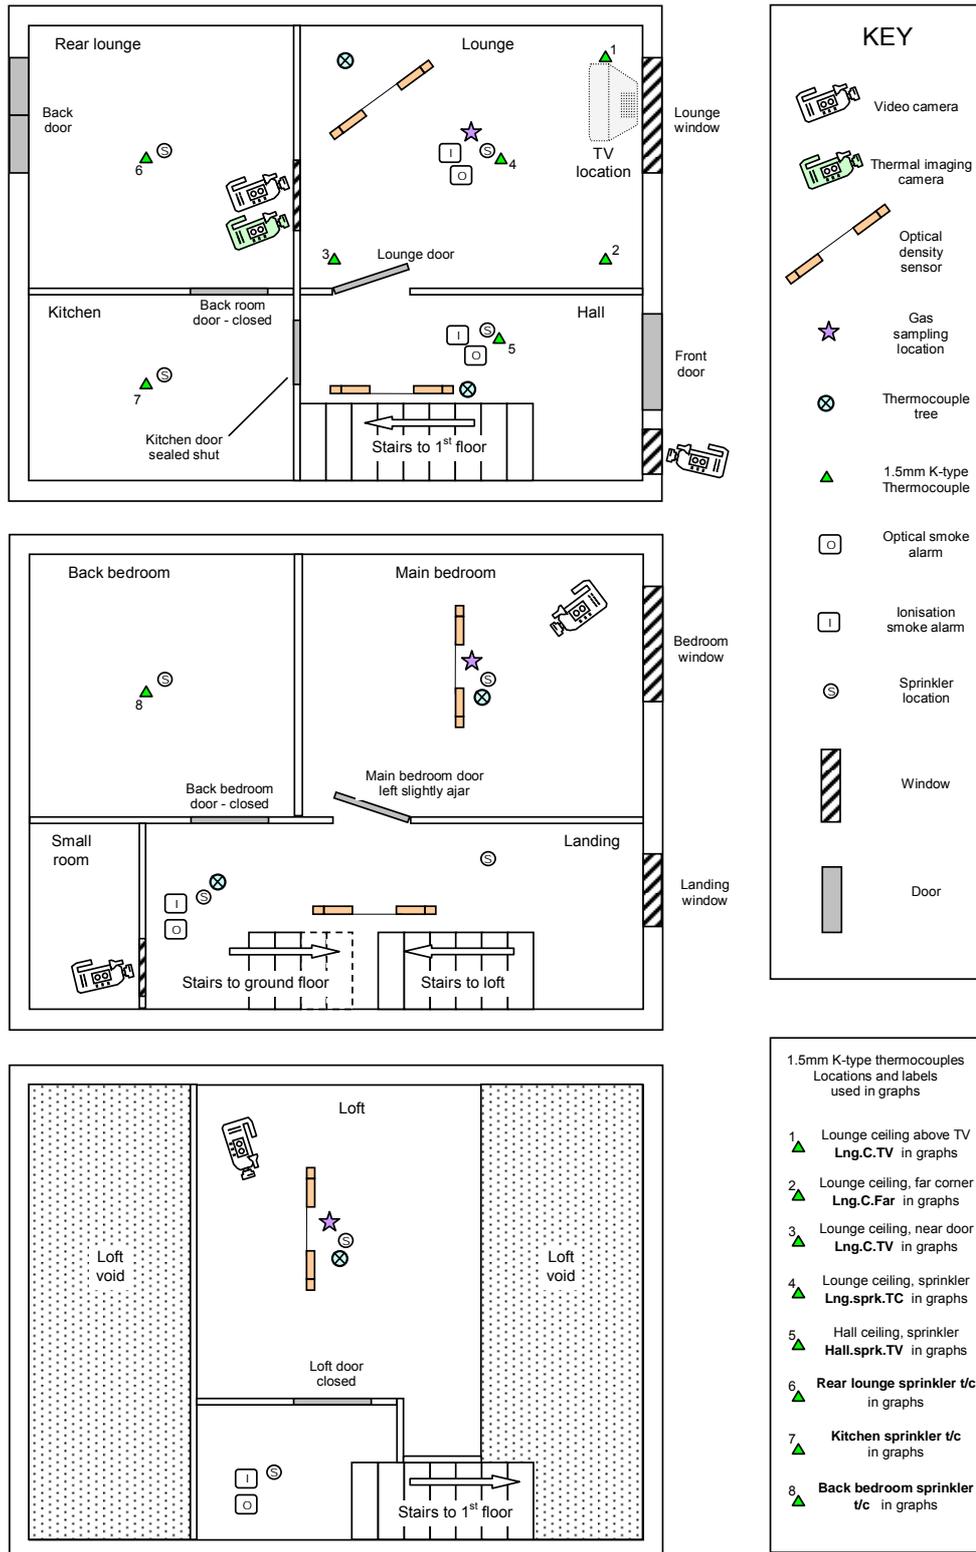
Figure 5.2 Schematic diagram showing the internal layout of the house and instrument locations

The received light intensity was measured at strategic locations within the house, as shown in Figure 5.2, at 1 m and 1.6 m in the lounge, 1.6 m in the ground floor hallway, 1.6 m in the first floor landing, 1.6 m in the main bedroom and 1 m in the loft. All these distances are measured above the floor.

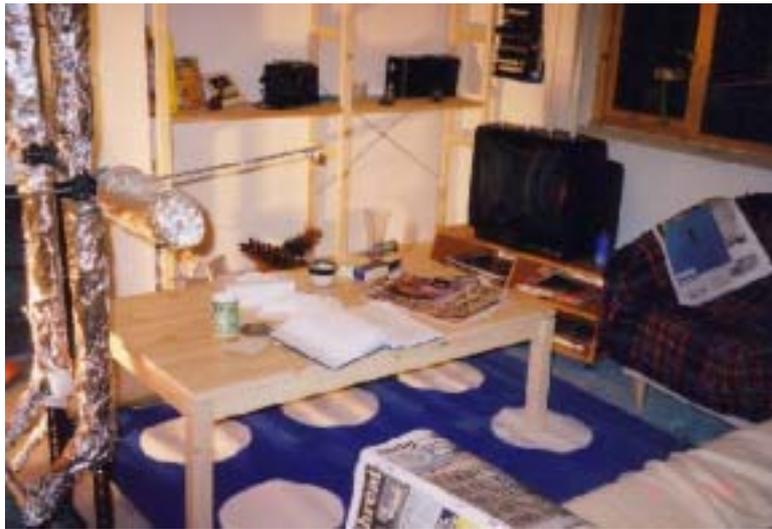
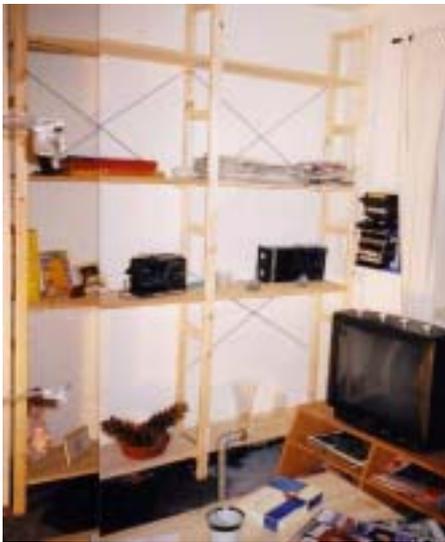
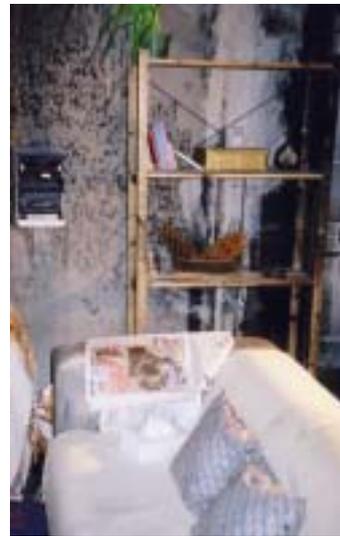
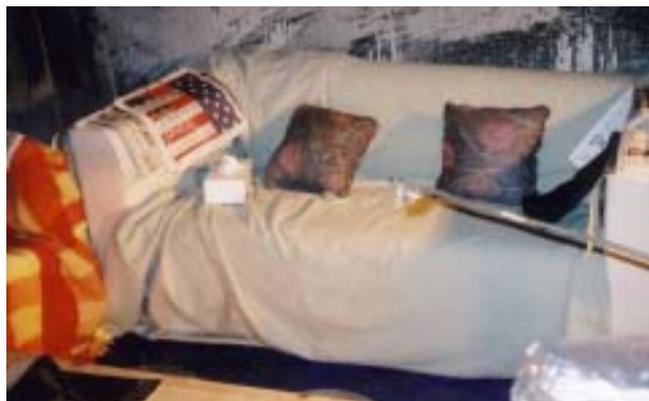
Figure 5.3 Photographs showing the lounge furniture arrangement(s)

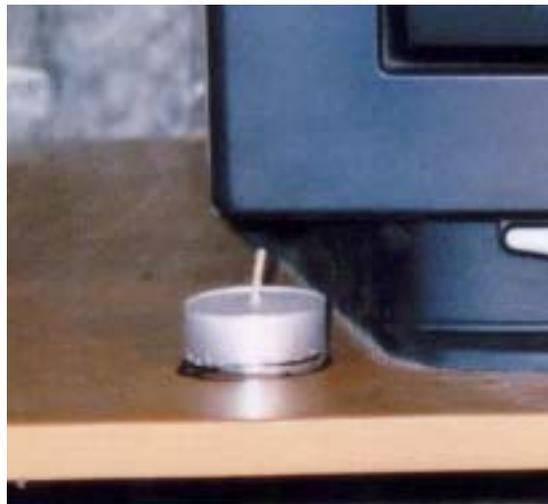
Figure 5.5 Ignition source

The ignition source was a lit tea light candle placed under the front left-hand corner of the television, when facing the television screen, see Figure 5.5. The tea light was pre-burnt for 60 s prior to being placed under the corner of the television.

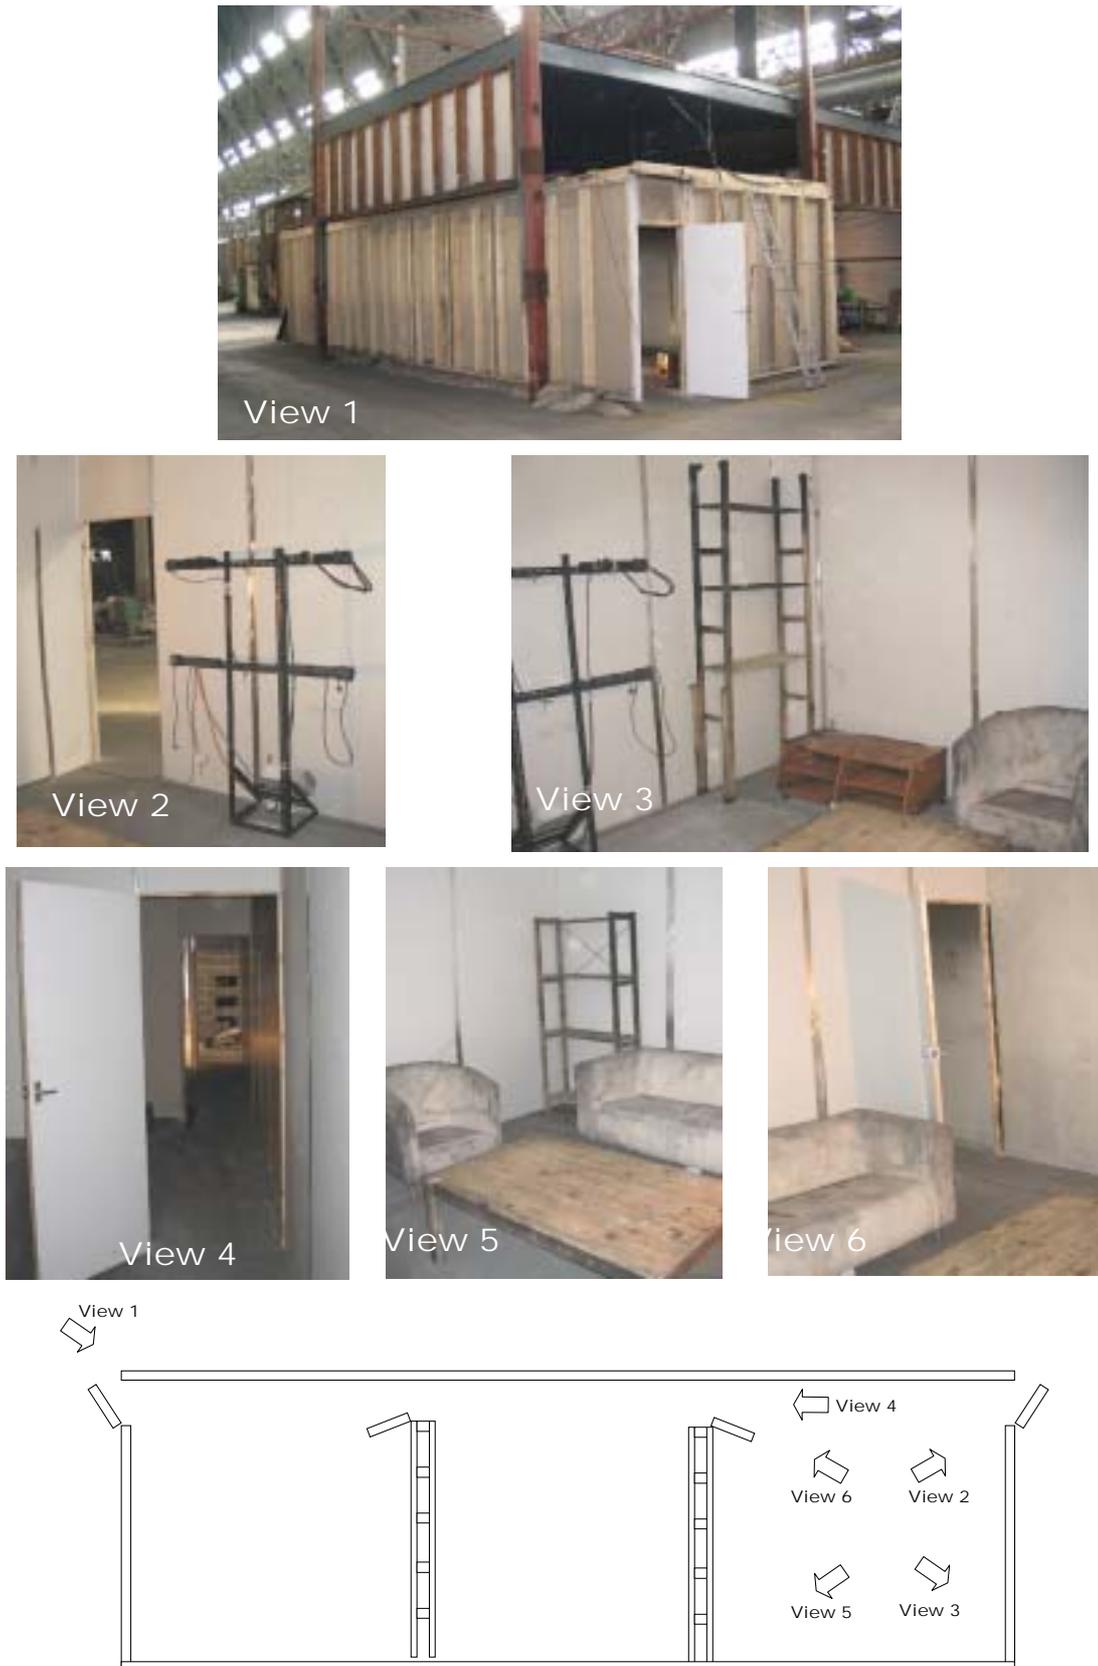
Figure 5.8 Layout of the experimental facility

Standard size, non fire-resisting, internal doors were also fitted to the internal compartment dividing walls to allow ventilation conditions to be controlled. For each fire, one end room was fitted with furniture (the room of fire origin). The other end room remained empty. In all tests, the door of the non-fire room was left fully open. Therefore, during tests in which the internal fire room door was left open, the effective enclosure volume was approximately 118 m³. This was reduced to 40 m³ when the fire room door was closed.

Several of the test fires required a larger fire room of size 8 m by 4 m by 2.5 m high and therefore the experimental facility was further modified.

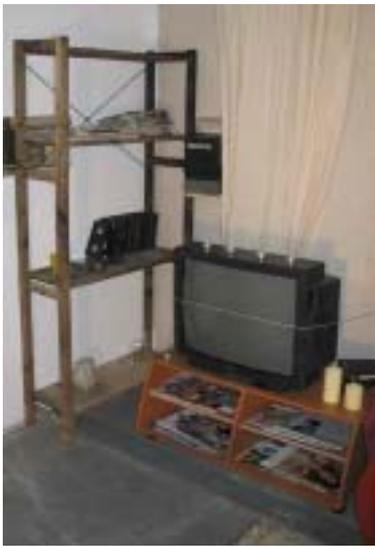
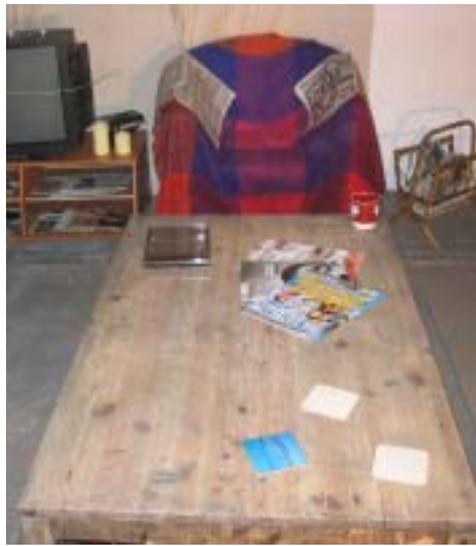
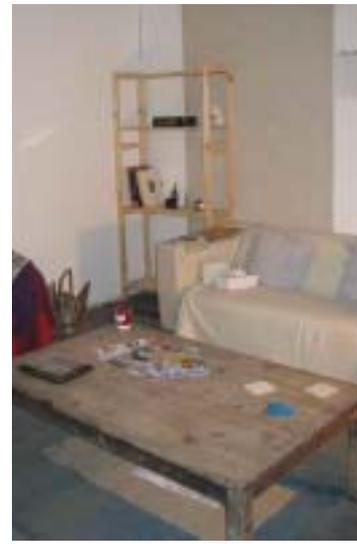
Figure 7.11 Fuel arrangement for television fire (in room 1)

<u>Main items</u> 1 sofa 1 chair 1 coffee table on rug Television on cabinet 2 single shelving units Magazine rack Curtain pole 2 video racks
	Sundries
On sofa	1 large throw 2 matching cushions 1 handbag 1 box of tissues 1 newspaper on each arm
Chair	1 small throw 1 newspaper on each arm
Videos	39 needed, see below
Video rack 1	10 videos
Video rack 2	10 videos
On television table	20 glossy magazines, 5 per shelf 2 wax candles 5 videos 4 nightlights on top of television 2 nightlights to one side Television wired in places
On curtain pole	1 pair of curtains
On coffee table	1 mug 3 magazines 2 coasters 1 chocolate box
Newspapers	10 kg weighed out, see below for details
Magazine rack	10 folded newspapers
Shelf unit next to television	Top shelf – 4" broad sheet, 5" tabloid newspapers Middle shelf – 14 videos, 10 CDs, 2 birds, plastic cup Bottom shelf – large vase or china owl and glass
A3 sheets of white paper	1 on camera wall 1 on sofa wall 1 under coffee table

Shelf unit next to sofa	Top shelf – plastic alarm clock, board game, small cuddly toy Middle shelf – 1 large book, two picture frames, 1 radio cassette Bottom shelf – basket containing two large fir cones

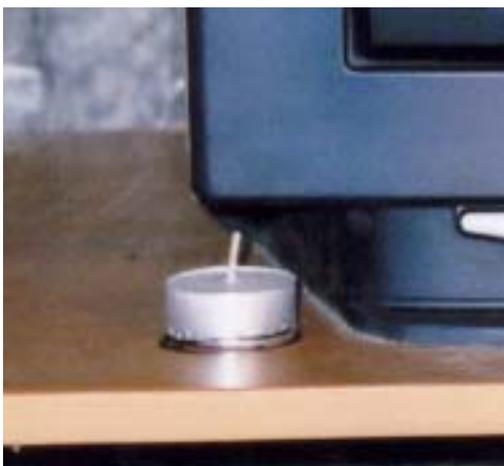
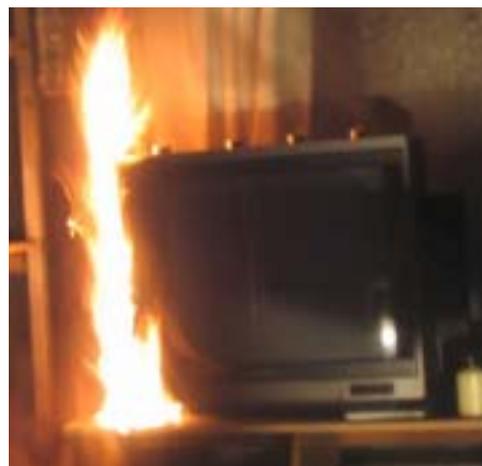
Figure 5.12 Television fire ignition source

The primary ignition source for this fire was a lit nightlight candle placed under the front corner of the television closest to the bookshelf. Figure 5.12 shows the location of the nightlight for a fire in room 1 and a typical photograph of fire growth up the side of the television several minutes after ignition. For each of the television fires, the nightlight was ignited and allowed to burn for 60 s prior to being placed under the corner of the television.

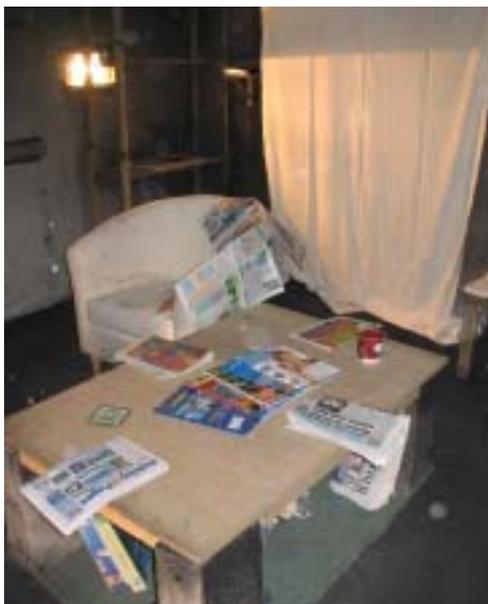
Figure 5.13 Fuel arrangement for table fire (in room 1)

Figure 5.13 shows the furniture arrangement for the table fire. A full list of items used is contained in Table 5.4. The main components of the 'table' and the material beneath it are shown in Figure 5.14. The whole of this table arrangement except the blocks and the materials below it were replaced for each test.

The table fire comprised a simulated coffee table below which was placed a wicker magazine rack filled with newspapers and videos. Also, under the table were two stacks of four videos, four jigsaw boxes and eight loose newspapers resting vertically against the videos and boxes.

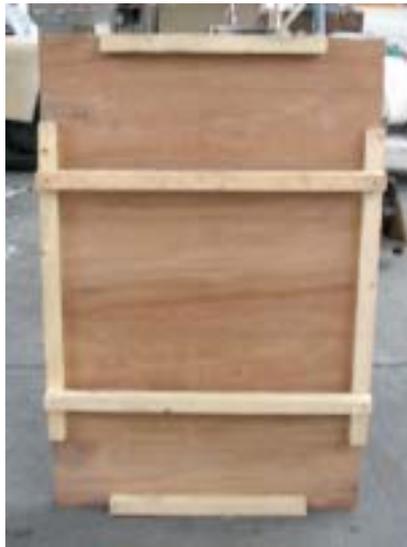
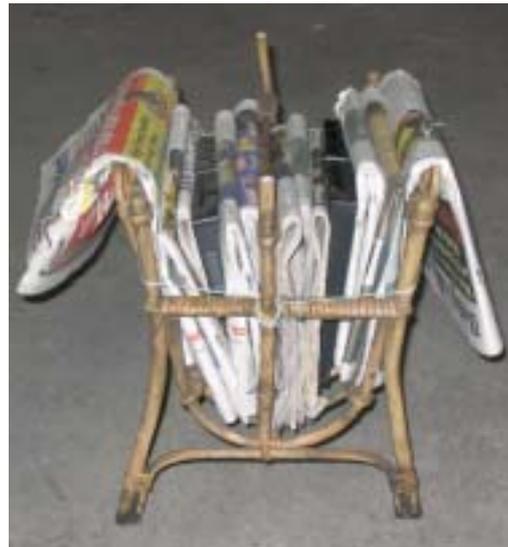
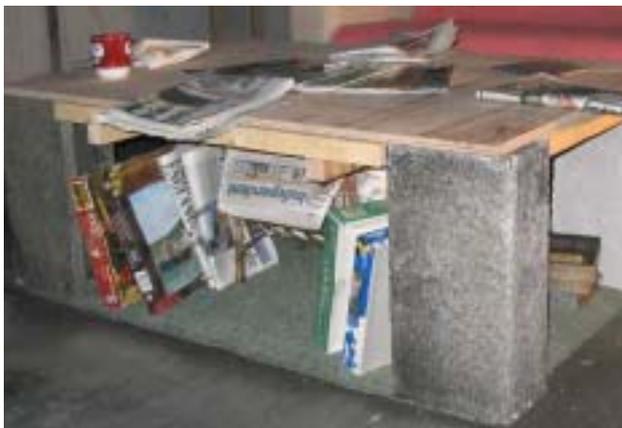
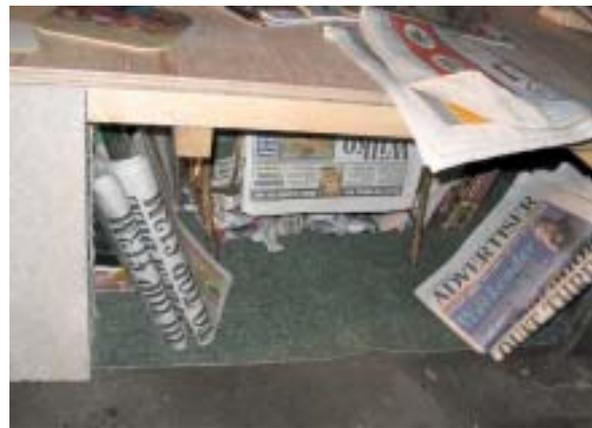
Figure 7.14

Plywood table top with wooden battens

Magazine rack with papers and videos

View of 'table' facing towards sofa

View of 'table' facing away from sofa

Details of table fire arrangement

The table consisted of a single sheet of 1.2 m by 0.8 m plywood to which eight wooden battens were screwed. This 'table top' was supported on four concrete blocks (215 mm by 100 mm by 440 mm tall) to help prevent the table collapsing. Ignition was achieved by igniting a total of six scrunched up newspapers, positioned three on each side under the magazine rack, as shown in Figure 5.15. A piece of Hessian-backed carpet, of the same size as the tabletop, was positioned on the floor below the concrete blocks.

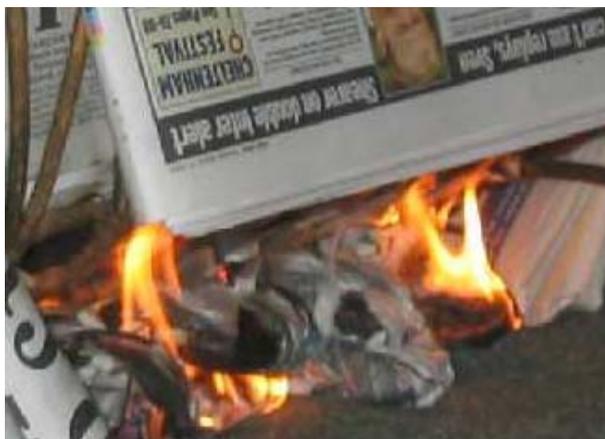
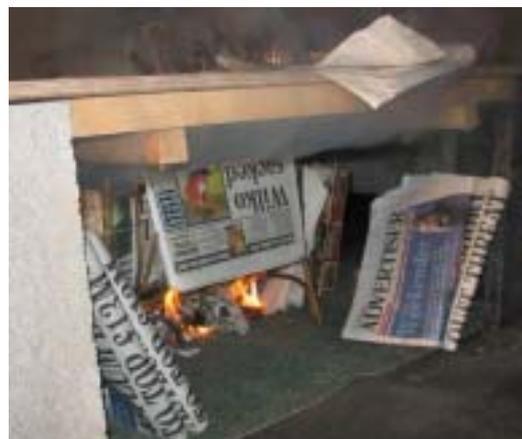
Figure 5.15

Table fire ignition point

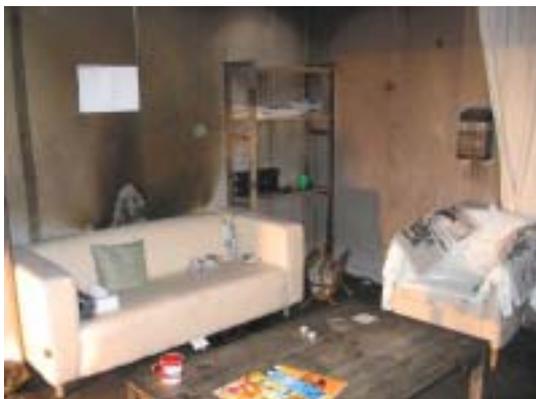
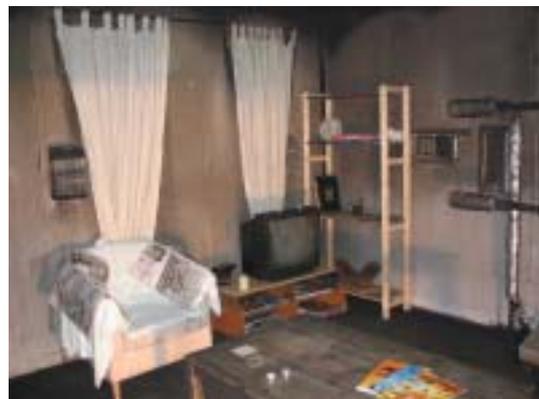
1-sofa 2-coffe table 3-small table 4-Shelving units 5-Arm chair *-approximate location of ignition

Figure 5.16 Fuel arrangement for sofa fire (in room 2)

The primary fuel source for this scenario was the same type of sofa used in the other lounge fires. The fuel arrangement used was similar to that used for the television fires, see Figure 5.16. A full list of items used is contained in Table 5.5.

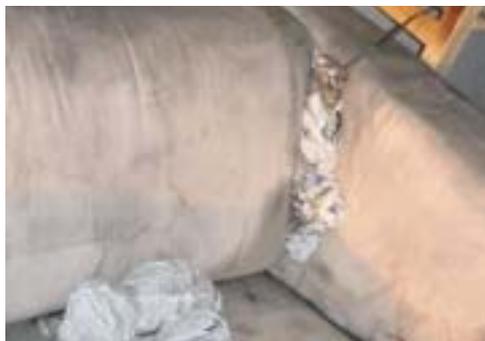
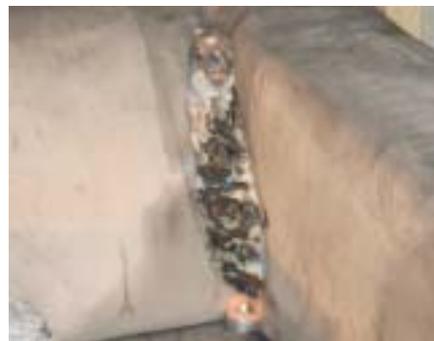
Figure 5.17 Sofa fire ignition source

Ignition was achieved using a lit nightlight placed below three scrunched up newspapers pressed in between the side and rear cushions of the sofa as shown in Figure 5.17. Due to the fire retardant treatment of the cushion fabric it was not always possible to achieve and maintain a consistent growing fire. In some cases, the papers burned and extinguished without the sofa catching alight. This was partially rectified by replacing the burnt paper with new additional newspaper which was then ignited.

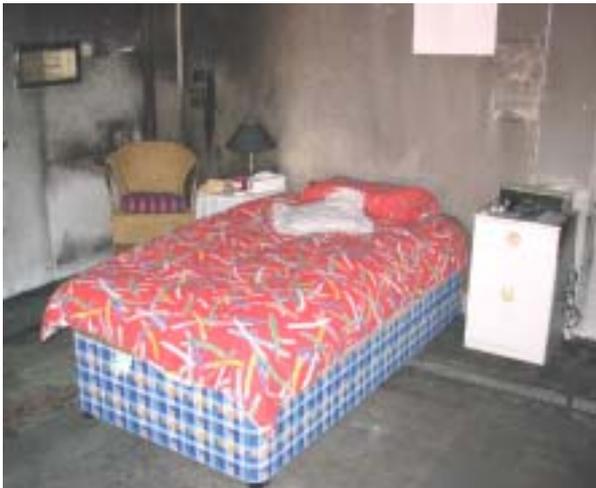
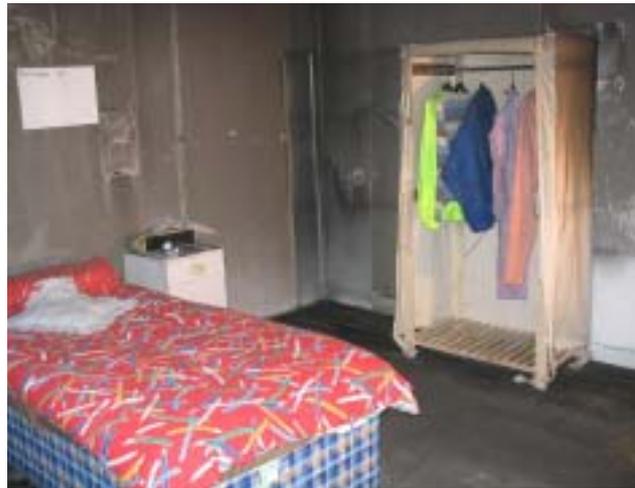
1-bed 2-pillow and cushion 3-Bed-side table 4-Fabric wardrobe 5-Wicker chair * -approximate location of ignition

Figure 5.18 Fuel arrangement for sofa fire (in room 2)

The main items for the bedroom arrangement were: a single bed, two bedside cabinets, a wicker chair and a fabric wardrobe. Sundry items included bedding, bedside table items, a rug, cushions, items of clothing on plastic hangars. The bed was made up with fitted sheets, pillow, duvet and an additional small cushion placed next to the pillow.

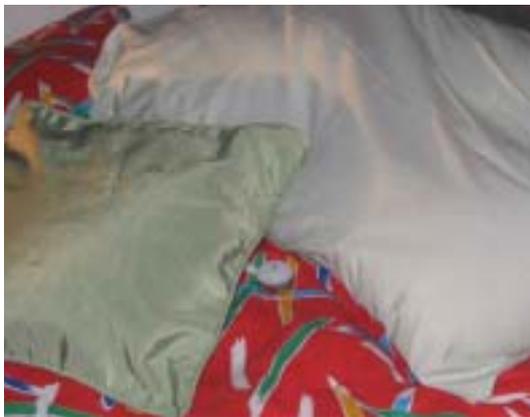
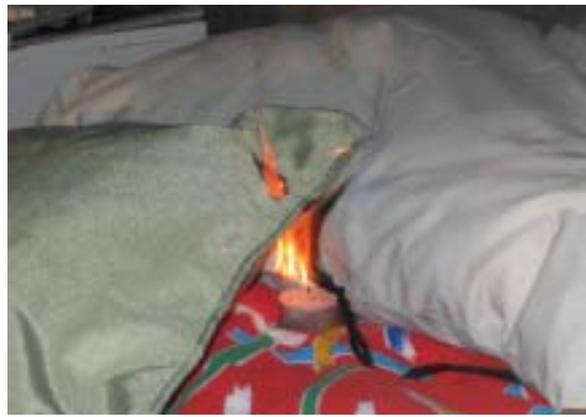
Figure 5.19 Bed fire ignition source

Ignition was achieved using a lit nightlight placed under the front edge of the pillow, close to the cushion, see Figure 5.19.

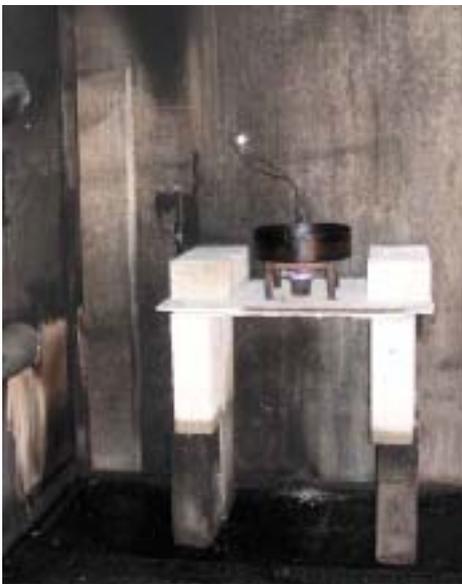
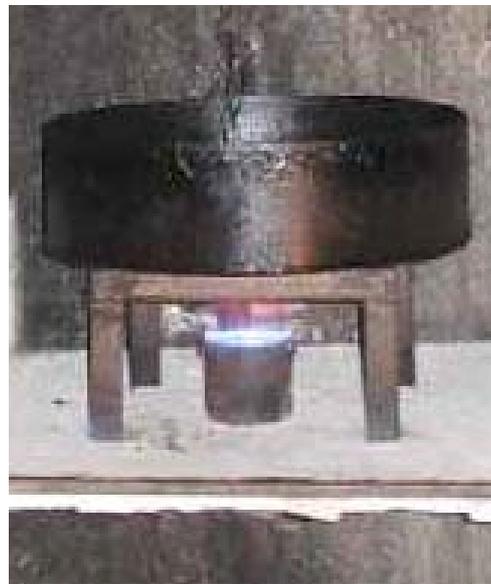
1-raised platform 2-oil pan

-gas burner located under oil pan

Figure 5.20 Fuel arrangement for oil pan fire (only done in room 1)

The oil pan fire used for this scenario was based on the arrangement used in BS EN1869:1999 [British Standards Institution 1999] for fire blanket testing. This used a 350 mm diameter pan with side walls of 100 mm supported on a metal frame 140mm tall. This arrangement was in turn located on a sheet of fire resisting board supported on concrete blocks, as shown in Figure 5.20. The remainder of the fire room was empty.

A gas burner was located underneath the pan and propane was fed to it from a cylinder located outside the experimental facility. The burner was used to heat the oil to its auto ignition temperature, nominally 360°C. Three litres of new sunflower cooking oil were used for each fire. The temperature of the oil was monitored using a thermocouple connected to a display unit. To prevent the room from overheating prior to ignition of the oil, the external door of the fire room was kept open until the oil temperature reached 350°C. Immediately the oil had auto-ignited, the gas burner was turned off and removed from the fire room through a small hole in the wall.

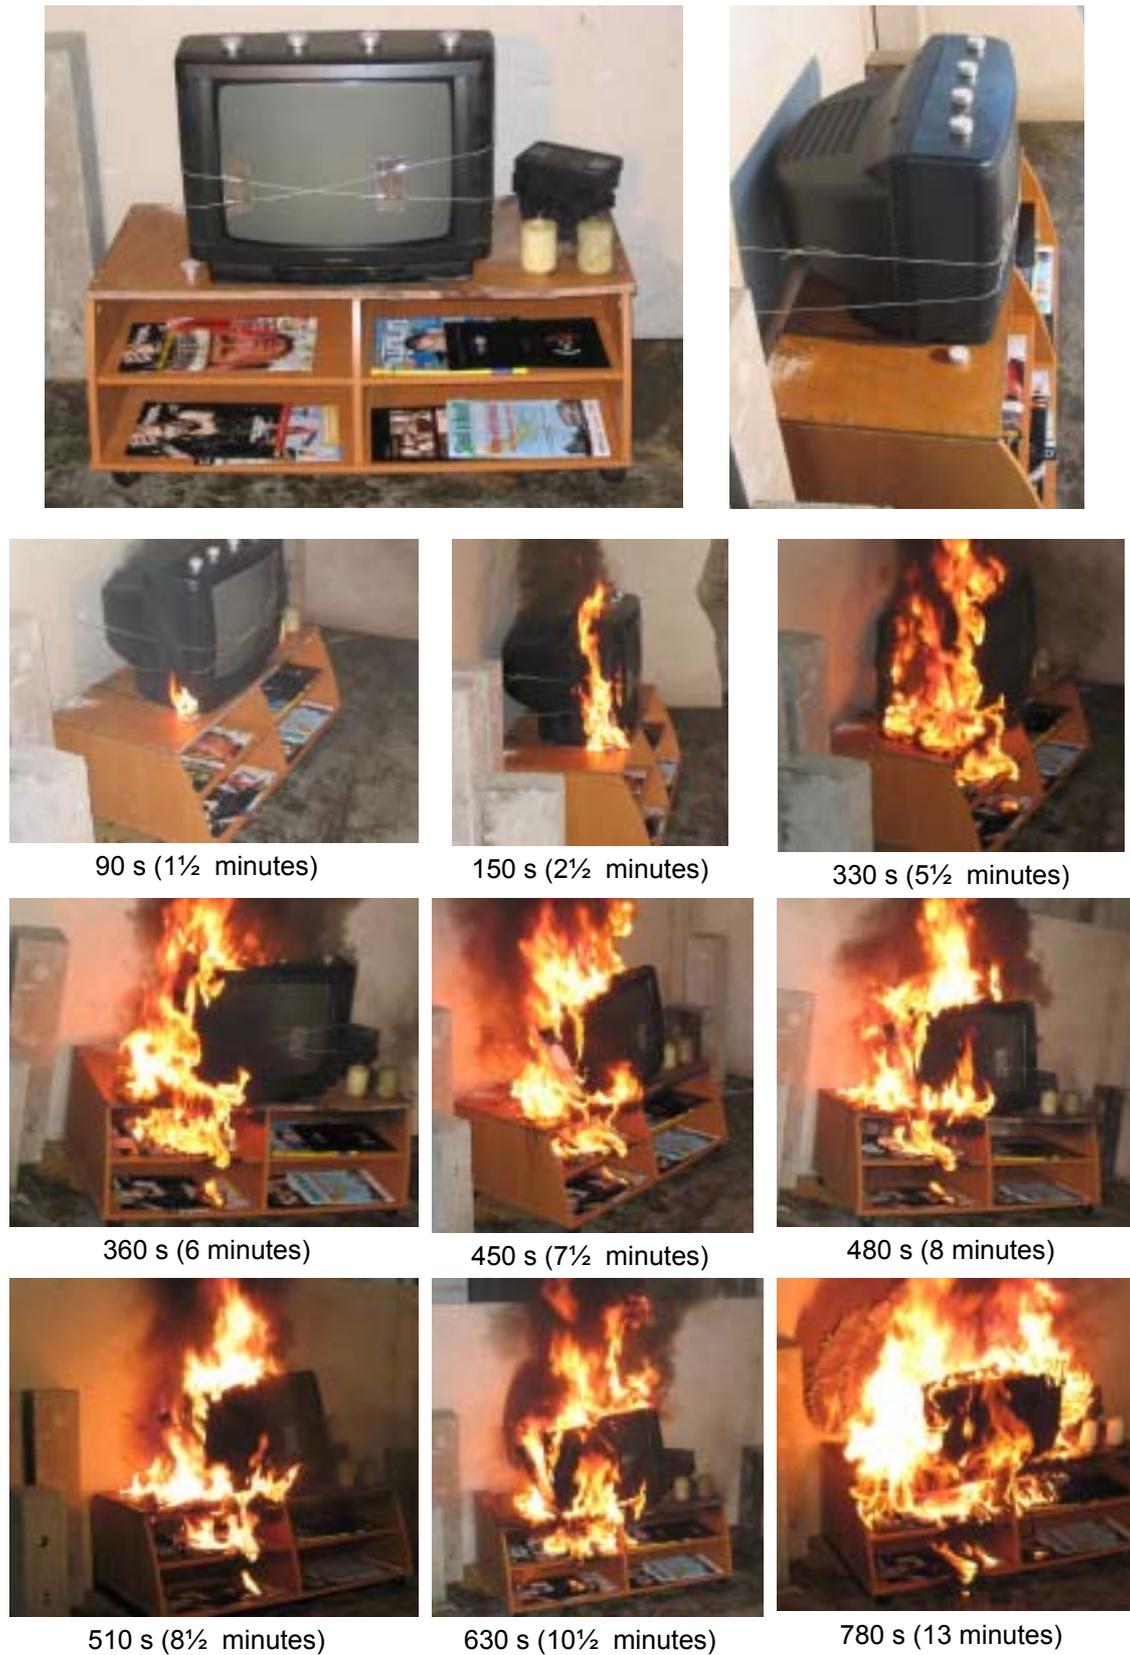
Figure 5.27 Photographs taken before and during television calorimetry fire

The recorded HRR rate profiles provide an indication of the burning characteristics of each fire in a well-ventilated open space. The peak values and the rates of burning observed are likely to be greater than would have occurred in the house and compartment tests. However, the results provide important benchmark data of the types of fires studied. They also give a useful insight into the growth and relative sizes of each fire that would have been difficult to obtain otherwise during the compartment tests.

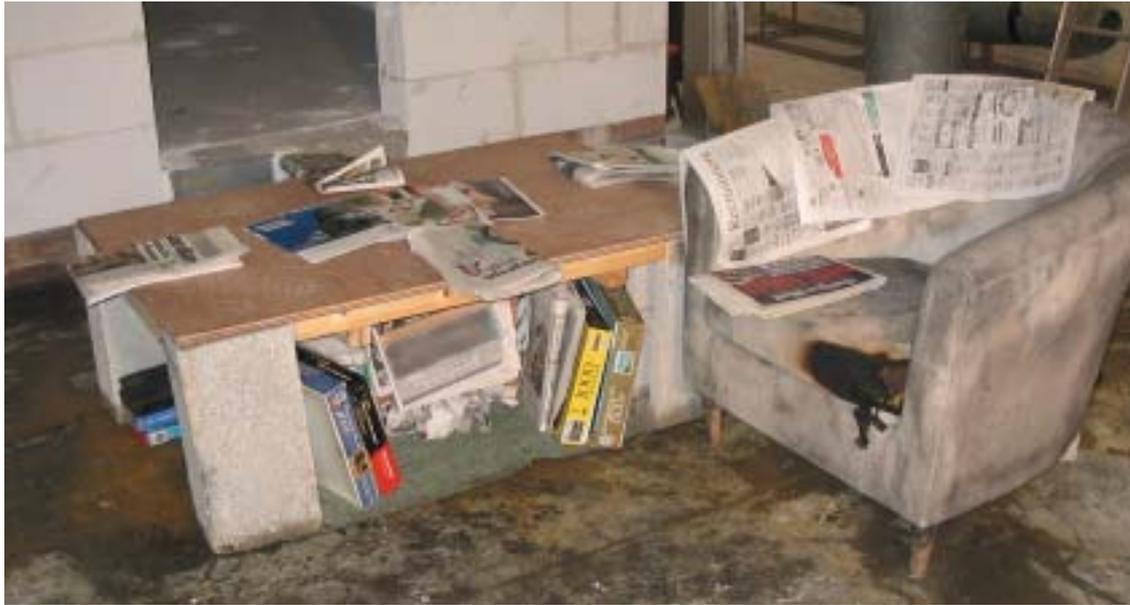
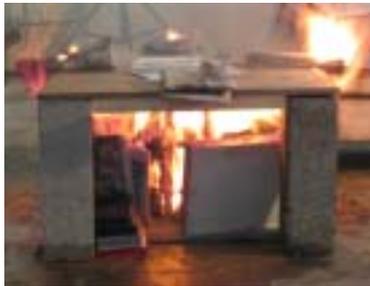
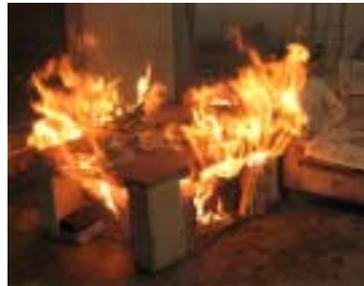
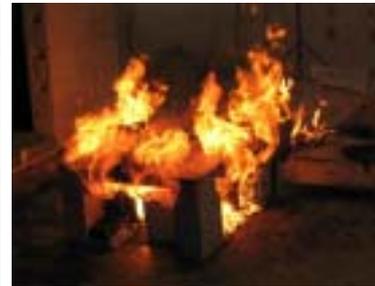
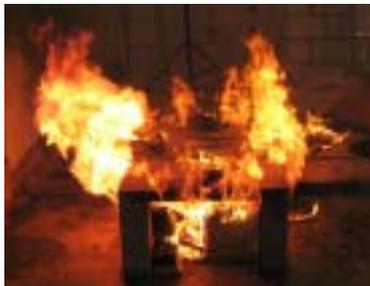
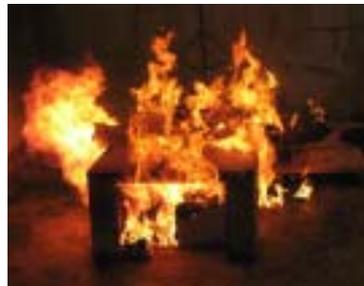
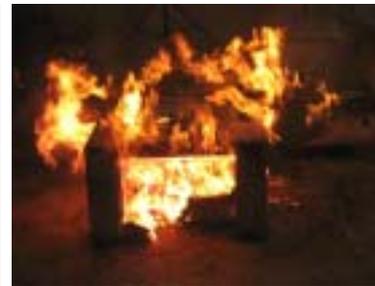
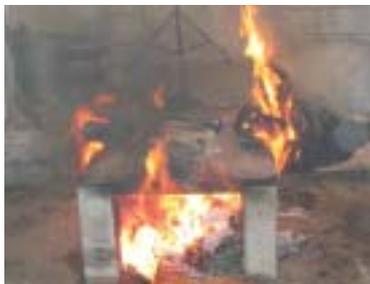
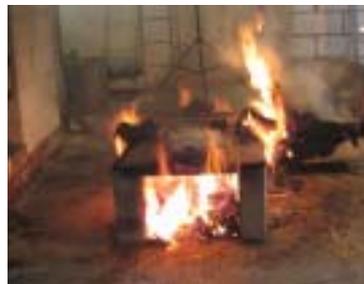
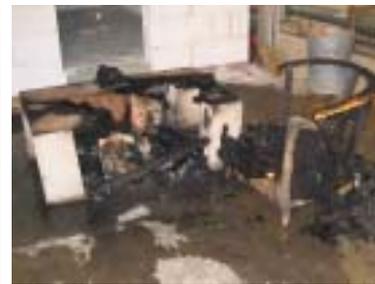
Figure 5.28 Photographs taken before, during and after table calorimetry fire

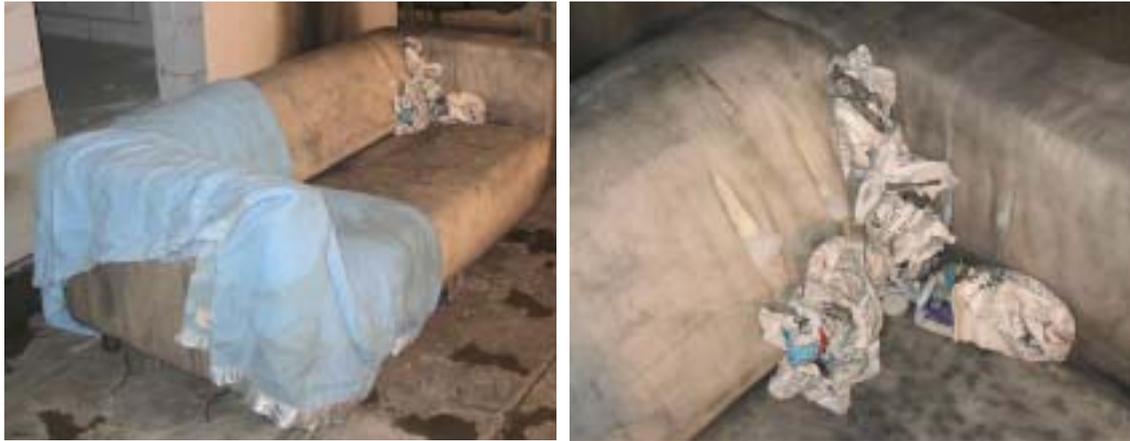
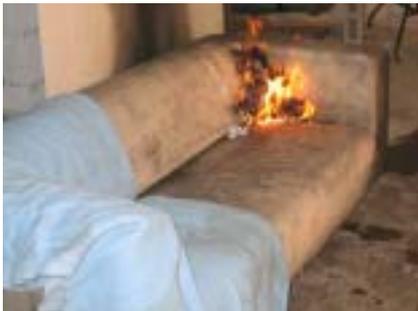
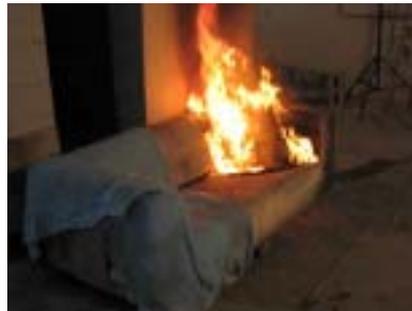
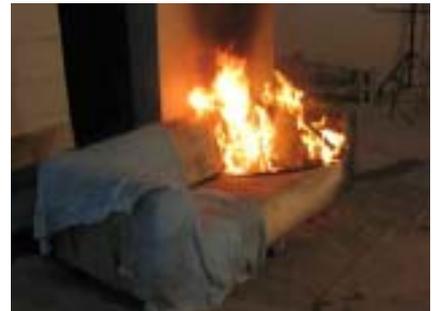
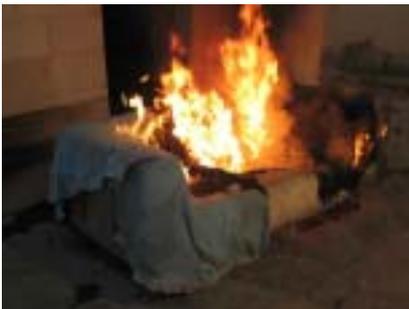
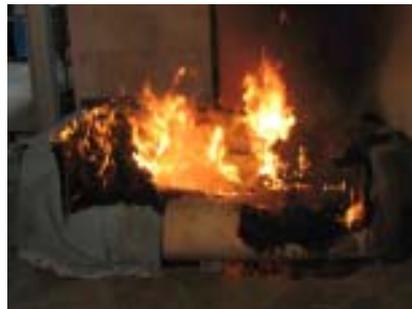
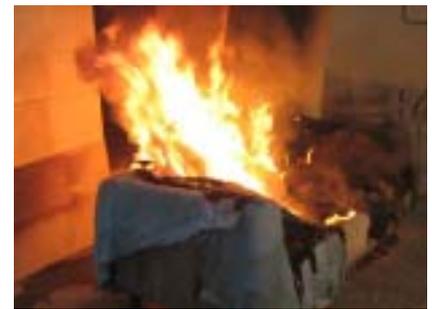
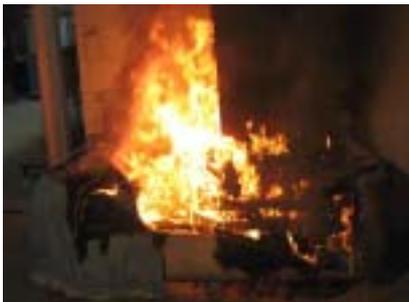
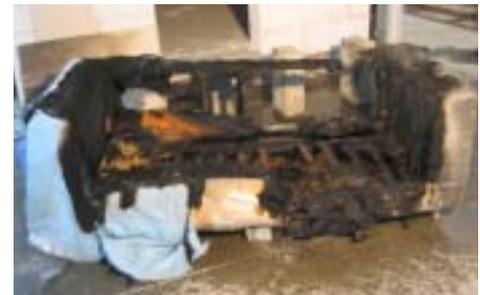
Figure 5.29 Photographs taken before, during and after sofa calorimetry fire

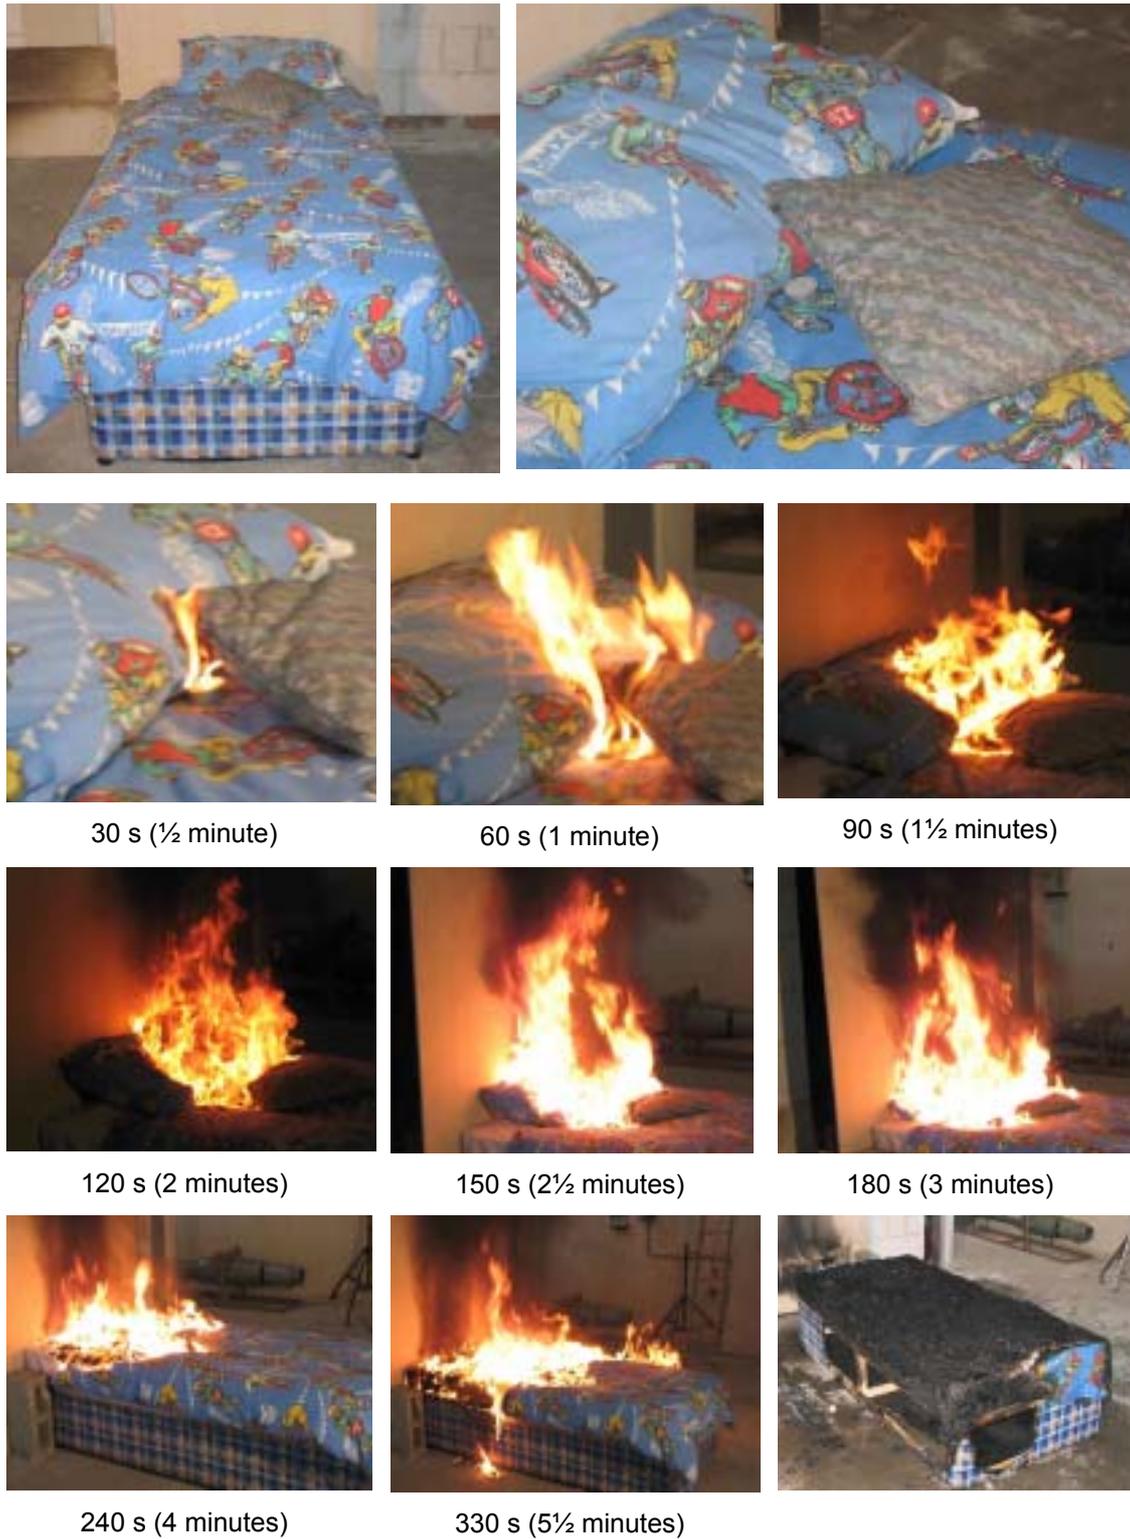
Figure 5.30 Photographs taken before, during and after bed calorimetry fire
