Potential Perils of Modern Methods of Construction – a short introduction

David Crowder
Business Group Manager, Fire Investigation
20th September 2011

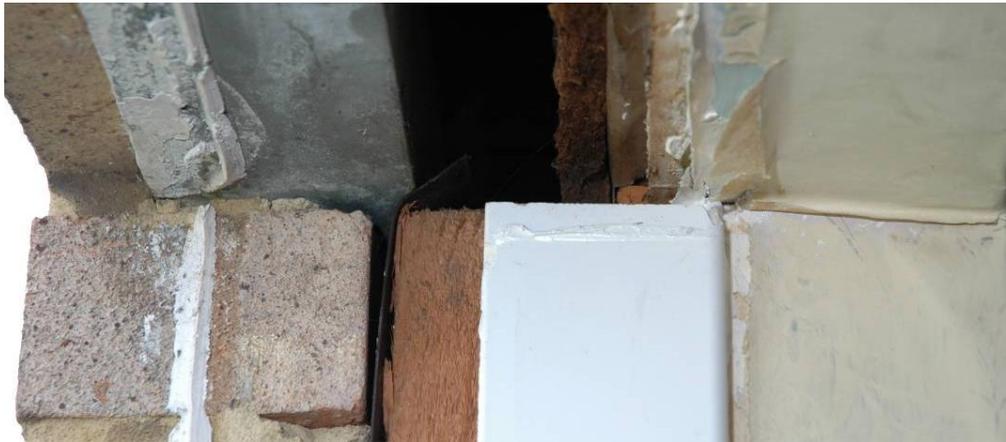
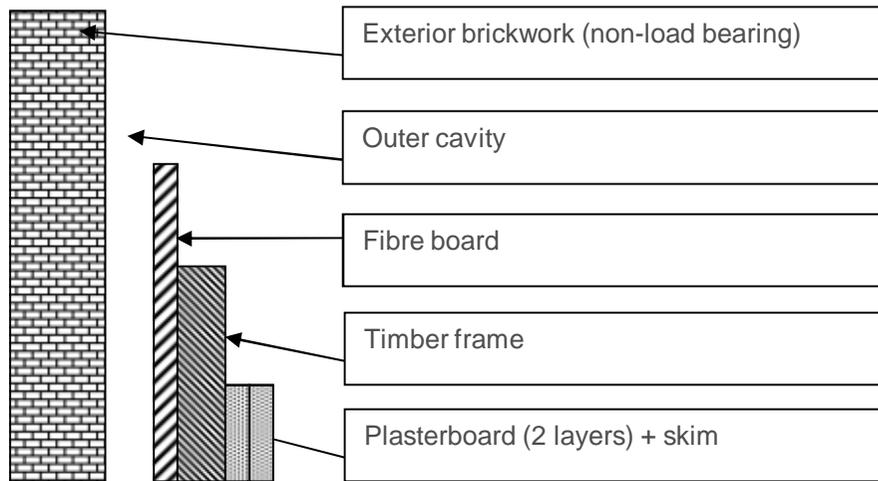
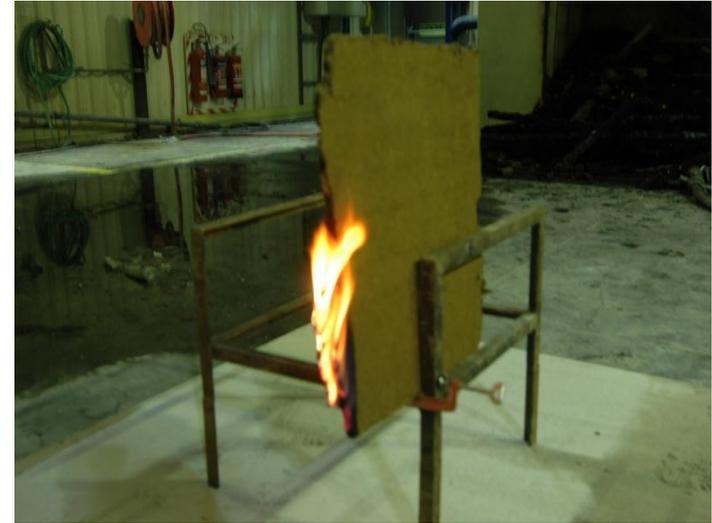
Marston Way, Upper Norwood 25th – 26 December 2007

- Timber frame block of flats
 - Constructed in 1970s
 - Refurbished post 2000 (including
- Fire started deliberately in bedroom
- Initial attendance by fire brigade, fire believed extinguished
- Fire had spread into cavity after burning through uPVC window frame
 - Smouldering bitumen impregnated fibre board
- Fire spread throughout structure, eventually requiring demolition

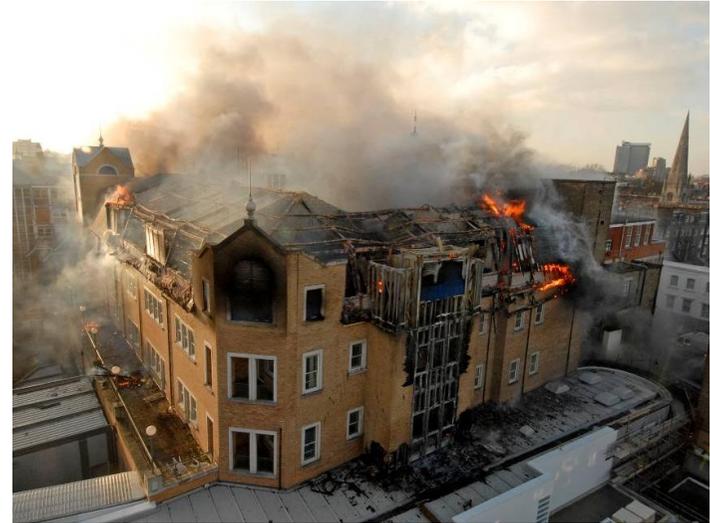
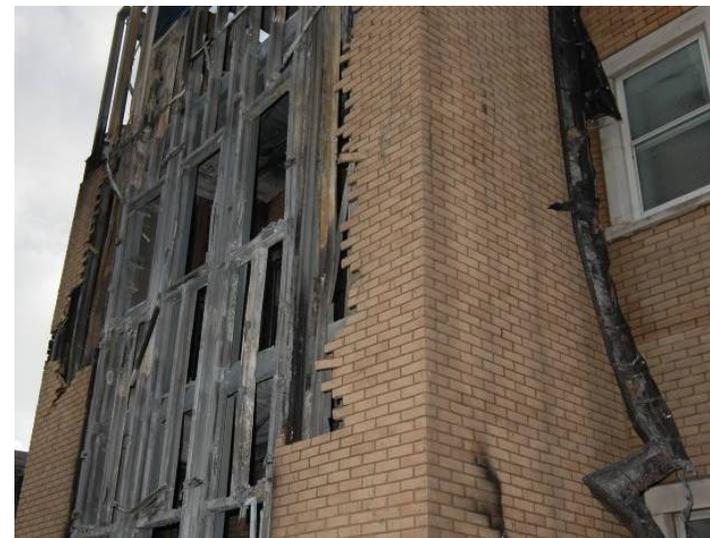
Royal Marsden Hospital, London 2nd January 2008

- Brick, block & concrete original building
- In process of being extended
- Steel framed tower constructed to conceal service riser
- Fire broke out in vicinity of tower
- Destroyed roof and plant space beneath
- Smoke spread into building through windows penetrating tower
- Fire brigade forced to attack fire using neighbouring rooftops

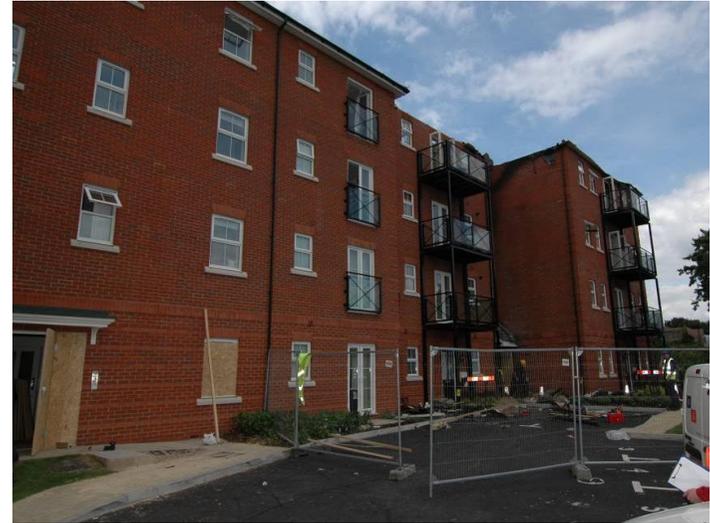
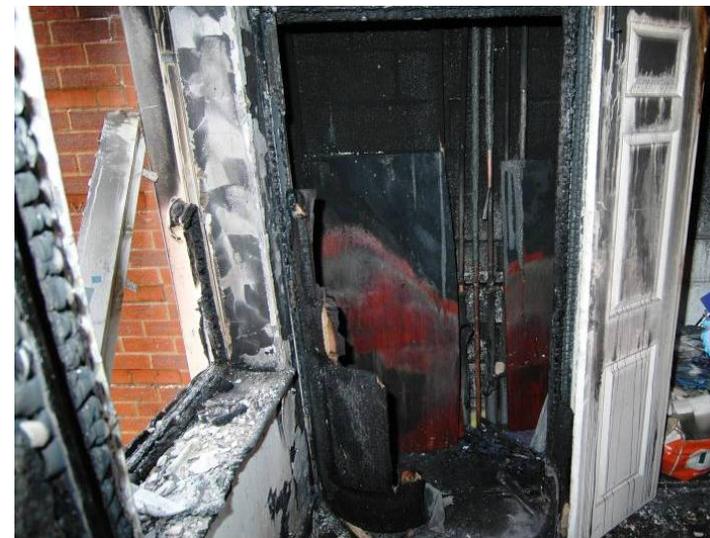
Lancaster Square, Ilford 9th June 2008

- Concrete block of flats
- Timber truss rafter roof
- Fire in common stairwell
- Broke out of window into roof soffit
- Spread throughout roof
- Residents first became aware of fire as collapsing roof sections fell in through ceiling
 - Rescued from windows and balconies – common areas impassable

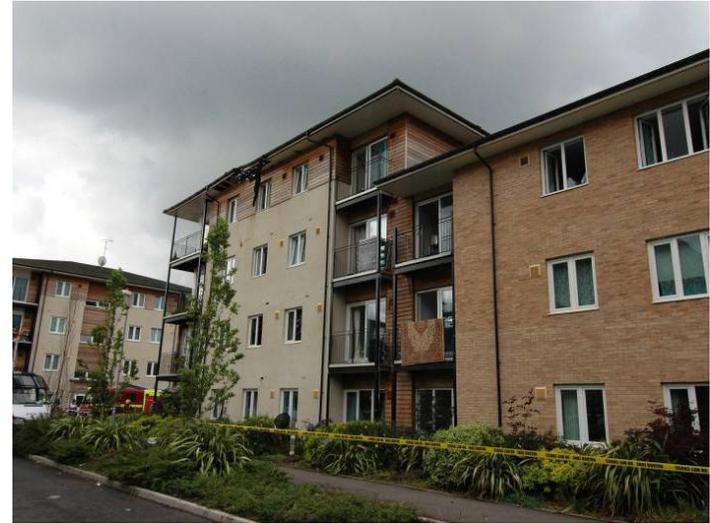
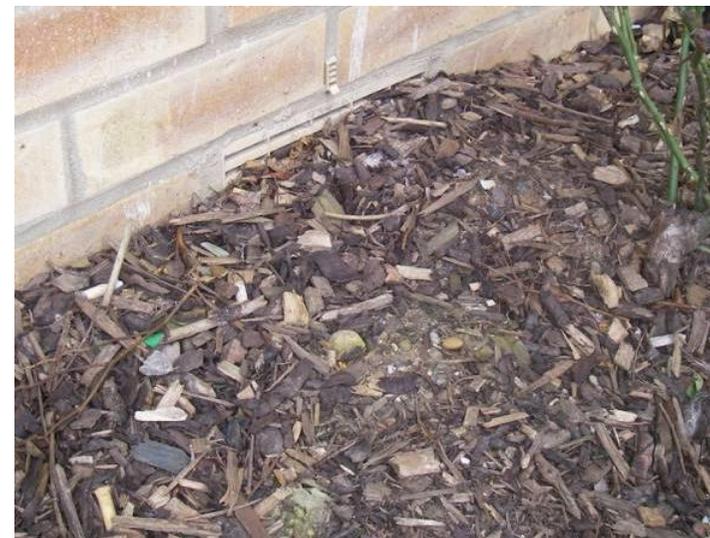
Bennett Close, Hounslow 10th June 2008

- Timber frame block of flats
- Fire started from discarded cigarette outside
- Spread up through timber frame
- Building collapsed from central staircase
- Brigade decision to evacuate immediately upon arrival meant no casualties
 - Learnt from experience at Marston Way

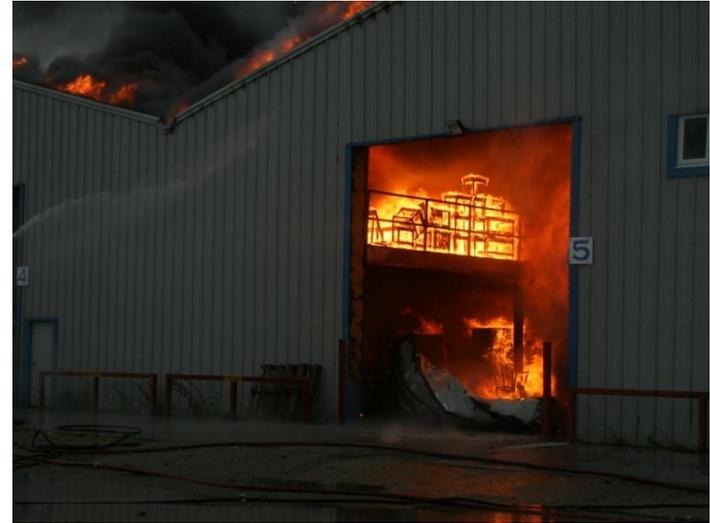
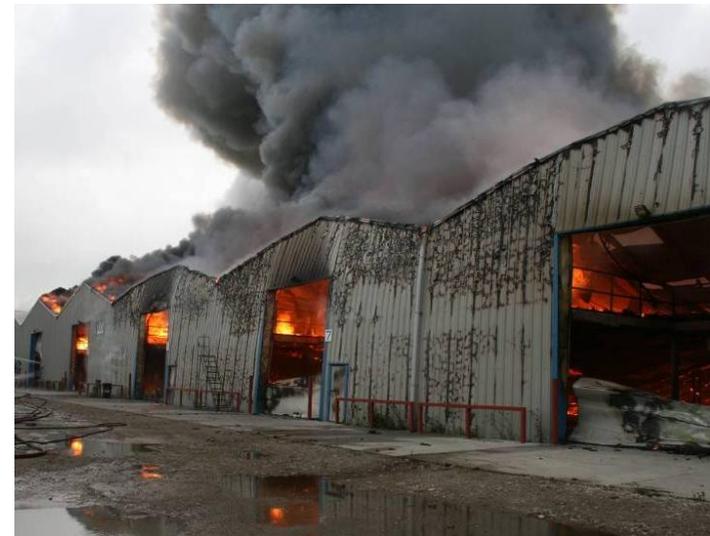
CPW Furniture, Rye 10th July 2008

- Steel frame and sandwich panel furniture warehouse
- Fire broke out in waxing booth
- Brigade entered but forced to retreat by heat - some injured
- Fire appeared smaller than actually true due to level of insulation
- Combination of insulation and fuel loading produced extreme temperatures
 - Total destruction of structure

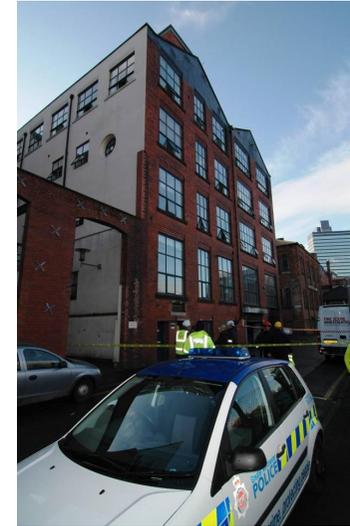
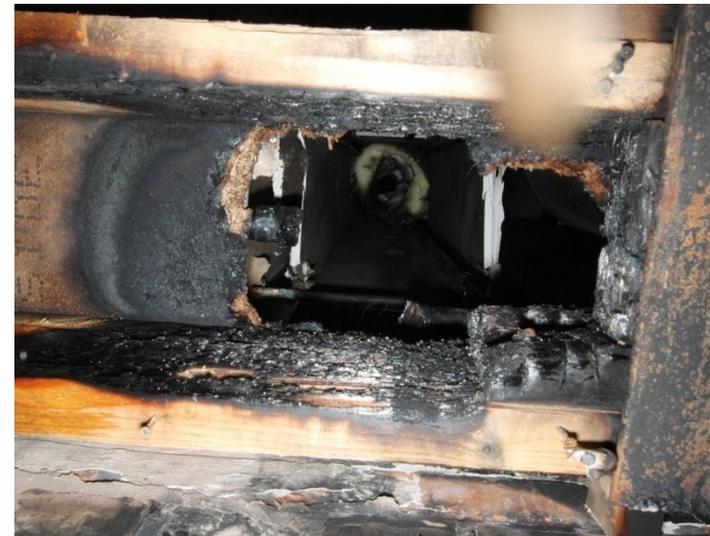
Ancoats, Manchester 6th November 2008

- Luxury apartments over enclosed semi-basement car park
- Converted tobacco factory
 - Unusual ceiling layout in car park
- Two cars completely destroyed
 - Two further cars damage by radiant heat
- Smoke and fire spread into upper floors though:
 - Poorly designed smoke shaft
 - Burnt soil pipes through timber structure
- Residents unaware of fire prior to brigade attendance

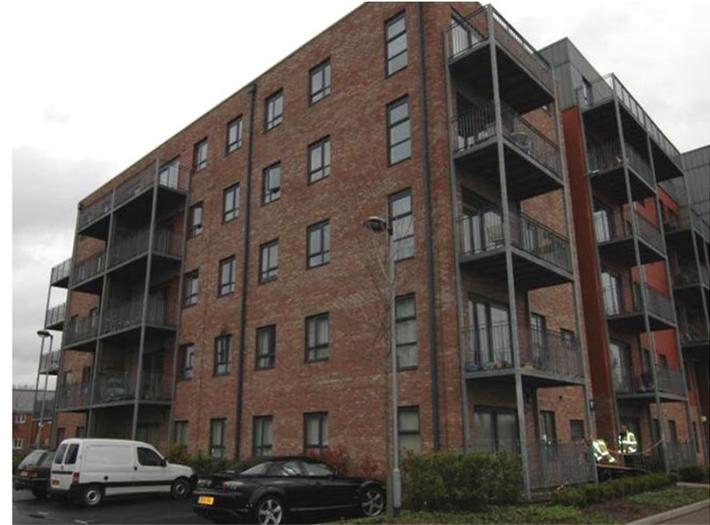
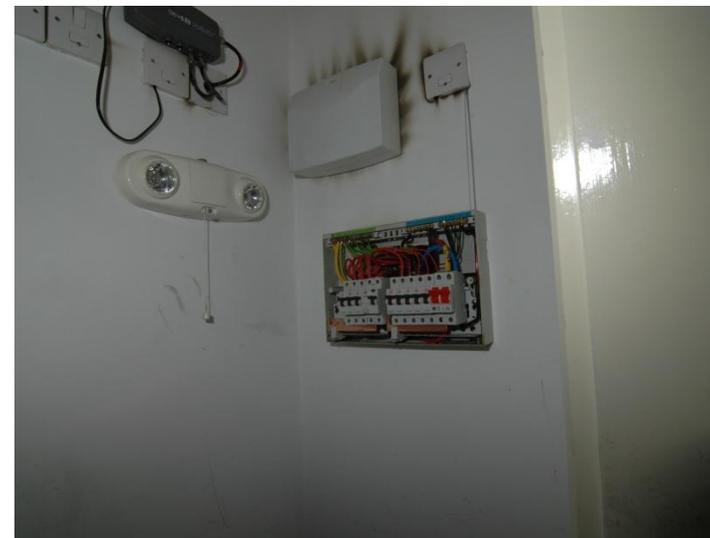
Waterfront Apts, Manchester 7th April 2009

- Timber frame flats
- Modular construction
- Fire started in electrical cupboard
- Spread into cavity
- Total of 12 apartments over 4 floors were affected

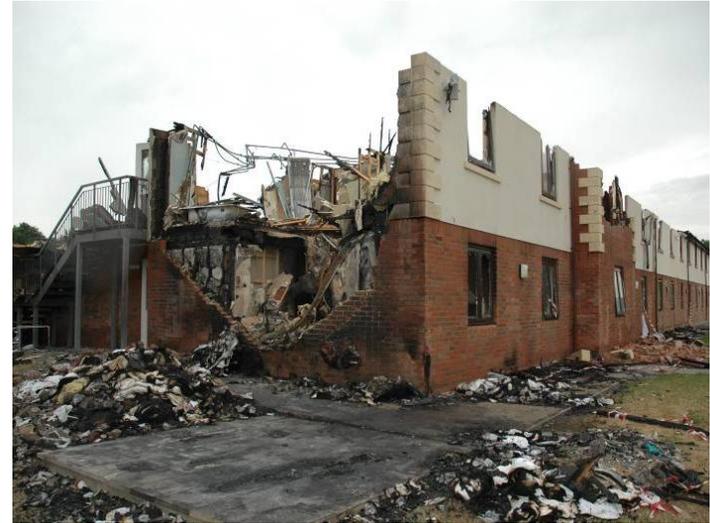
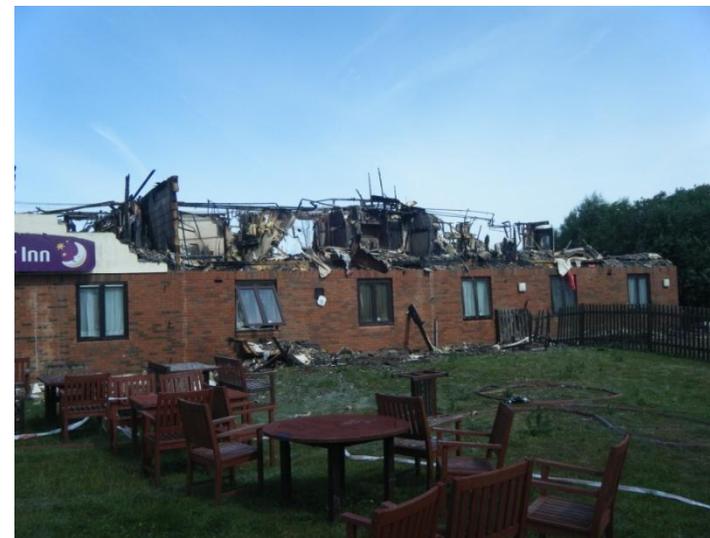
Premier Inn, Silverstone 5th July 2010

- Timber frame hotel
- Extended over a number of years
 - Extensions required additional services to be laid through roof
 - Service penetrations poorly fire stopped
 - Junction between walls and roof poorly fire stopped
- Fire started in external linen store
 - Likely to have spread into structure through plastic airbricks and combustible soffit, although too damaged to ascertain

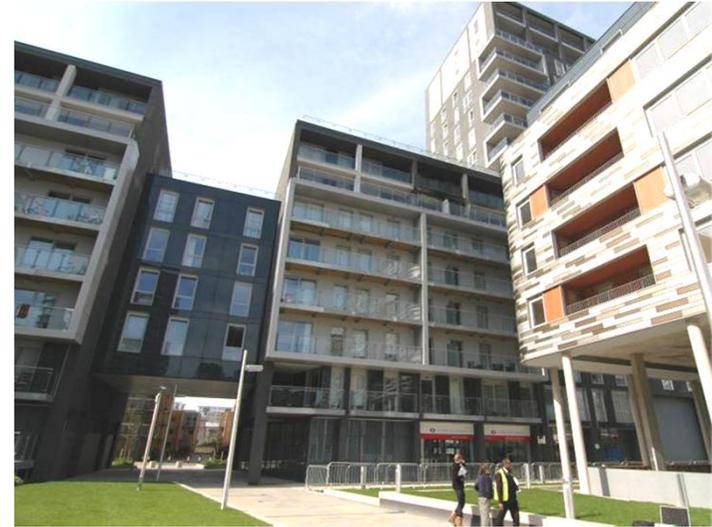
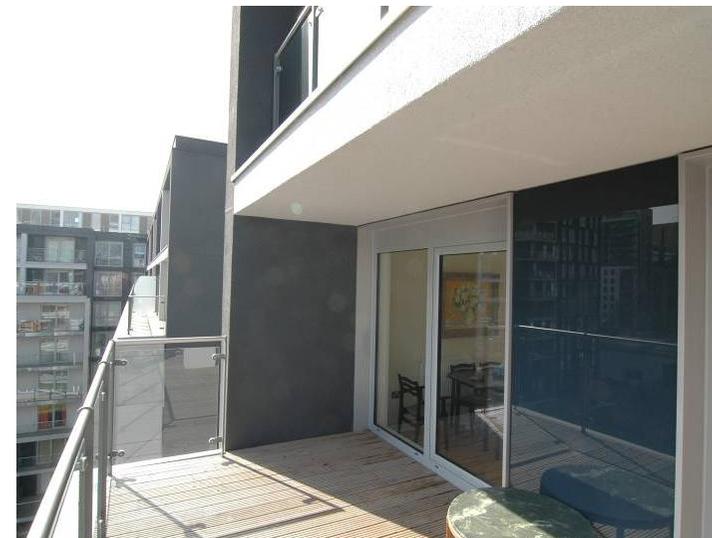
Indescon Court, London 22nd March 2011

- Purpose built flats, built 2009
- Concrete structure and numerous cladding systems
 - Cladding systems extended onto surfaces of balconies
- Fire occurred on a balcony
 - Cigarette in plastic cup
 - Involved combustible insulation around balcony
- Significant fire development on outside of building

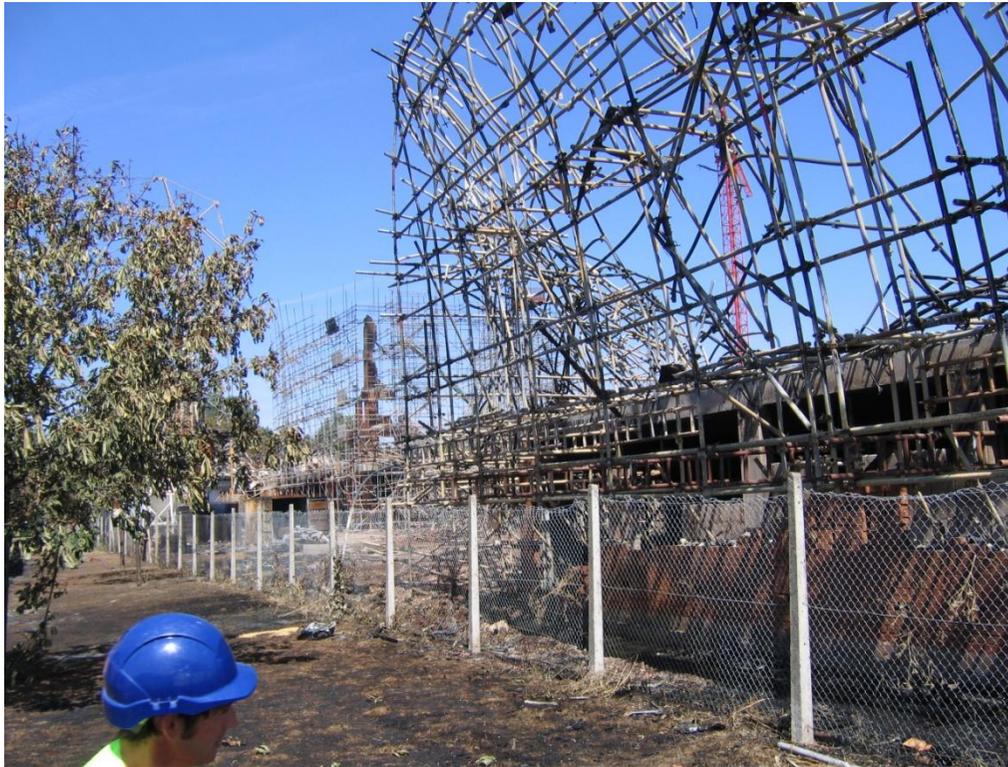
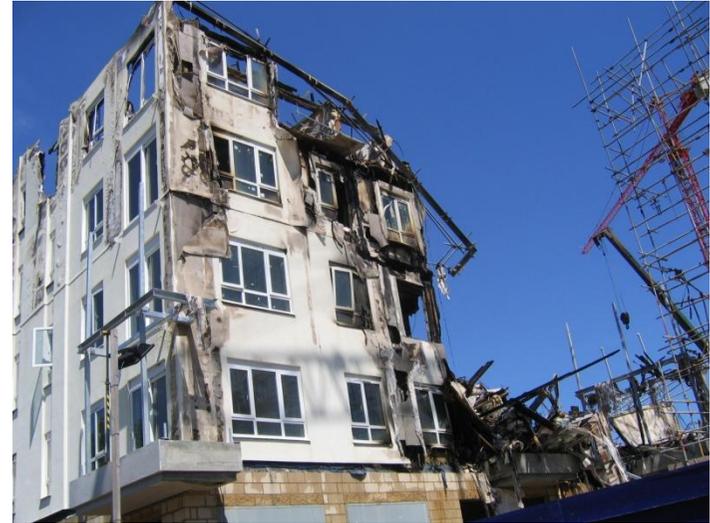
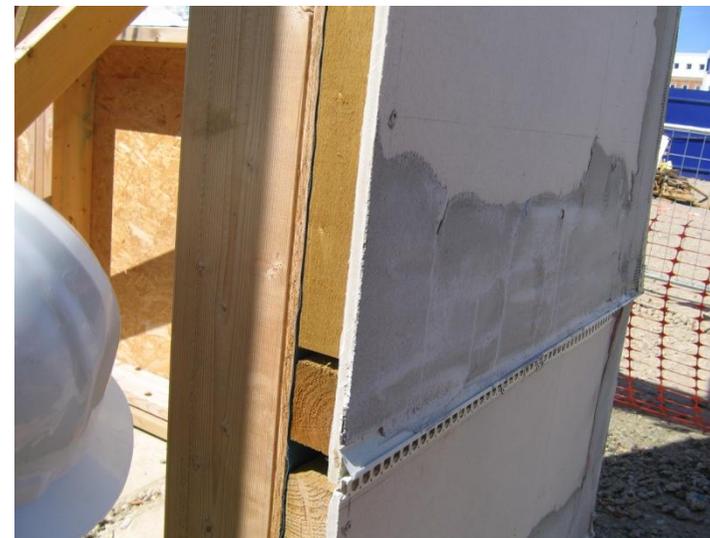
Beaufort Park, Colindale 12th July 2006

- Timber frame flats under construction
- Fire started in lower floors
- Cause unknown
- Timber frame engulfed and consumed in 6 minutes
- Due for occupation two days later

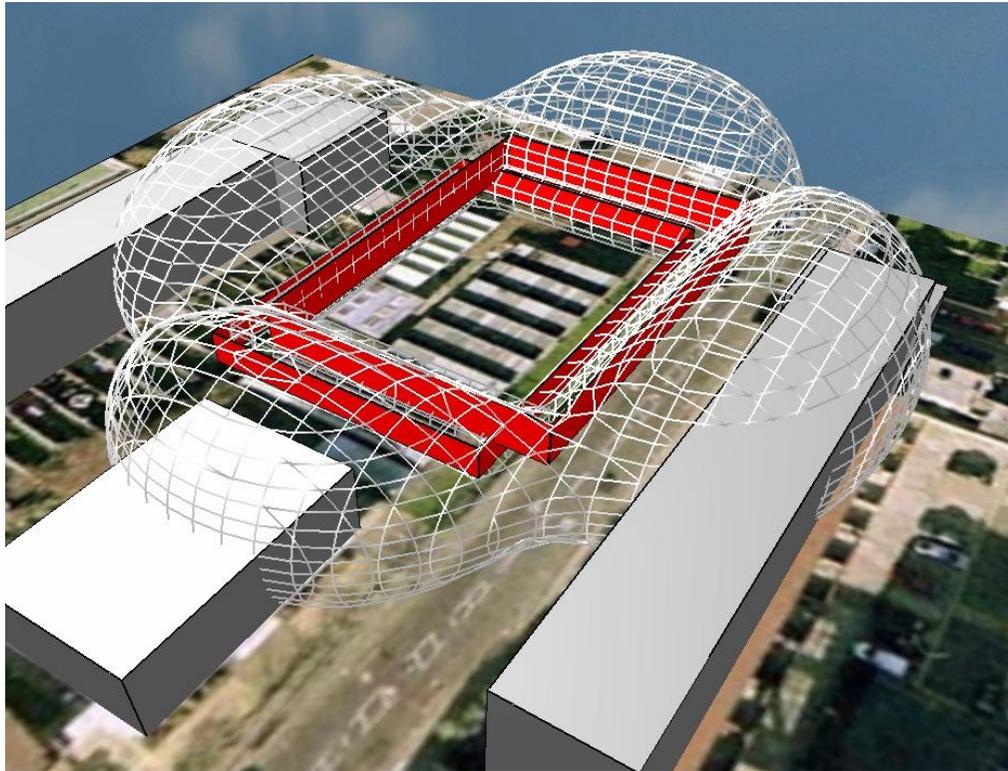
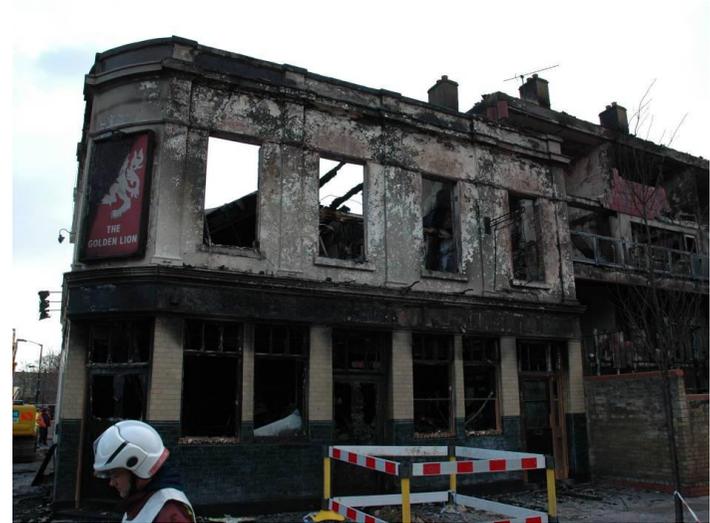
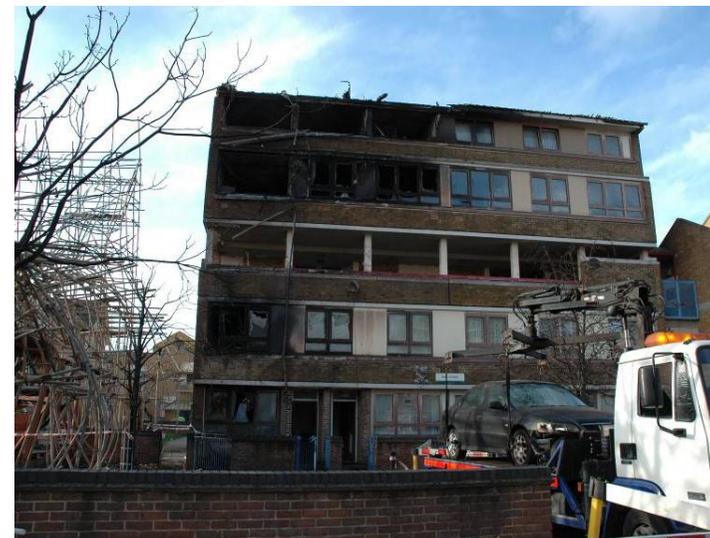
Carisbrooke Gardens, Peckham

- Timber frame flats under construction
- Fire started on ground floor
- Cause under investigation
- Wind driven fire
- 5 additional premises involved
- Significant radiated heat emitted by fire
 - Difficult for LFB
 - Escape routes could have been affected

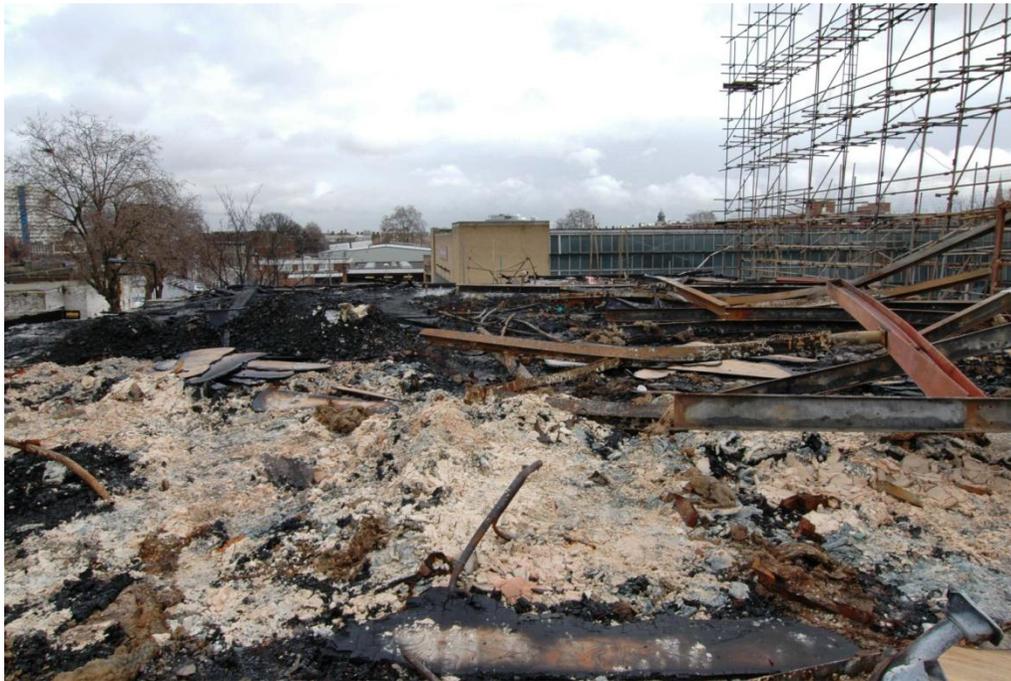
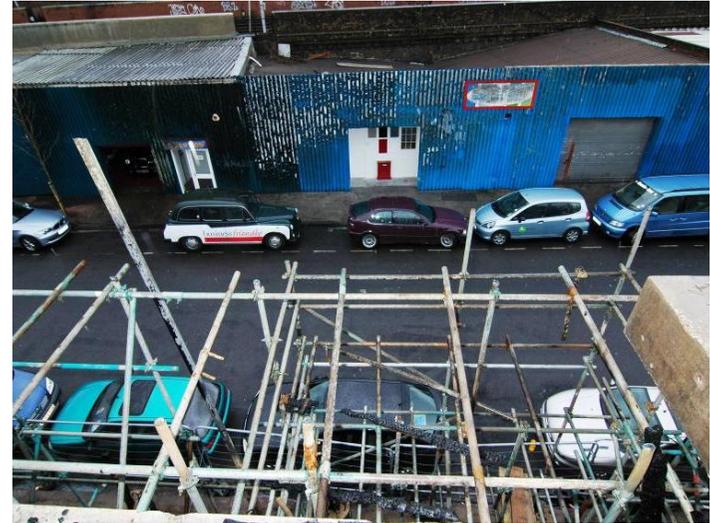
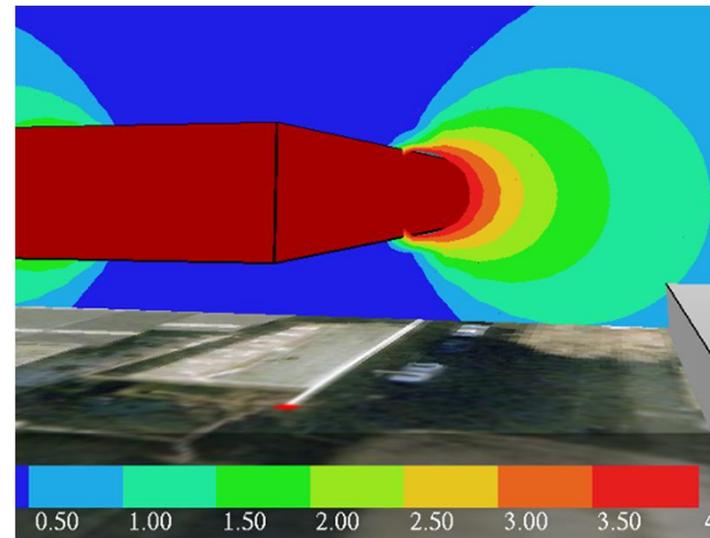
- Mixed material flats under construction
- Fire started on second floor
- Cause under investigation
- No significant wind involved
- Significant radiated heat emitted by fire
 - Difficult for LFB
- Nearby premises suffered heat damage only
