The Rosepark Fire: Ignition and early development

Stuart Jagger
Health & Safety Laboratory

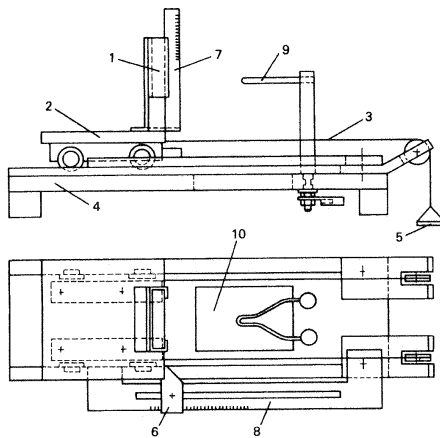
Glow wire testing - BS 6458-2.1 (1984)

Electrically heated glow wire at temperatures up to 960°C.

Tip of the glow wire is pressed into surface of the plastic component.

Parameters such as penetration depth and presence of flame, smoke noted.

To be compliant, plastics used for parts of the distribution board must withstand a range of glow wire temperatures, dependent on proximity to conducting metal parts.

Tests here went beyond the standard

Conclusion: All materials fit for purpose

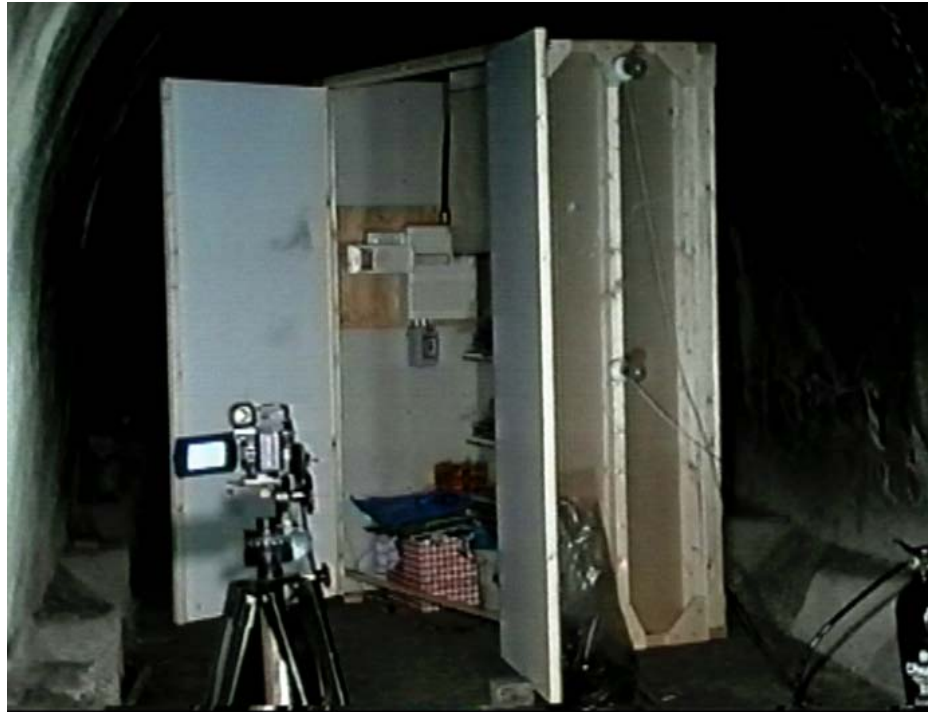
Fires with cupboard mock-up 2

- Ignition source - 2 of No 7 cribs on top of box of plastic aprons
- Cupboard doors left open
- Test videoed and still record taken
- mcbs under load and connected through light bulbs during test

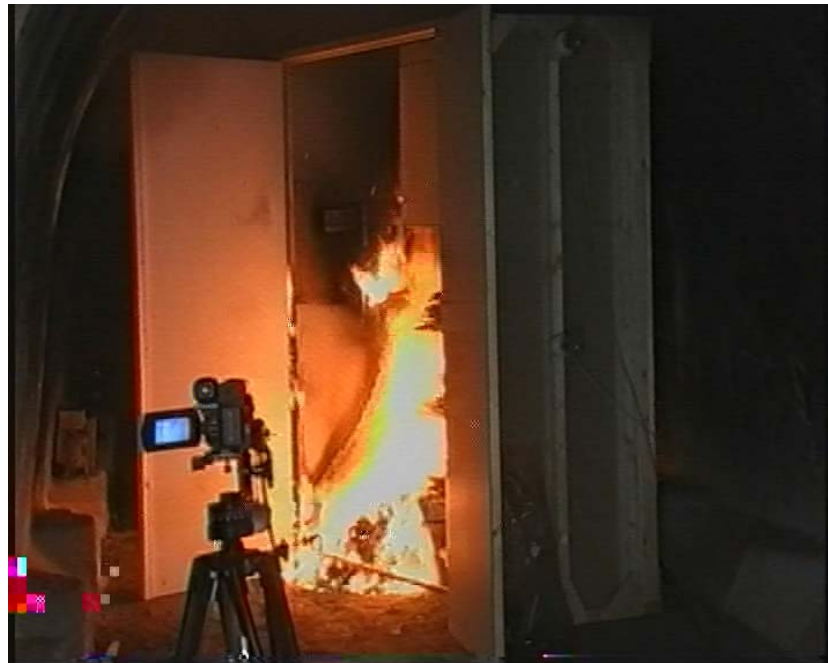
Fires with cupboard mock-up 3

<i>Time, minutes:seconds</i>	<i>Event</i>
00:00	Cribs lit, flames licking up around distribution board
03:10	Plastic mcb covers begin to melt and run
05:30	Flames begin to die back and pool fire beginning to form
11:00	Polythene aprons begin catch fire
12:05	Dripping molten burning polythene transmits fire to floor at front of cupboard
14:45	Cardboard box under polythene aprons catches fire
17:15	Residual current device casing begins to melt
18:03	Residual current device casing falls to floor
18:10	Bulbs go out within 2s of each other
19:55	Fire extinguishers arrive to tackle fire

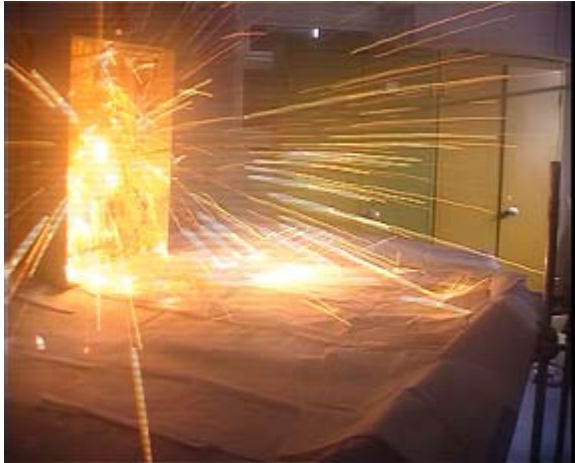
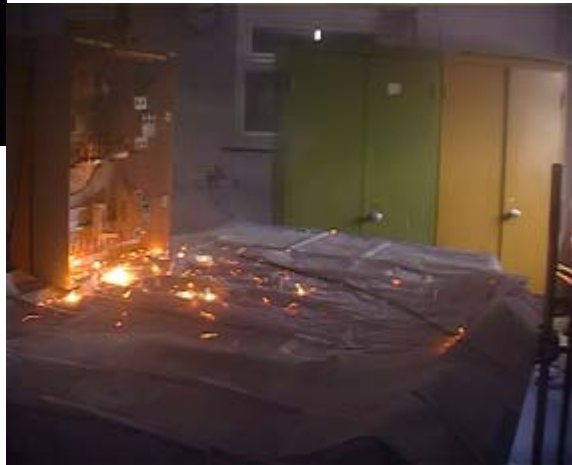
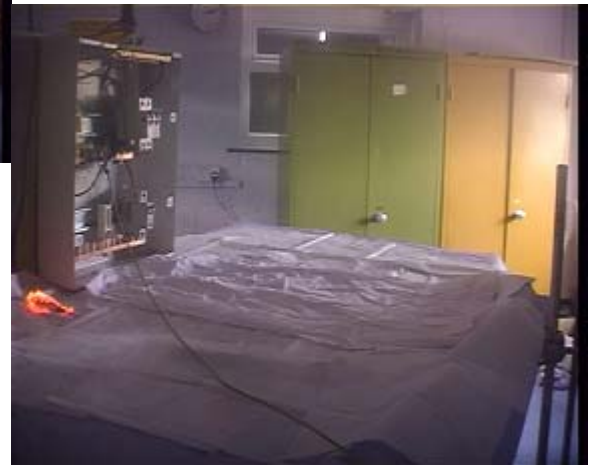
Potential for sparks to ignite cupboard combustibles 4

Cartridge fuse replaced with rewirable fuse wired with 1mm² copper

One ignition obtained with tissue paper

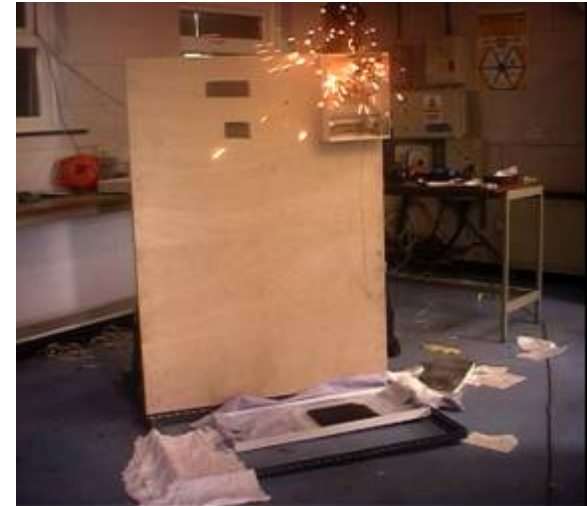
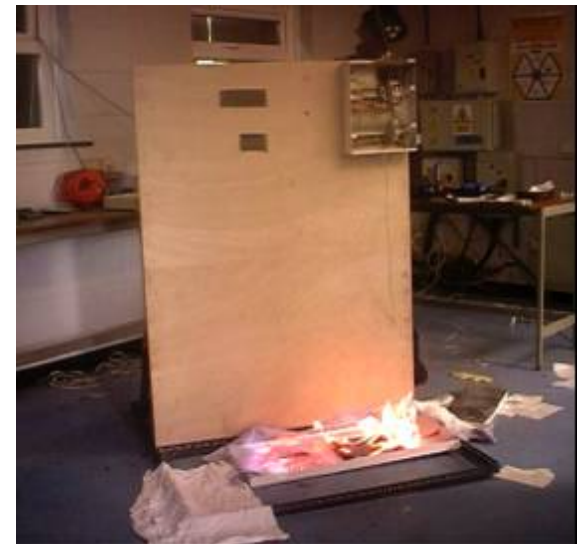
Height of target varied

One ignition obtained with foam

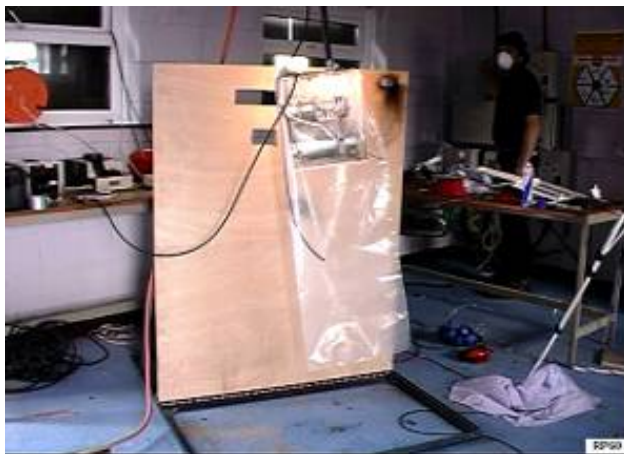
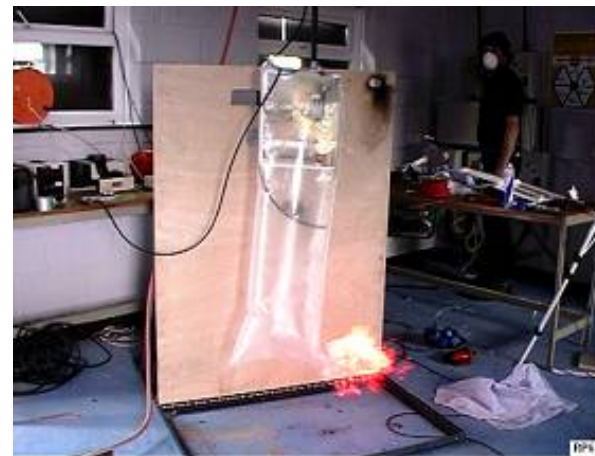
Aerosol can failure simulated by

(b) Spraying hairspray into the bag

Ignitions easily obtained in both cases

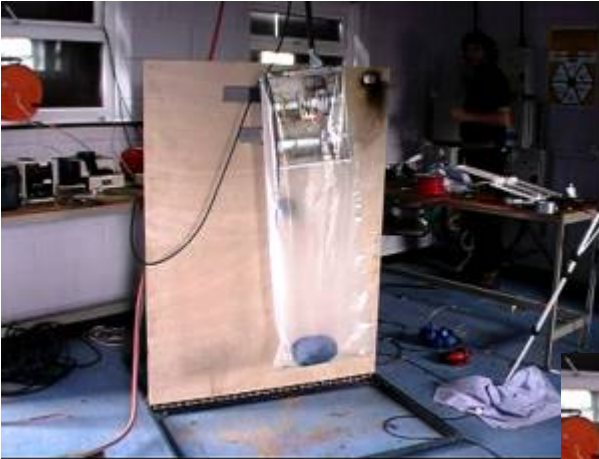
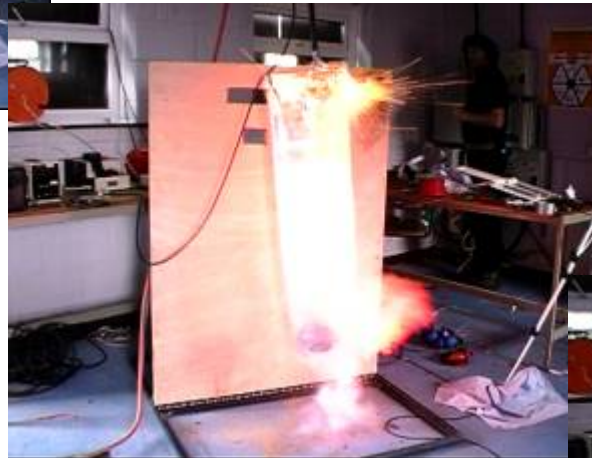
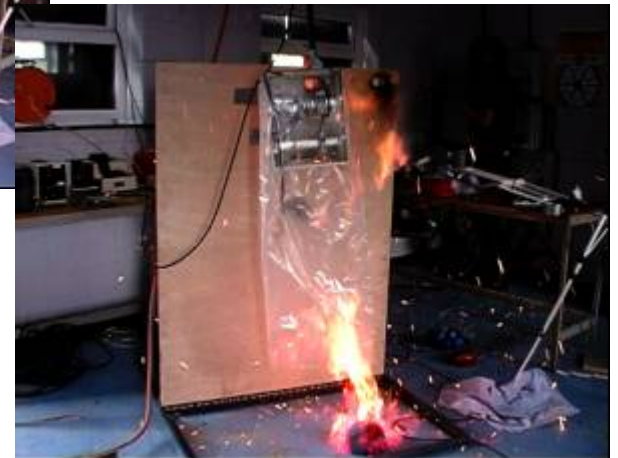
Potential for sparks to ignite cupboard combustibles 8

Acetone-soaked acrylic
